## 00479 ELECTROCHEMICAL CORROSION TESTING IN TWO MEXICAN PIERS

An electrochemical evaluation of two pier substructures was performed in order to contrast corrosion parameters and to find similarities or differences that could help to elucidate the environment effect on the structural performance, and to outline maintenance actions to extend both piers service lives.

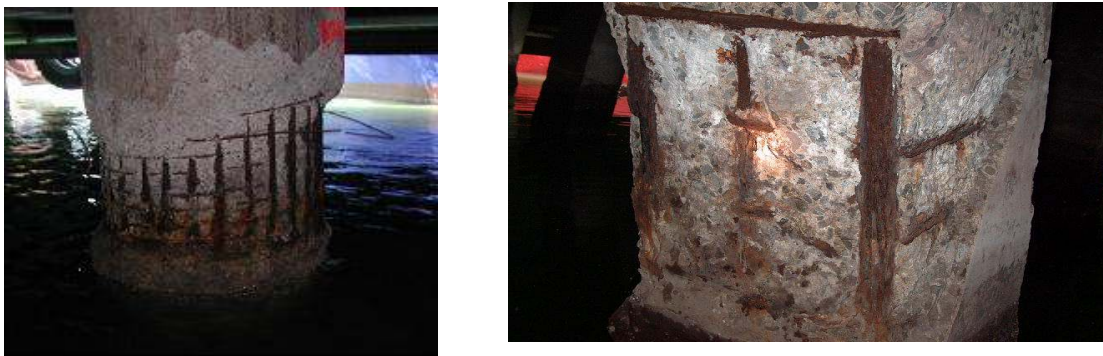
- All the major damage was found to be located on the pier substructure. The top surface of the concrete decks of both piers had no apparent defects except for abrasion or wearing of the concrete surface.
- Spalling of concrete was the most common defect found at the beams and the piles at both Piers. The spalling was noted at various stages, from developing crack lines to spalled cover concrete. This can be seen in Figure 1. Rusty reinforcement, or lack of reinforcement due to corrosion, was noticed at some areas where the concrete cover had spalled off. At locations where previous repairs were installed, the whole patch repairs had started to crack and spall due to the expected phenomenon of macro-cell corrosion. Figure 2 shows the occurrence of incorrect repairing.

Figure 1- Lack of reinforcement due to advanced state of corrosion on the North and South Pier respectively.

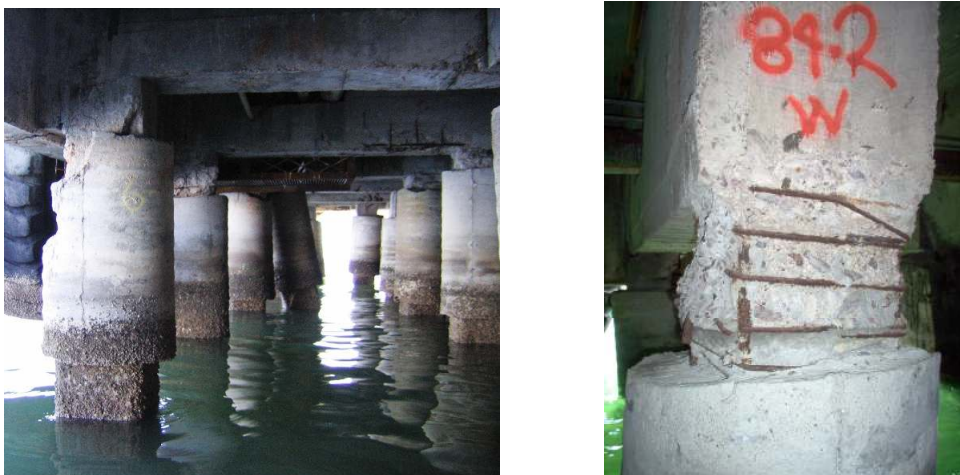
Figure 2- Incorrect repairing of a corroded pile on the North and South Pier respectively.

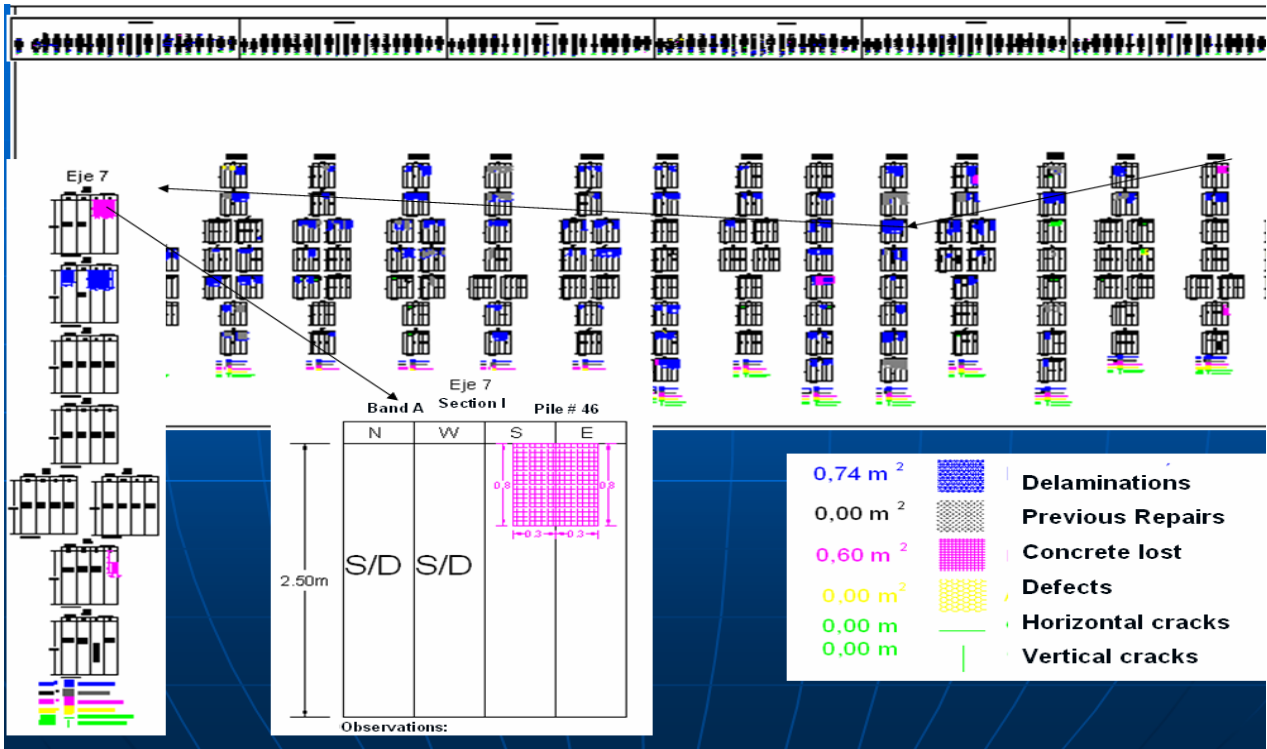
Figure 3 - Data survey example

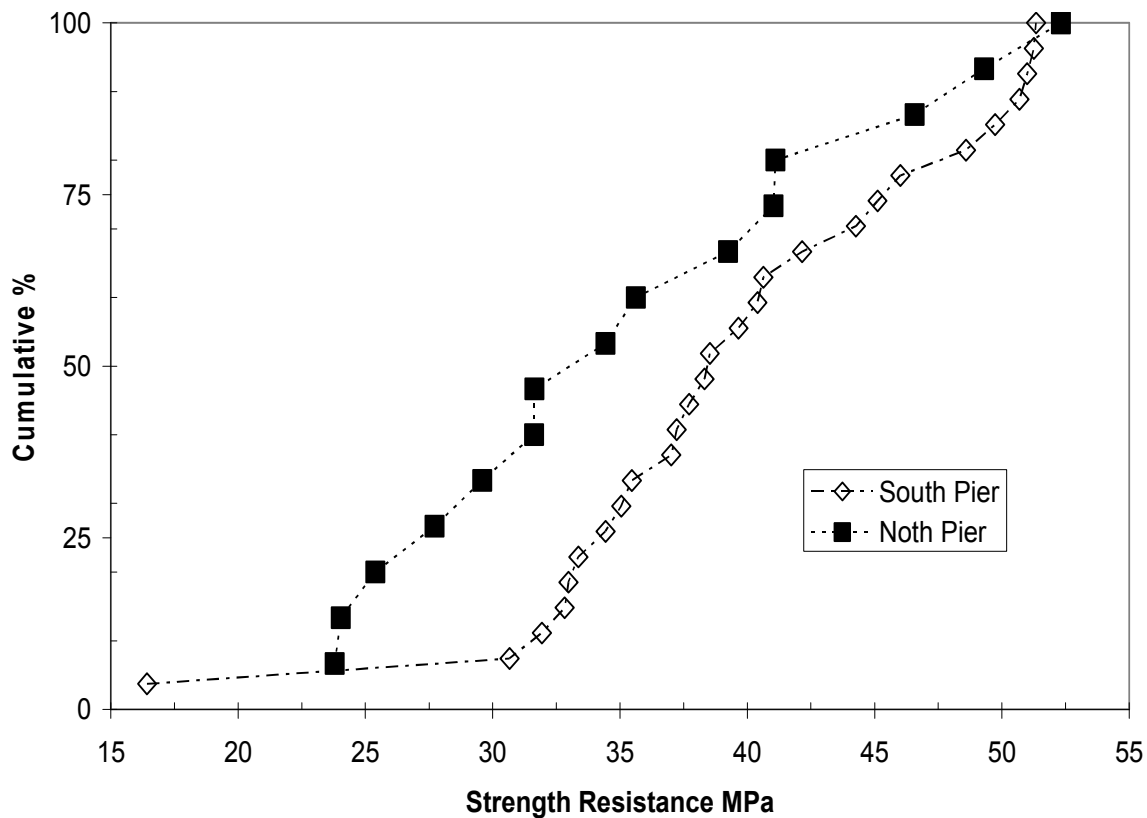
Figure 4 represents, in a statistical cumulative percentage, the strength resistance, for both piers. South Pier presented the highest compressive strength of its piles. The acceptance criterion was  $f'_{c-estimated} \geq f'_{c-design}$ , where  $f'_{c-estimated}$  is the value obtained from extracted cores and  $f'_{c-design}$  is the design compressive strength based on plan specifications. The average  $f'_{c-estimated}$  was  $39.7 \pm 8$  MPa (value written as average  $\pm$  standard deviation) for South Pier and  $35.6 \pm 9$  for North Pier. On the other hand,  $f'_{c-design}$  was 25 MPa for North Pier and 35 MPa for South Pier. Based on these estimates, the acceptance criterion was met (only two data points for North Pier were below 25 MPa and six data points were below 35 MPa for South Pier, see Figure 4). The variation coefficient provides a way to estimate the homogeneity of the concrete: average 26% for North Pier and average 23 % for South Pier is indicative of significant variations in the concrete fabrication procedure (mixture materials, water/cement ratio, concrete placement and compaction, curing, etc.).

Figure 4 - Strength Resistance for the North and South Piers.

Even though, the concrete compressive strength values complied with specifications ( $f'_{c-estimated} \geq f'_{c-design}$ ), the variability between data from piles at different locations in same pier is indicative of little quality control during construction of these two piers, as it is observed from Figure 4 results.

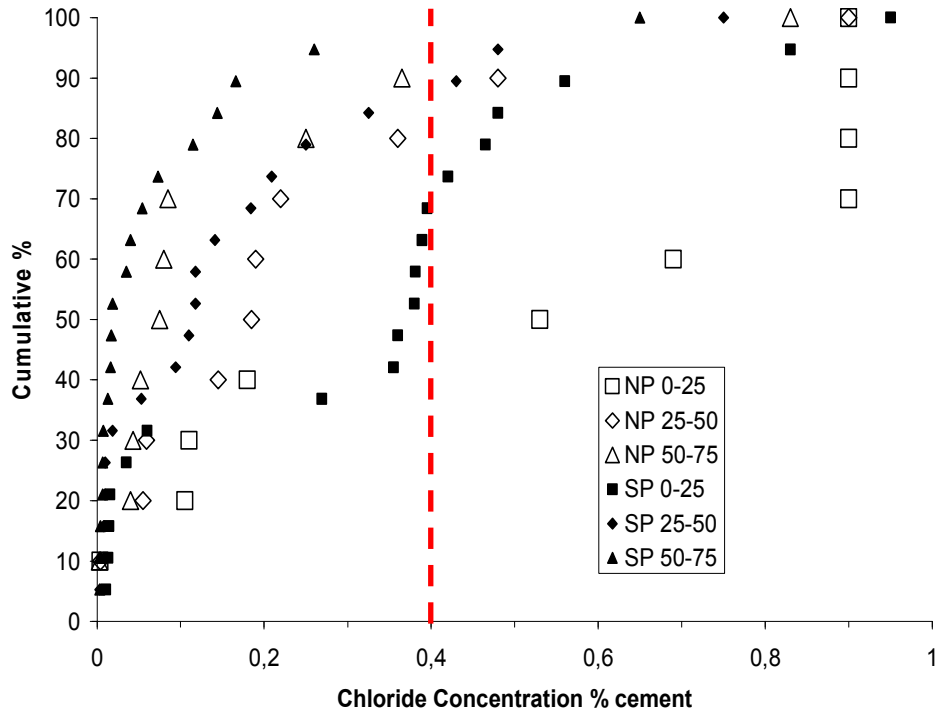
Chloride concentration levels (at three different concrete depths: 0-2.5, 2.5-5.0, and 5.0-7.5 cm) on South Pier were lower than those of North Pier (at similar depths). As seen in Figure 5, 50% of the data points at 0-2.5 mm depth were higher than the steel corrosion initiation threshold (0.4% per cement weight) [4]; only 25% of the data points at 2.5-5.0 cm exceeded the threshold for steel corrosion initiation (0.4% by cement weight); and no data points exceeded this threshold for concrete depths between 5.0-7.5 mm. The chloride concentration data obtained implies that the concrete service life was in the active corrosion or propagation stage. Even though chlorides level measurements were not carried out on the beams (due to the difficulty in obtaining samples), the fairly visible and widespread spalling of the concrete indicated that chloride levels on the beams would also have exceeded the threshold value.

Figure 5 – Chloride Concentration for both Piers at three depths.

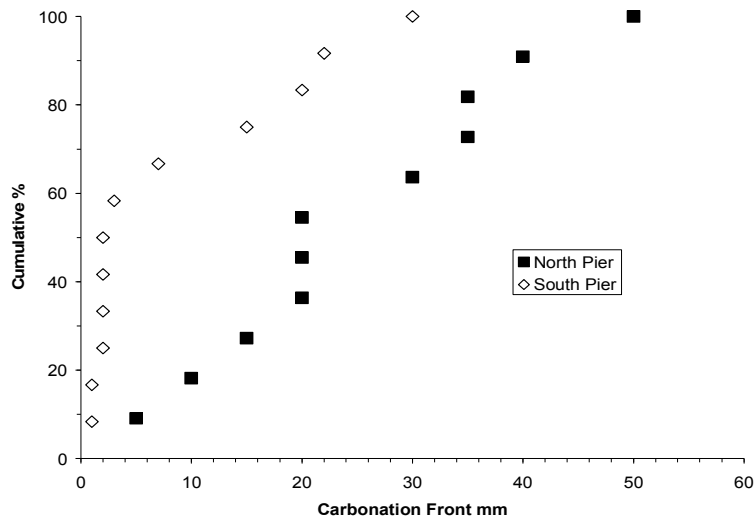
Apparently the high moisture of the closed environment where the piles are located, allowed the saturation of the concrete pores, thus preventing the penetration of  $CO_2$  or  $SO_2$  gas. Carbonation front reached only  $0.9 \pm 0.1$  cm on South Pier and 25 m on North pier, far from the more superficial steel reinforcement (3.5 cm) measured at South Pier and North Pier (4.2 cm). As can be seen in Figure 6, even though North Pier had a larger front than South Pier, both have not reached the reinforcement depth, so the carbonation did not contributed to the corrosion process.

Figure 6 - Carbonation Front for the North and South Piers.

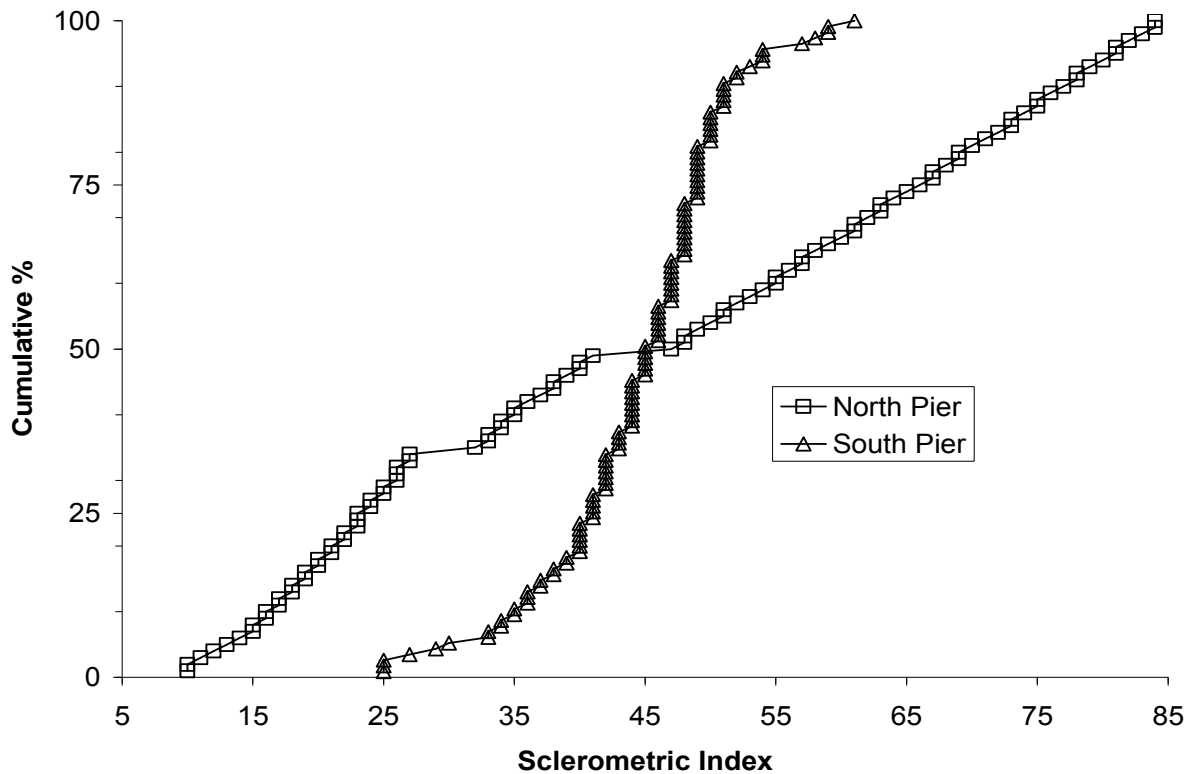
Figure 7 represents, in a cumulative percentage, the sclerometric index results obtained from both piers. The Rebound Index Number (RIN) was useful to determine the homogeneity of the concrete. The average value obtained from this test were for North Pier 46 RIN and for South Pier was 45 RIN (just as a reference, 1 MPa approximately 1.04 RIN). The experimental data variation coefficient for North Pier was larger (23 %) than the obtained for South Pier (7%) in concordance with the strength resistance as can be seen in Figure 4. This behaviour may be due to higher carbonation depths of North Pier, which in turn increase its apparent strength by filling the surface pores by calcium carbonate by products.

Figure 7 – Sclerometric Index for both Piers.

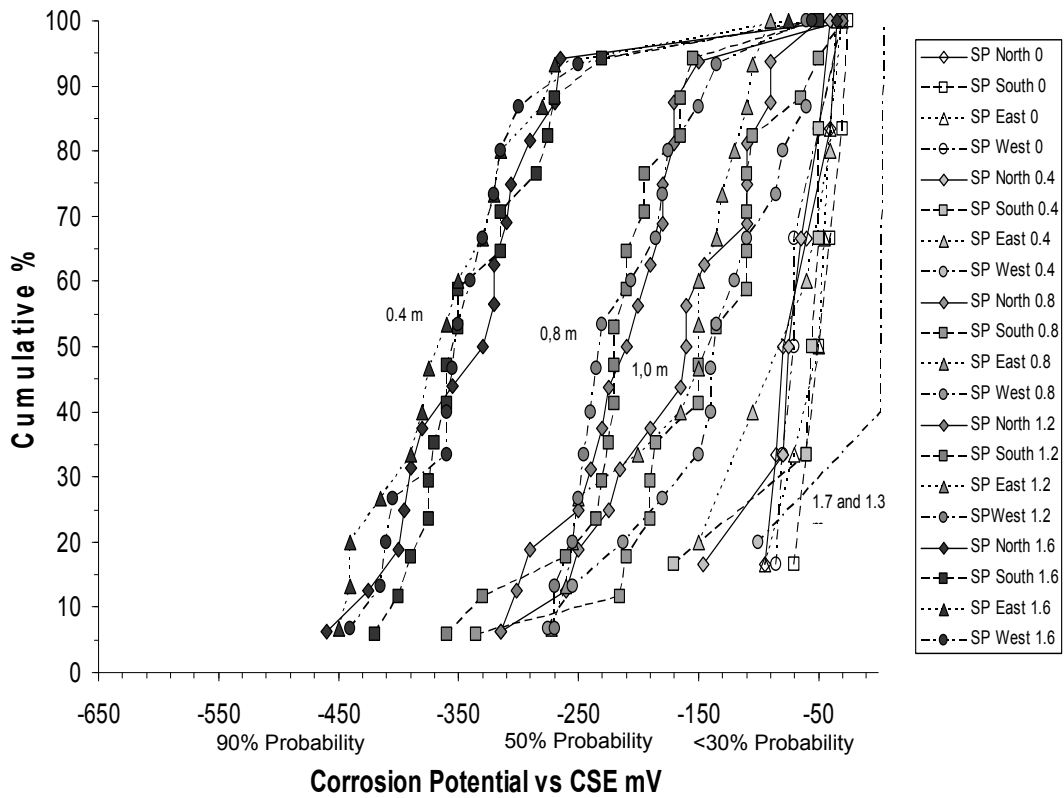
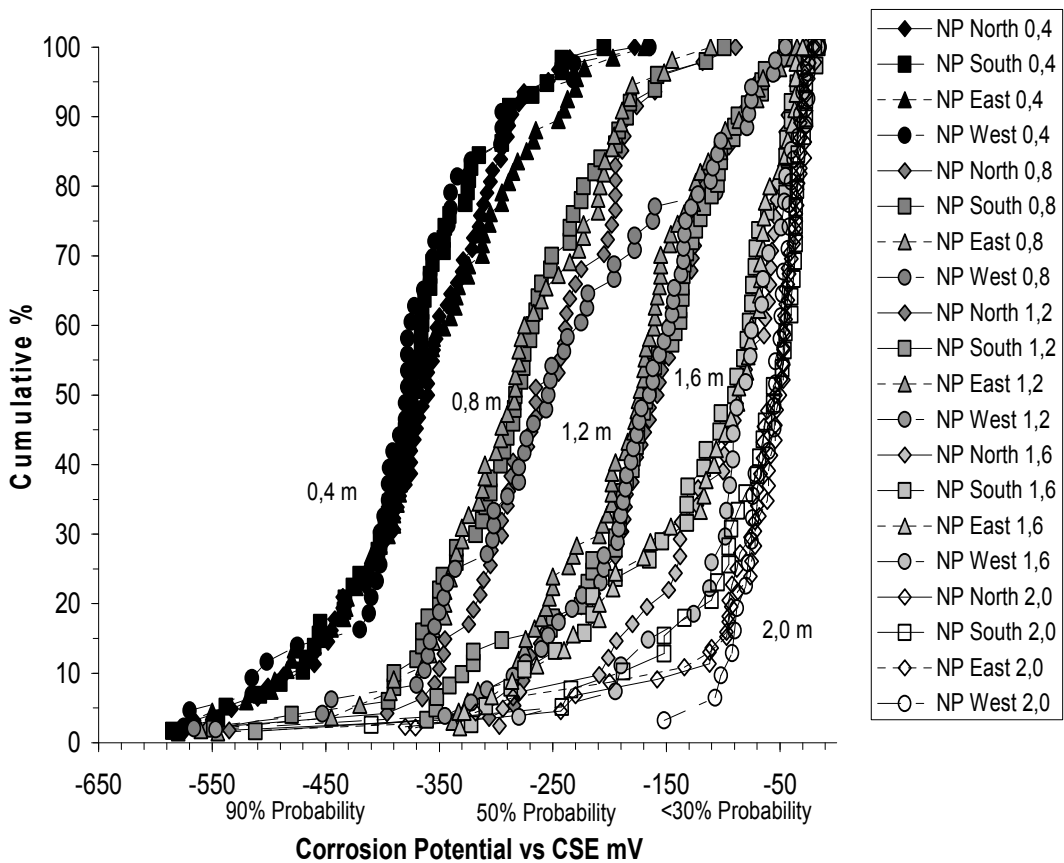
From this figure 40% of the measurements for North Pier and 25% for South Pier were typically in the range of -350 mV to -450 mV, mostly in the aerial zone where no spalling had occurred. According to ASTM C876-91:1999 [5], there is a 90% probability that corrosion had started in these zones, based on the half potential measured. It was also observed pitting corrosion of the steel in piles, resulting in a cross section reduction in many cases over 15%, hereby affecting the load carrying capacity of the piles and consequently the stability of the entire structure.

The values obtained on North and South Piers revealed active corrosion potential located at approximately  $\pm 40$  cm from high tidal level. In this area, about 60% of readings were more negative than -250 mV, and among them, over 25% were more negative than -350 mV, which means that there is a likelihood of 90% of active corrosion at this zone. Eventually, some piles presented more negative potential values than -350 mV until -550 mV for North Pier and -450 mV for South Pier. Well defined potential differences were observed as a function of height AHT. As observed from Figure 8, pile face orientation did not show any half cell potential difference in any of the Piers. On the other hand, results obtained show more negative reinforcement potential values at lower pile heights, in accordance with chloride concentrations obtained at similar position AHT.

Figure 8 – Rebar half cell potential for North and South Piers, respectively, as a function of height AHT.

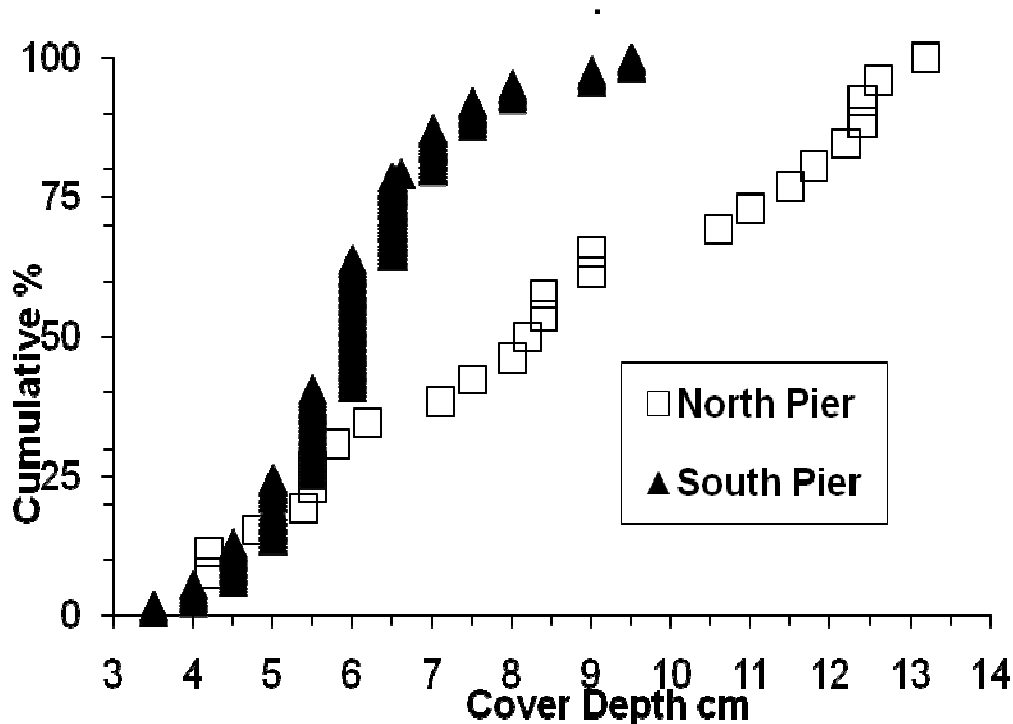
The main purpose of this test was to find the concrete cover depth to which the reinforcement was located, as well as their diameter. Noticeable variation registered in the measured steel reinforcement concrete cover depth: between 2.5 to 13.2 cm ( $8.4 \pm 3.1$  cm) for North Pier, and 3.5 to 9.5 cm ( $6.6 \pm 1.1$  cm) for South Pier. Figure 9 shows all measurements obtained, implying once again inconsistencies during the construction process and/or during the previous repairs.

Figure 9 – Reinforcement Cover Depth for both Piers.

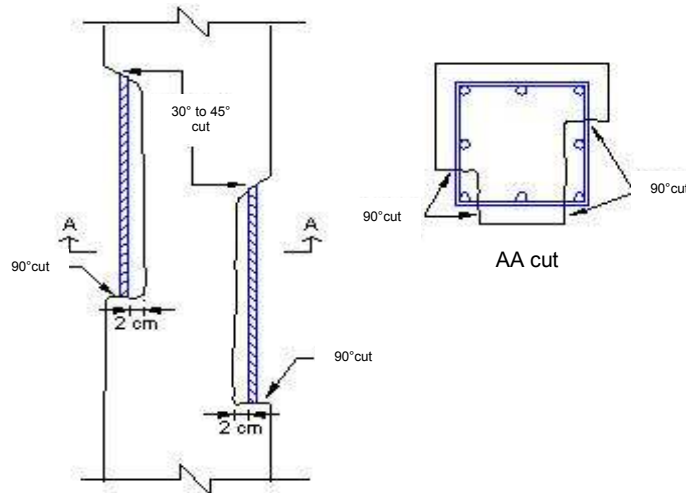
Figure 10 – Rehabilitation procedure for both Piers.

1. Detect and mark the steel rebar position. Explore by tapping with a hammer and delimit the damaged areas using a disk cutting machine. The cut must be done keeping the disc always perpendicular to the surface and penetrating depth of at least 1.5-2 cm or the minimum necessary to avoid damaging the existing steel. Only in the upper horizontal cuts of areas to repair, the cut should be from 30 to 45 ° inclination downward, in order to ensure that the upper parts of the area is completely fill. (Figure 10).

2. Remove the concrete in the demarcated area using pneumatic hammers of maximum 20 pounds to avoid weakening the healthy concrete or hurting the steel reinforcement. It should be reviewed that the equipment used does not have any damage which could mean an oil spillage which would pollute the area and could endanger adherence with the repairing materials. The clearance should be to a depth of at least 2 cm behind the corroded steel so it can be cleaned up in its entirety. If beyond the borders of the demarcated area corrosion is found, the removal of concrete should continue at least 10

cm after finding healthy steel. The edges of this new clearance also must be shaped with disk cutting machine as described above. It is very important to seek precautions during this work as regards a correct underpinning of the pile. The underpinning should not be withdrawn until the repair is completed and the repairing material has reached at least 80% of its strength. It is also recommended to switch both transverse and longitudinal axes to do not lead to the formation of a weak area in the structure.

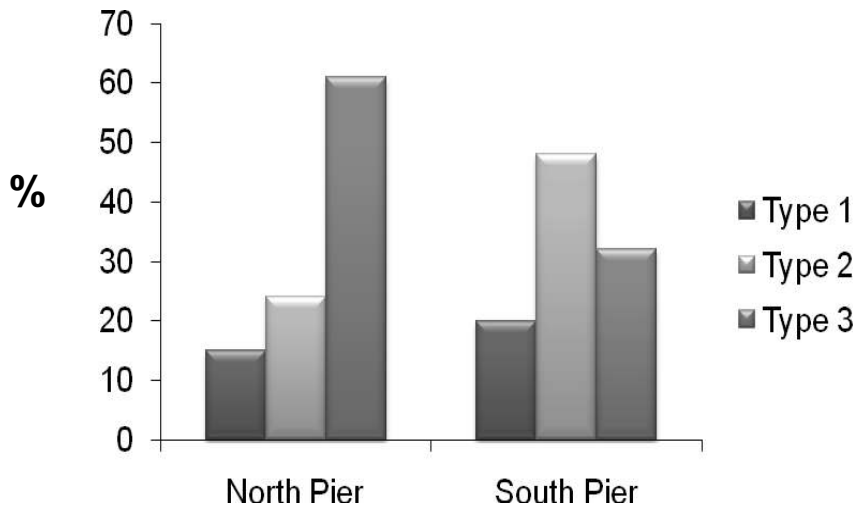
Figure 11 shows the differences on the kind of rehabilitation required on both piers, this means that the structure's characteristics play an important role on its durability. Even though South Pier was built 20 years after North Pier, the first had a higher chlorides concentration and a lower concrete cover which could be a determining factor on the corrosion process. South Pier had a more generalized corrosion, 68% of the piles must be repaired, compared with the 39% of the North Pier.

Figure 11 – Comparison of rehabilitation type between North and South Piers.

Piles classified as Type 1 (412 piles for North Pier and 826 piles for South Pier) should be repaired using a concrete with micro-silica and super-fluidificants to be capable of supporting a tremie type system. Steel should be replaced by using mechanical connectors and to warranty the adhesion of new to old concrete, the area should be moistened with free chlorides water for at least 4 h previous to the concrete positioning, additionally, it should be applied a galvanic cathodic protection system.

Piles classified as Type 2 (651 piles for North Pier and 2014 piles for South Pier) should be repaired using an self-levelling expansive mortar, with aggregates of 12 mm up to 30 % maximum weight of the mortar and the area to repair should moistened with chlorides-free water for at least 4 h before concrete positioning. In addition it should be installed a galvanic cathodic protection system to the boundary of patch repairs to protect against macro cell corrosion, thereby mitigating corrosion of steel around patch repairs.

Piles classified as Type 3 (1601 piles for North Pier and 1337 piles for South Pier) should be installed a cathodic protection system as a sustainable long term remedial option, the
