RÍO PAPALOAPAN BRIDGE: DESIGN AND SUCCESSFUL APPLICATION OF SPECIAL NON DESTRUCTIVE INSPECTION TECHNIQUES

J. A. López-López, J. A. Quintana-Rodríguez, F. J. Carrión-Viramontes, José Luis Moreno-Jiménez

Instituto Mexicano del Transporte, Carretera Querétaro-Galindo Km. 12, 76703, Sanfandila, Pedro Escobedo, Querétaro, México.

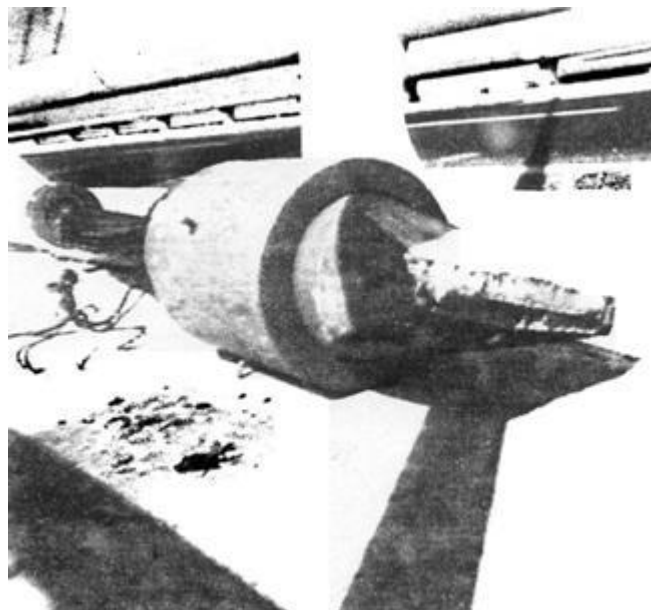
In January 2000, the failure of the upper anchorage element from cable 11, semi-harp 7 (Fig. 4), led to a series of analysis, concluding that its constitutive material was structurally deficient [3,4].

Figure 4 - Failed upper anchorage element from cable 11, semi-harp 7, occurred on January 2000 [3].

While the fracture took place close to the heat affected zone (HAZ), two initial hypotheses were focused on the steel quality of the upper anchorage element and on the heat treatment process given after welding. Later results showed that, although the chemical content of the material, and the yield and ultimate strengths were all within design specification of ASTM A148-80/50 steel [5], three main problems were identified [4]. As the piece was manufactured from a cast process; first, it had a high content of pores (Fig. 5); second, the steel was not properly normalized with a large grain size microstructure (ASTM 2) as it can be seen in Fig. 6; and third, elongation was 3%, far below to the 22% specification.

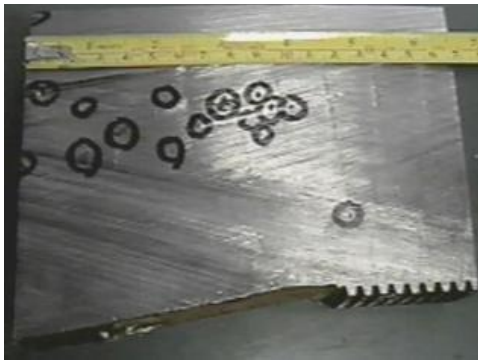
Figure 5 - Section of the upper anchorage element with high content of pores

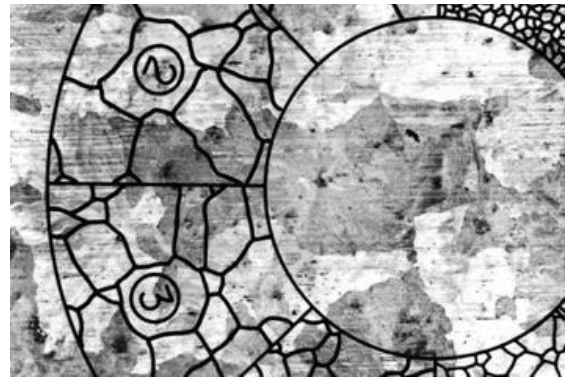
Figure 6 - Picture of the upper anchorage steel microstructure

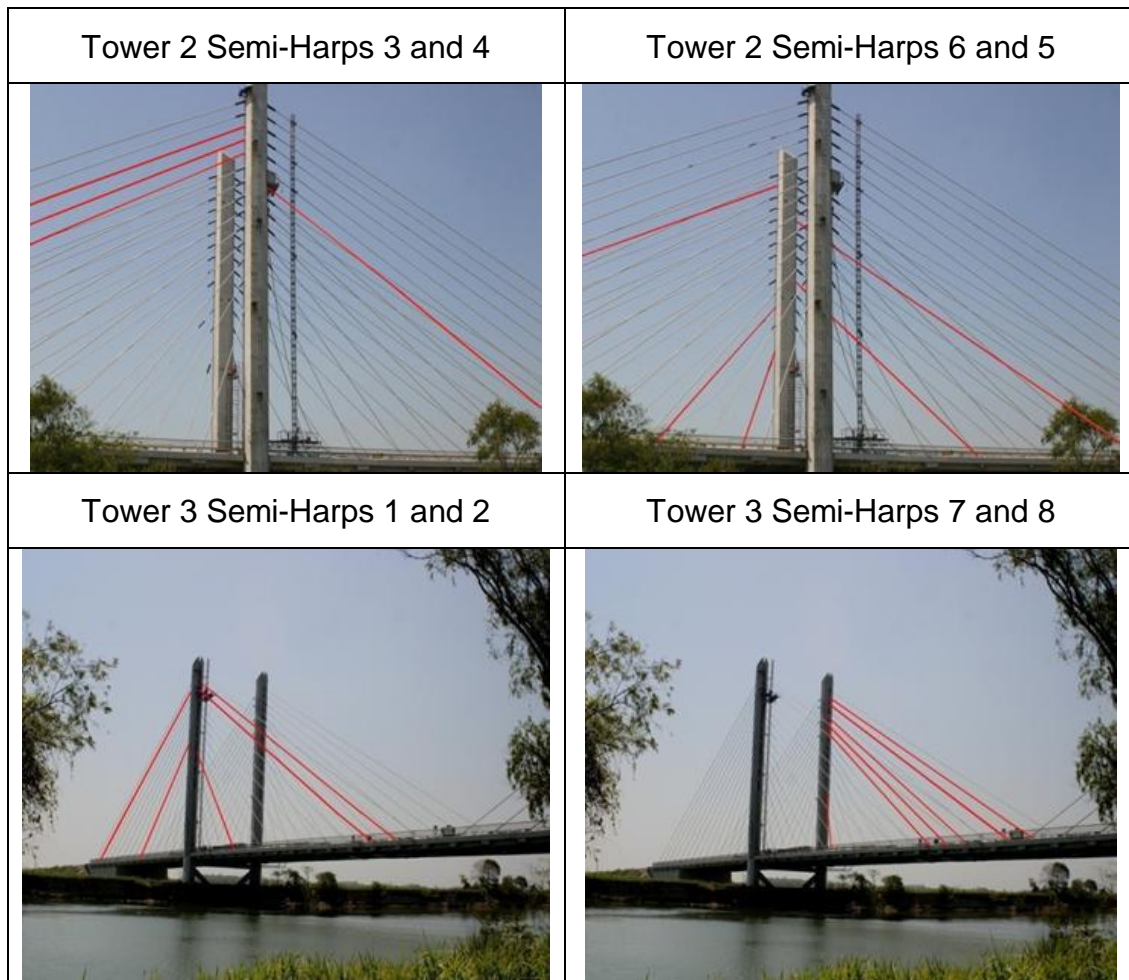
Once the structural deficient elements were identified, a rehabilitation project was proposed to replace these elements and an integrity analysis was required to evaluate the structural reliability of the remaining elements, considering the statistical characterization of their microstructural, mechanical and chemical properties. While the characterization from the 16 deficient elements was not sufficient, 4 elements classified as in good condition were included in the rehabilitation project to obtain the complementary data necessary to characterize statistically all the elements (Fig.12). For the good condition elements, 1 was type 1, 2 were type 2 and 1 was type 3.

Figure 12 - Elements proposed to replace.

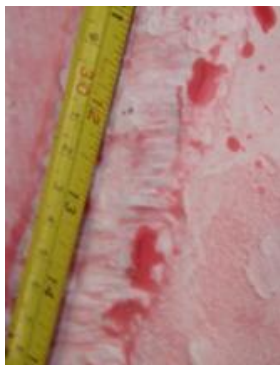
(a) Element Id. No.
10

Flaws and cracks detected from the inspections on the welded union are reported in Table 5 and pictures from the penetrant inspections are shown in Fig. 16 (elements not included in table 5 had no flaws or cracks). As it can be seen, flaws were detected with ultrasonic inspection in one case, for an anchorage element with fine grain size but with high pore content. At the same time, with penetrant inspections, critical cracks were identified in three different welds with no clear correlation to the grain size, but most probably to the welding process quality.

Figure 16 - Cracks detected with liquid penetrant testing (PT) in the welded union
