# EVALUATION OF SOME RESULTS OF THE 2010 AASHTO HIGHWAY SAFETY MANUAL

A. MENDOZA, G. SAUCEDO & E. ABARCA

In this paper, the HSM methodology is applied to the section Ciudad Mendoza-Córdoba, which corresponds to a stretch with high accident rate along the Puebla-Córdoba toll road, being the latter one of the most congested in the country and a communication axis between the central highlands and the southeastern part of the country. The results thus obtained are compared with those of a safety inspection carried out in that section; the previous, for the purpose of evidencing benefits and disadvantages of using either of the two approaches.

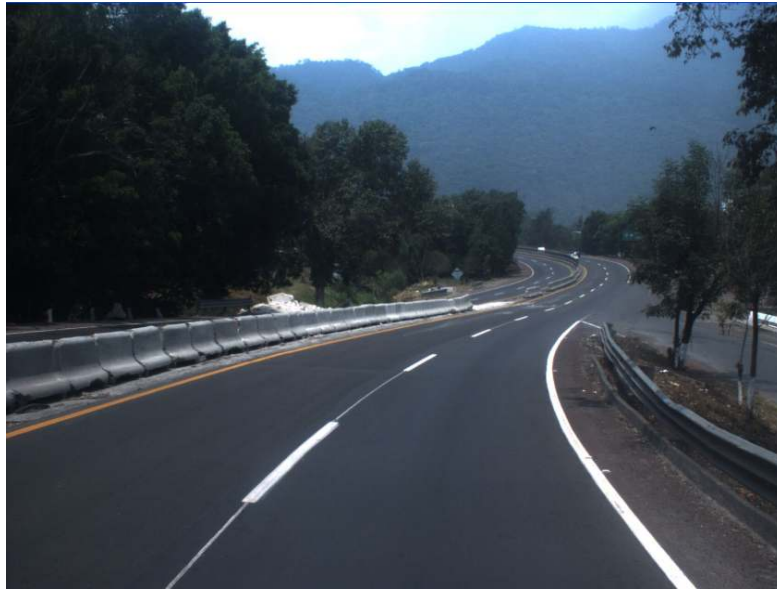
The segment is located in a right horizontal curve with a degree of curvature of approximately  $6^{\circ}30'$  (for a speed of 70 km/h). At the end of the curve there exists the access to Río Blanco and Nogales. The width of the lanes falls slightly below the statutory dimensions (smaller than 3.5 m). The width of the shoulder is insufficient (less than 0.5 m the internal and than 2.5 m the external). The horizontal signing at the weaving area is not suitable to channel the vehicles. The vertical signing is scarce since there are no signs indicating the approach to a semiurban and vehicle weaving zone. There are no devices to assist in delimiting the curve alignment. The concrete modules of the central barrier have been crashed and in some cases they are discontinuous, particularly at the weaving area, as it can be observed in Figure 2. A considerable percentage of vehicles exceeding the maximum speeds allowed by the visibility has been detected.

**FIGURE 2 Discontinuous concrete central barrier in Segment 1**

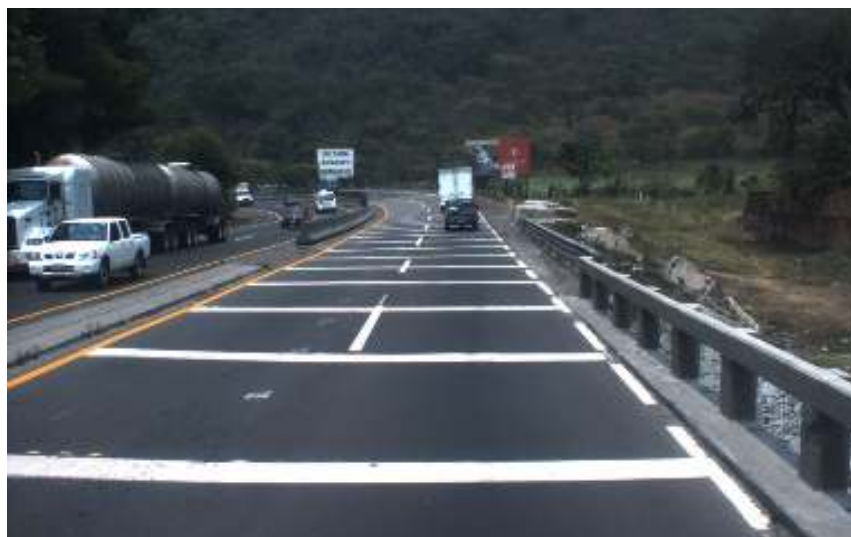
The site is located in a left horizontal curve with a degree of curvature of approximately  $5^{\circ}00'$  (for a speed of 60 km/h). The width of the lanes is found slightly below the standard dimensions. The width of the shoulders is insufficient. The bridge before the curve has no external shoulder and therefore its cross section decreases along this structure (see Figure 3). The concrete modules of the central barrier have been shattered and in some cases they lack the necessary continuity. In this curve there are no inlets at the median to capture the runoff coming from the one-way traveled way bound for Córdoba, and therefore such runoff crosses toward the one-way traveled way of the other direction generating problems to the vehicles moving along such traveled way at the site of the curve.

**FIGURE 3 Reduction in the cross section of the bridge at Segment 2**

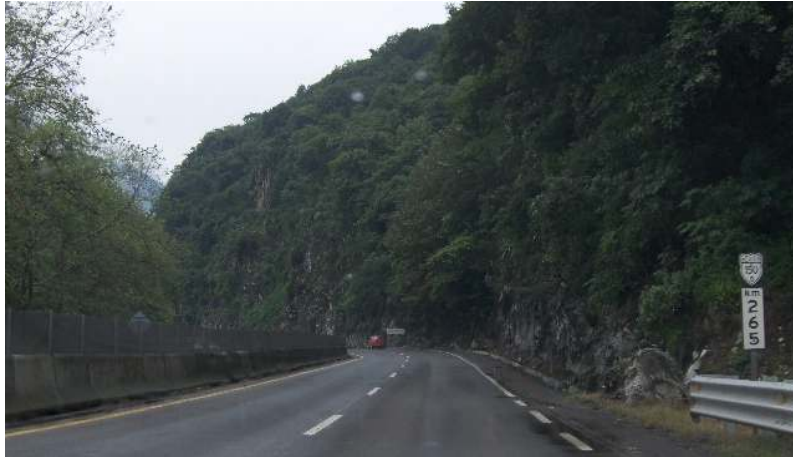
The segment is located in a left horizontal curve with a degree of curvature of approximately  $5^{\circ}00'$  (for a speed of 60 km/h). The width of the lanes is found slightly below the standard dimensions. The width of the shoulders is insufficient and this provides the driver a feeling of narrowness, in addition to have a very high cut on the side of the external shoulder. This segment evidences rock fall problems coming from the cut slope, probably due to the unstable condition of the slope itself (see Figure 4). Some concrete modules of the central barrier in this segment have been hit.

**FIGURE 4** Cut slope at Segment 3

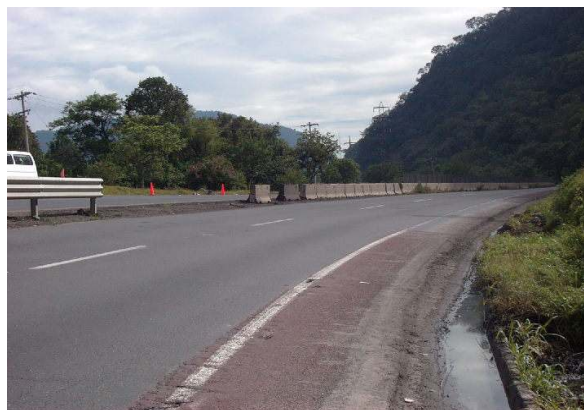
The segment is located in a right horizontal curve with a degree of curvature of approximately  $6^{\circ}00'$  (for a design speed of 60 km/h). The width of the lanes is slightly smaller than the standard dimensions. The width of the shoulders is insufficient. The segment lacks protective devices in its respective drainage works (side ditches and culverts). The horizontal signing includes marks with logarithmic spacing before the horizontal curve that fails to comply with the suitable spacing, and shows faded paint. Vertical signing is scarce. In what refers to the retaining devices, the central concrete barrier that separates the two one-way traveled ways evidences poor condition and lacks continuity in several parts, as can be observed in Figure 5. The visibility in this segment is very reduced and it is not suitable for the operating speeds registered.

**FIGURE 5** Condition of the central barrier in Segment 4

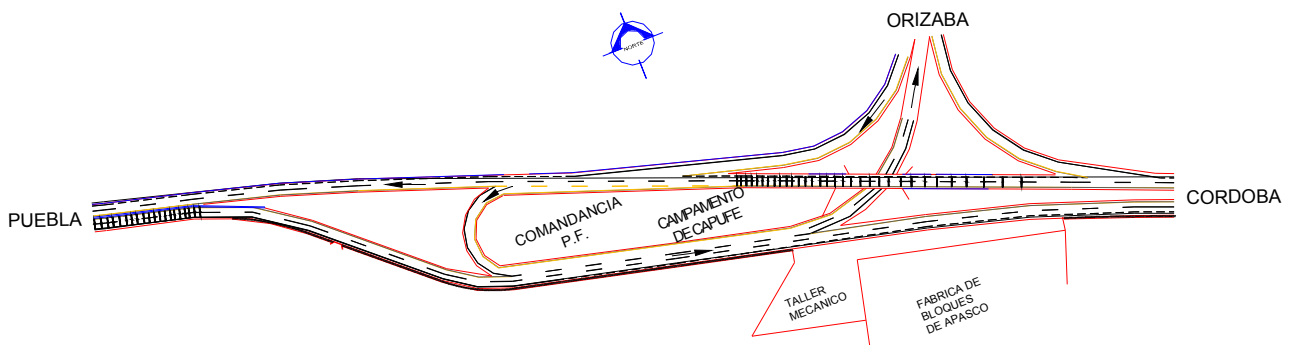
The segment is located along a right horizontal curve with degree of curvature equal to approximately  $6^{\circ}00'$  (for a design speed of 60 km/h). The width of the lanes falls slightly below the regulation dimensions. The shoulder width is insufficient and there is also a rather high cut on the right side. In this site the two one-way traveled ways are split to accommodate a campment of CAPUFE, as well as a detachment of the Federal Police (PF), corresponding this segment to the one-way traveled way from Puebla toward Córdoba as shown in Figure 6. A U-turn also exists at this place as well as an exit loop passing through the lower part of a vehicular overhead crossing bound for the city of Orizaba. This site is characterized by accidents due to the weaving between the vehicles taking the exit loop to Orizaba and those leaving the U-turn and heading toward Córdoba. At the horizontal signing in the segment there are marks with logarithmic spacing that fail to comply with the suitable spacing, in addition of being faded. The visibility at this site is very poor both along the curve and at the weaving zone, being the visibility insufficient for the speeds of the through vehicles and of those that weave.

**FIGURE 6 Weaving of vehicles at Segment 5**

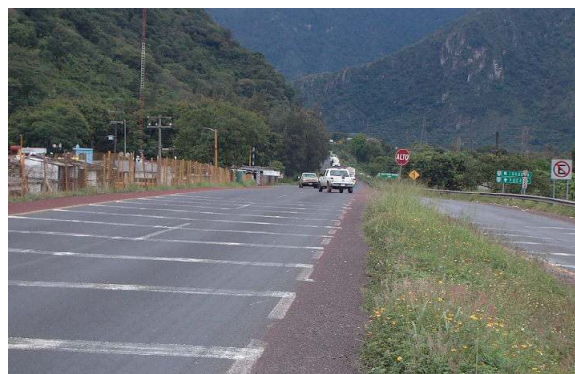
This segment is located at the same site than the previous segment, but along the one-way traveled way from Córdoba to Puebla as shown in Figure 6. The width of lanes and shoulders falls quite below the standard dimensions. There is coincidence in this segment, in a very short length, of the incorporation of the road coming from Orizaba, which has no acceleration lane, as well as the weaving of vehicles coming from Orizaba and taking the U-turn, with those going through toward Puebla. The horizontal signing is in poor condition due to lack of maintenance and presents low reflection rate at all lane separating lines, shoulders and logarithmic lines (see Figure 7).

**FIGURE 7 Horizontal signing in poor condition at Segment 6**

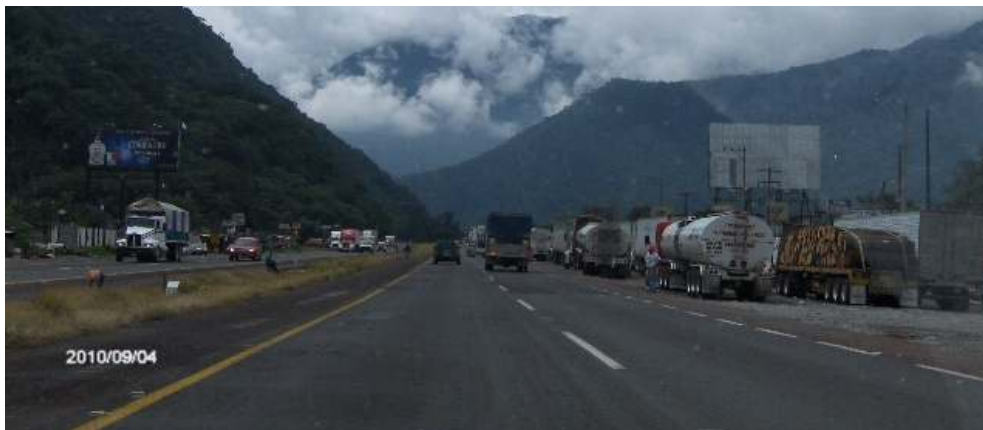
This segment is located at a straight stretch with descending vertical grade in the one-way traveled way bound for Córdoba and with upgrade slope at the one-way traveled way bound for Puebla. Lane and shoulder widths are satisfactory. In both one-way traveled ways of the segment there are commercial and service areas that constitute an irregular stop, being the main users the operators of freight trucks. As it can be observed in Figure 8, these vehicles park in two lanes encroaching the shoulder; there is also a steady stream of pedestrians crossing the road. There is no retaining element separating the vehicles parked at the stops from the normal flow of the roadway, and no pedestrian bridge or pedestrian protecting barrier are available. The horizontal signing is in poor condition. There are not some preventive and restrictive signs to inform drivers about the presence of the truck stop and of the services, nor to restrict parking over the shoulders.

**FIGURE 8 Irregular parking of freight trucks at Segment 7**

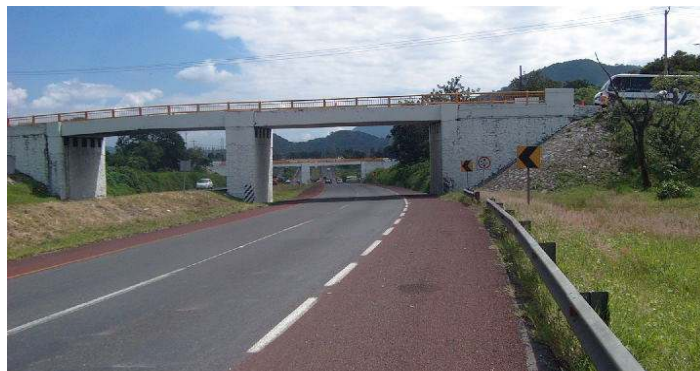
This segment is located in a straight section where there is a directional exit bound for Jalapilla that has a transition to channel vehicles, followed by a left curve with a degree of curvature of  $4^{\circ}10'$  (with a radius of 275 m). The combination of the curve and of the abutment of the overhead crossing represent a risk for speeding drivers (see Figure 9). There are neither marks nor protective elements for the structures, such as in the case of the abutment of the vehicular overhead crossing.

**FIGURE 9 Trajectory projecting towards the right abutment of Segment 8**

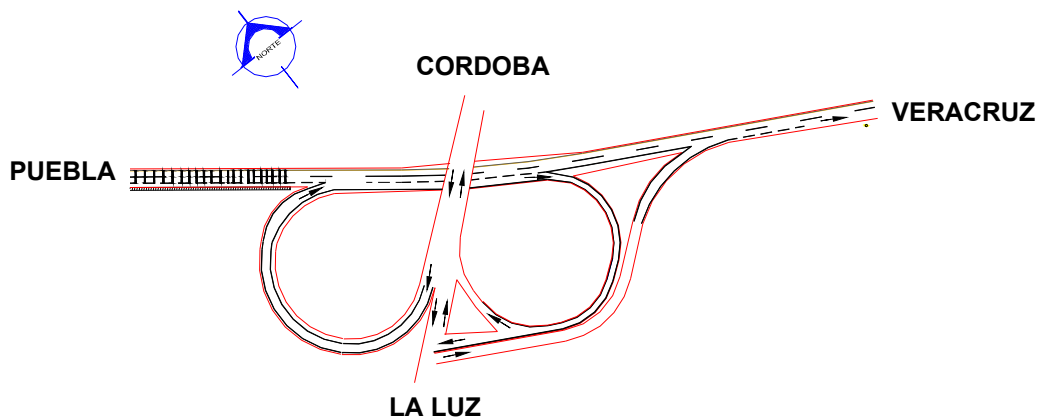
This segment is located in a straight section with descending vertical grade followed by a left curve with a degree of curvature of  $2^{\circ}06'$ , succeeded by another straight stretch. Between the first straight sector and the start of the curve there is an incorporation coming from Córdoba and right at the end of the curve the exit bound for Córdoba and to the town of La Luz is located; then, just after the second straight section there exists an incorporation coming from La Luz. Between the incorporation coming from Córdoba and the exit there exist a vehicular overhead crossing, with a distance of 120 m for the weaving. The width of the lanes and of the shoulder falls below the regulatory dimensions. The segment operates as a vehicle interchange in which at the weaving area, long waiting lines form to take the exit to Córdoba (see Figure 10). The through vehicles fail to decrease their speed in spite of the existence of the logarithmic lines. The combination of the abutment for the overhead crossing and the left curve represent a risk for the speeding drivers.

**FIGURE 10 Operation at Segment 9**

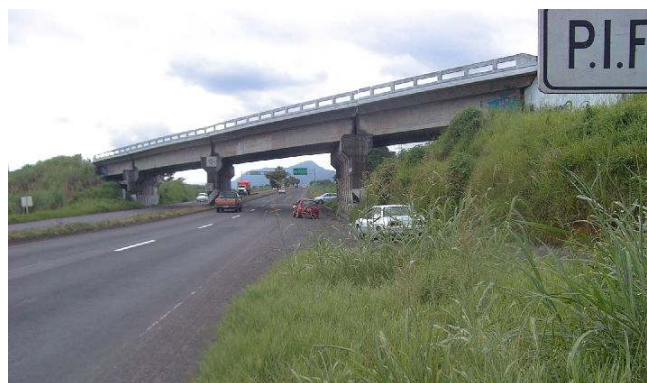
The segment is located at a straight stretch with upwards vertical slope. The segment contains in the first place an exit bound for Amatlán followed by an incorporation originating in the same place. Vehicles coming from Amatlán are incorporated into the expressway under an angle such that they have minimum visibility to be able to incorporate safely, with an additional disadvantage of a thick vegetation and the lack of an acceleration lane to be able to negotiate suitably the incorporation. This problem causes the vehicles to incorporate into the expressway at low speeds (see Figure 11). The horizontal signing is poor. There are neither certain preventive vertical signs, nor marks and protection devices for the structures.

**FIGURE 11 Conditions of the incorporation into the expressway at Segment 10**
