THE BRIDGE MANAGEMENT OF A TOLL MOTORWAY NETWORK RESULTS OF CURRENT DEVELOPMENTS AND IMPLEMENTATIONS

R. PÉREZ ARENAS & C. MILLÁN, Abertis Autopistas España

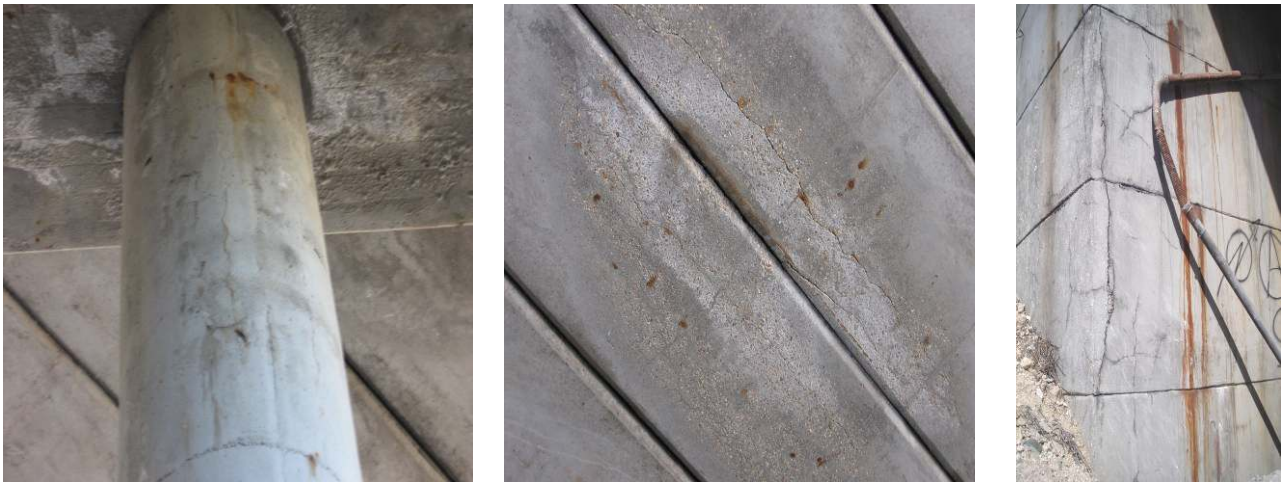
- There was no structure having indications of having a lack of the load capacity due to some damages on the structural elements.
- The 44% of all the structures have some cracks on structural elements, but the size of the cracks was usually small ($< 0,5$ mm), and so the bearing capacity was not affected.
- There were less than the 20% of all the structures having cracks due to corrosion; this is because the concrete use to be very compacted and the weather atmosphere was not very aggressive.

Figure 2 – Some crack son piers, decks and front walls

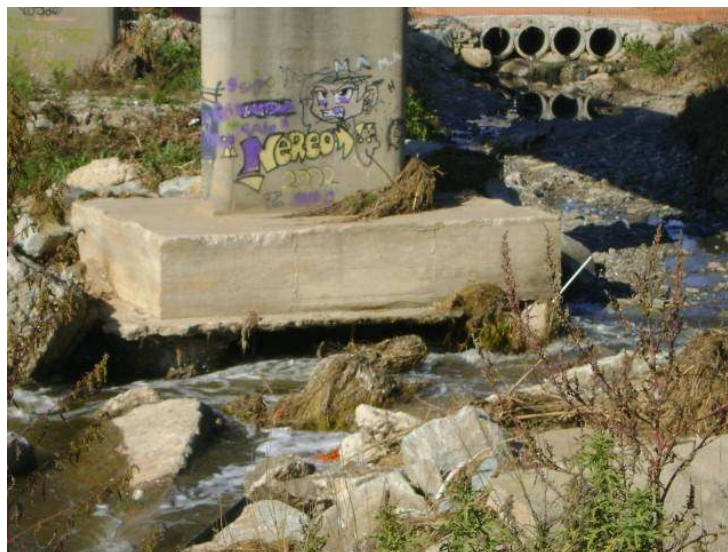
- There were settlements of the foundation, tilting of some walls or other damages due to scour problems on 23 structures.

Figure 3 – Scour effect on the foundation of a pier

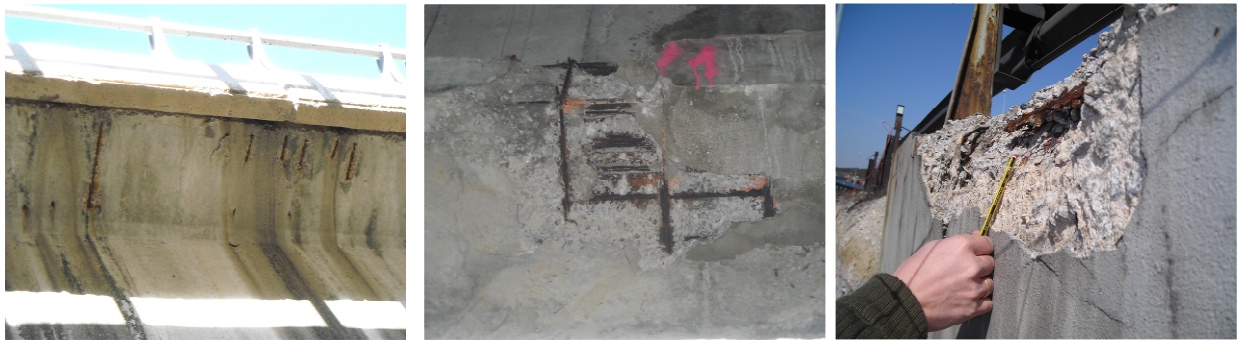
- There were 10000 m² of spalling on the concrete and some 26000 m² of reinforcing without cover and showing some indications of corrosion, but with no indications of structural affection.

Figure 4 – Loss of the cover and corroded reinforcing. Spalling of the concrete.

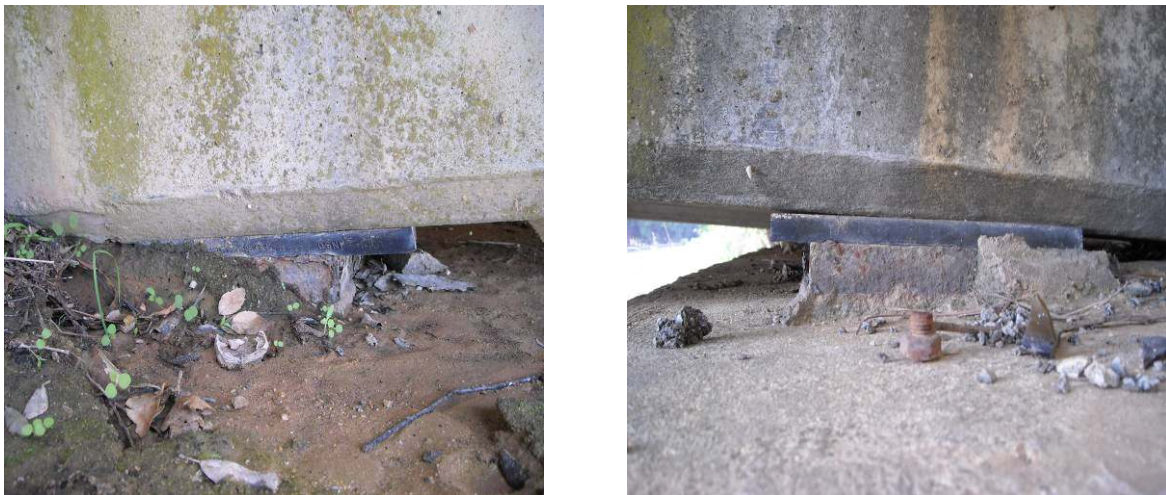
- There were some damages on the bearings of 263 bridges, that is nearly the 8% of the total structures.

Figure 5 – Blocked bearings o out of place

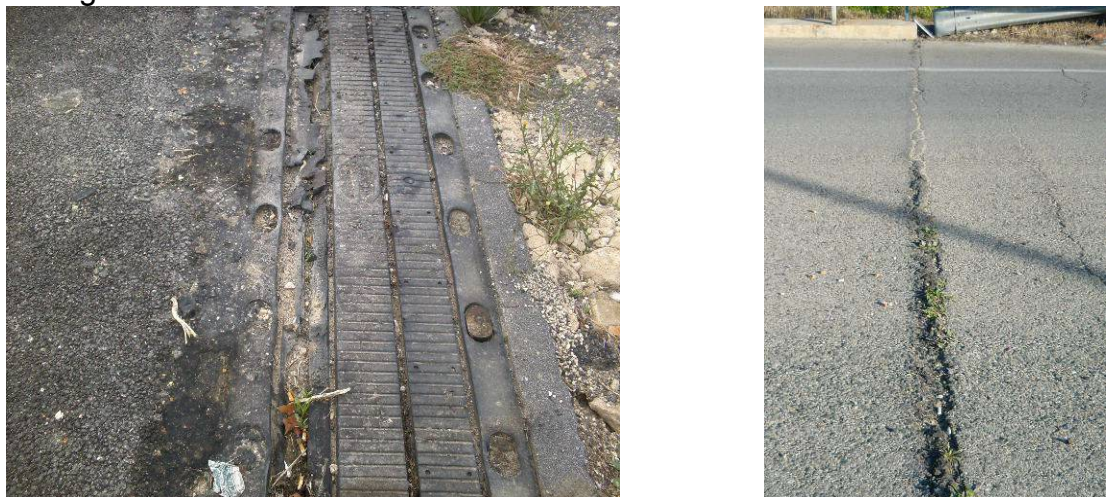
- The expansion joints of nearly 350 bridges, the 18% of all the bridges, were damaged.

Figure 6 – Damaged expansion joint . Non existing expansion joint

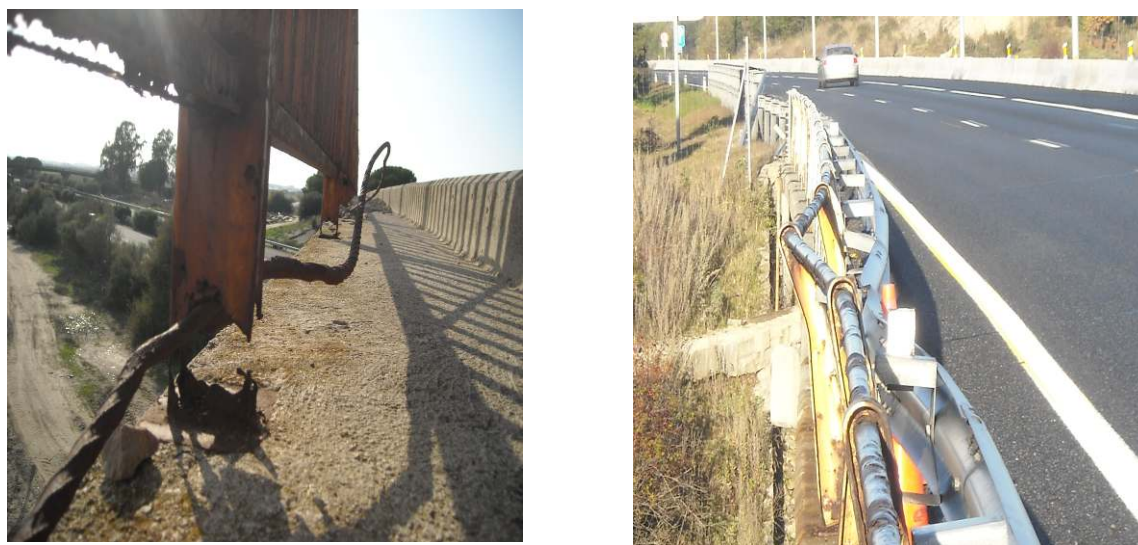
- The guardrails or the barriers of some 1300 structures were damaged, although nearly all of them will be repaired by the personnel in charge of the daily maintenance of the road.

Figure 7 – Damages on steel guardrails and barriers

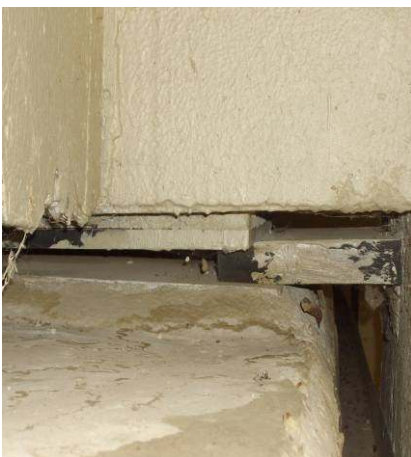
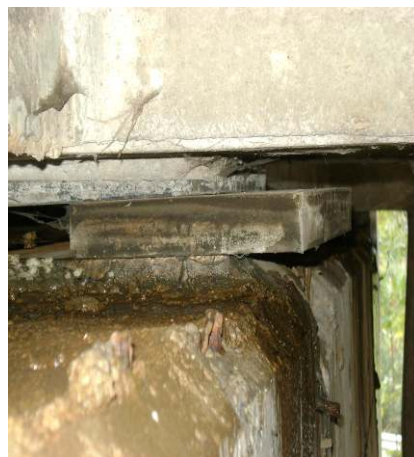
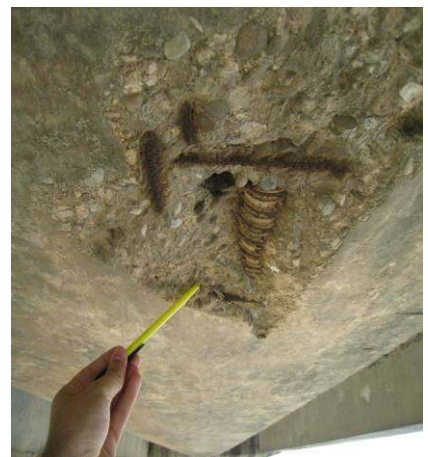
The results of the inspections made using special equipments showed some bearings out of place, the bad condition of the covering of some bearings or the lack of cover of a prestressed tendon; some cracks, not visible without using special accessing equipment, were also detected.

Figure 11 – An elastomeric bearing out of place, and a lack of cover of a prestressed tendon.

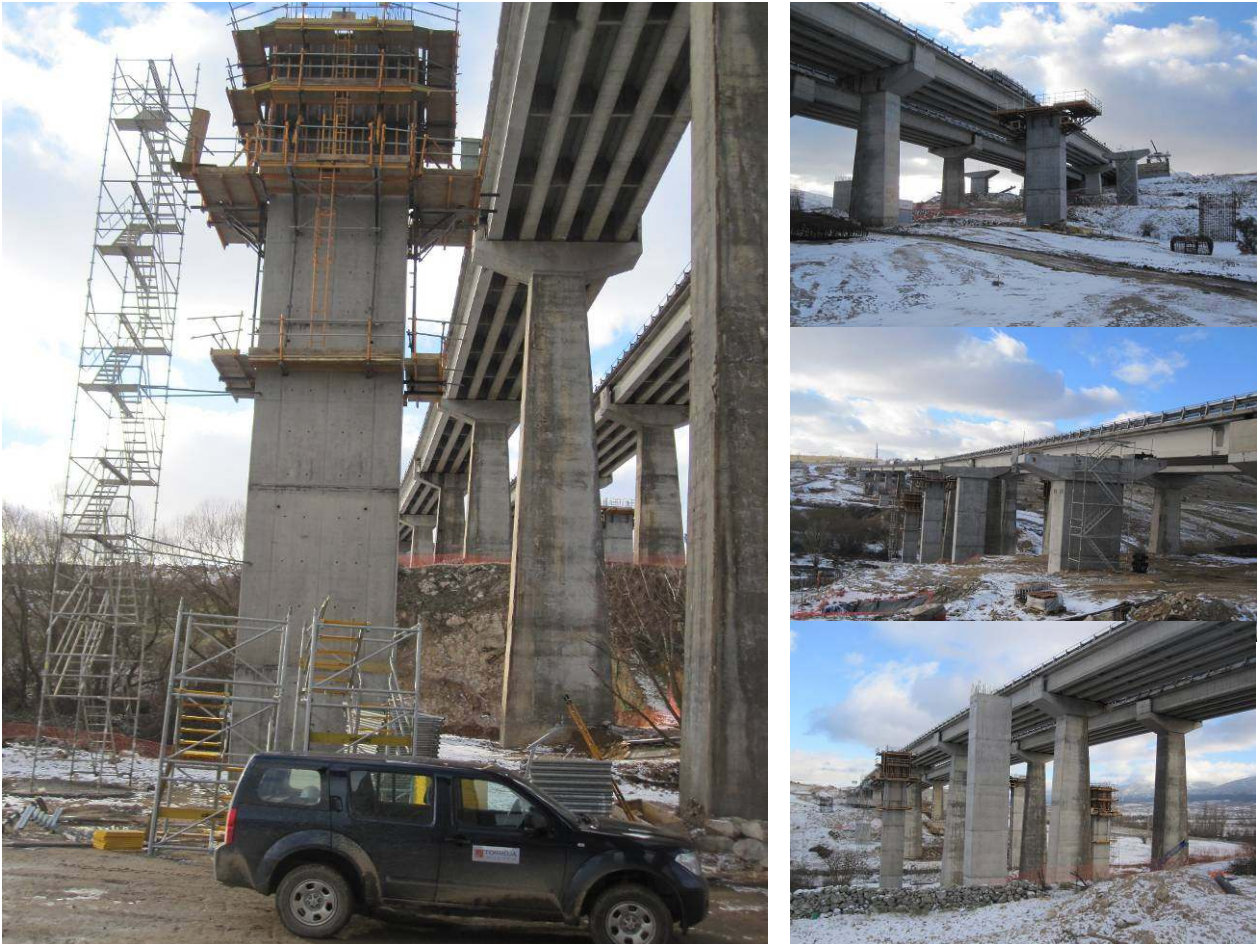
underpasses and the demolition of the deck of three existing bridges that were in very bad conditions due to the chloride attack.

Figure 12 – General views of the repairing works of some bridges of the AP-6

For example, now the enlargement of the platform, from 2 lanes to 3 lanes on each direction, of the section San Rafael-Villacastin (Segovia) of the toll motorway AP-6 is undergoing. Taking advantage of this situation, some repairing works, in addition to the enlargement and improving of some structures, are also being made such as the substitution of the bearings of the Viaduct of La Jarosa, the repairing works of some

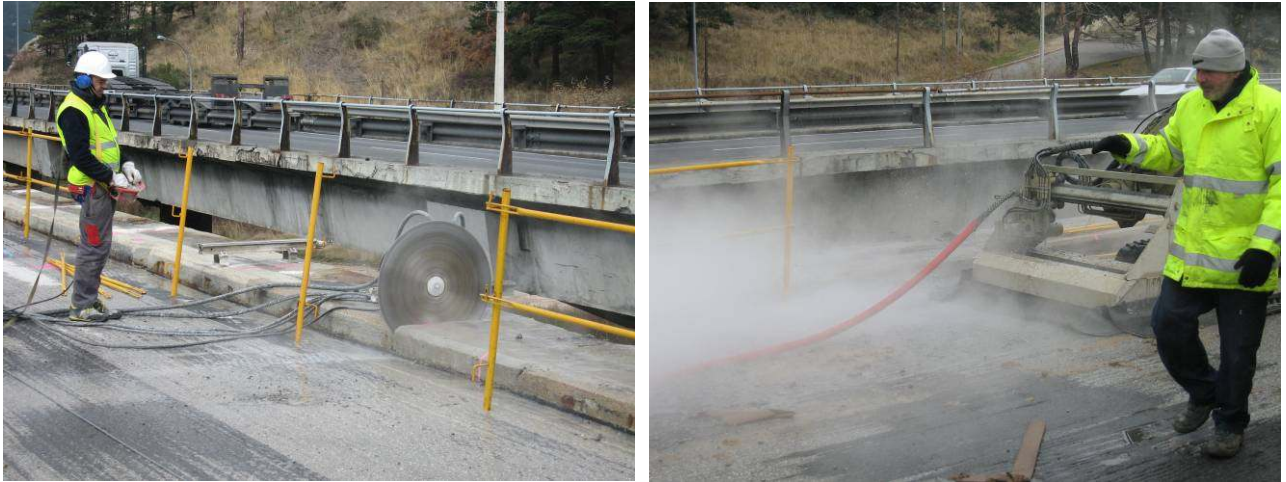
Moreover, the outer beams of the existing decks were severely damaged because of the use of chlorides in winter time, so it was proposed picking up the damaged beams and substituting them by some new ones. As it have been mentioned before, in some particular cases all the beams of the deck were substituted, because it was more effective changing all the beams, because of the poor condition of the beams.

Figura 13 –Repairing works of the top slab of the deck of the Viaduct of San Rafael (AP-6)

The Viaducts of San Rafael were seriously damaged and so it was proposed demolishing the compression slab of the deck end constructing a new one. Hydro demolition techniques have been used for demolishing the existing reinforced concrete slab of the deck. Special environmental measures have been followed while making such operations, particularly avoiding the dumping the waste of the demolition operations to the surroundings of the bridge.

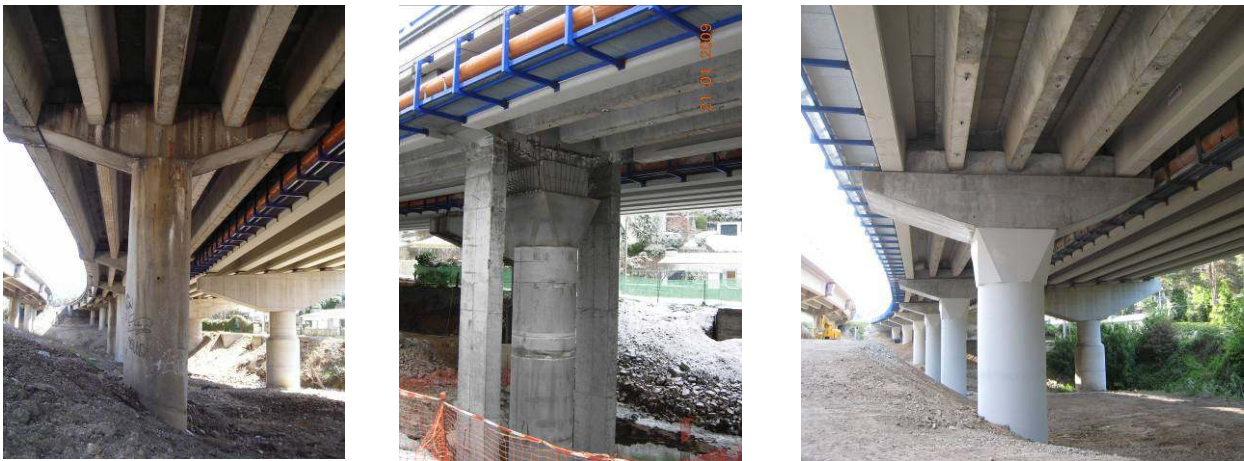
Figure 14 –Repairing works of the piers of a bridge of the AP-6

The piers and the piers cap were also repaired because they were also suffering Chemicals attacks due to the use of chlorides in winter time. The repairing works of the substructure have been made with no temporary diversion of the traffic over the deck.
