SLIPPERY ASPHALT RUNWAYS AFTER REJUVENATION

S Emery
University of Witwatersrand, South Africa

ABSTRACT

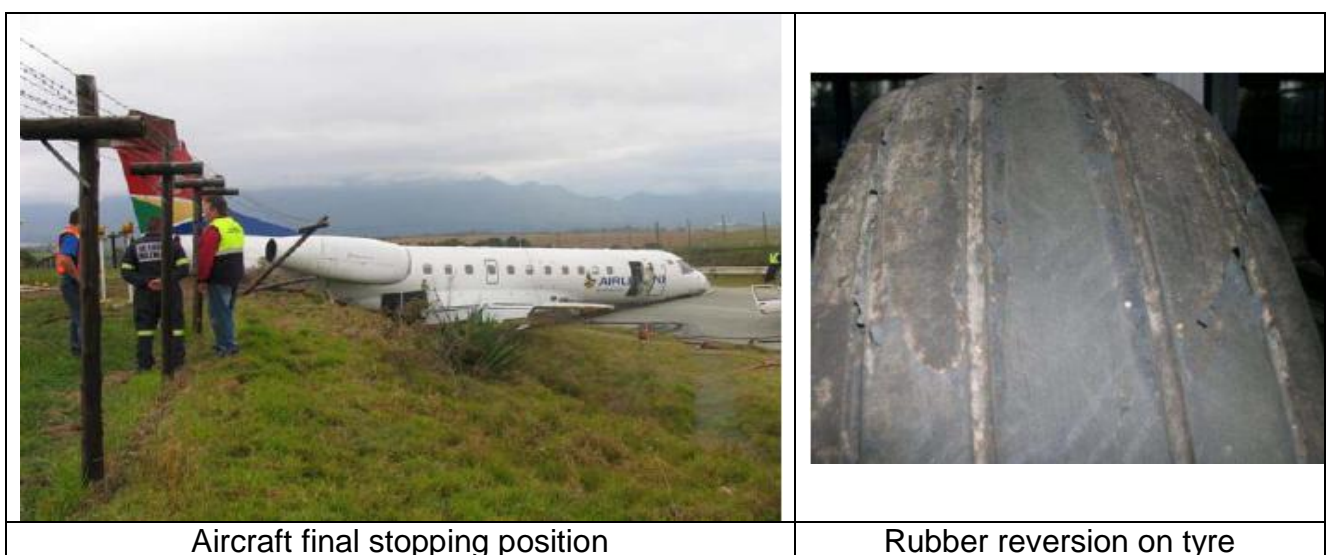
Figure 1 – George accident

The runway length was 2000 m with an upslope of 0.4%. According to figures provided by the manufacturer, the aircraft should have been able to have come to a complete stop in a distance of 1895 m. The deceleration obtained was on average -0.1g where levels of more than -0.15g were required to stop the aircraft in the distance available. The EMB 135 aircraft (ZS-SJW) was not fitted with a thrust reverser system and is fully reliant on the braking system of the aircraft (including spoilers) to bring the aircraft to a stop. All indications are that the aircraft was serviceable and that the anti-skid braking system of the aircraft worked as it should have, but that due to the slippery surface, the system was unable to apply sufficient brake pressure to effectively stop the aircraft. Although pilots may be applying maximum braking, the system will limit the actual brake pressure to prevent the wheels from locking. The tyres did display some evidence of aquaplaning, as there was a partial scalding effect to the tread rubber and the surface of the tread rubber had some evidence of reversion and peeling of the compound (Figure 1).

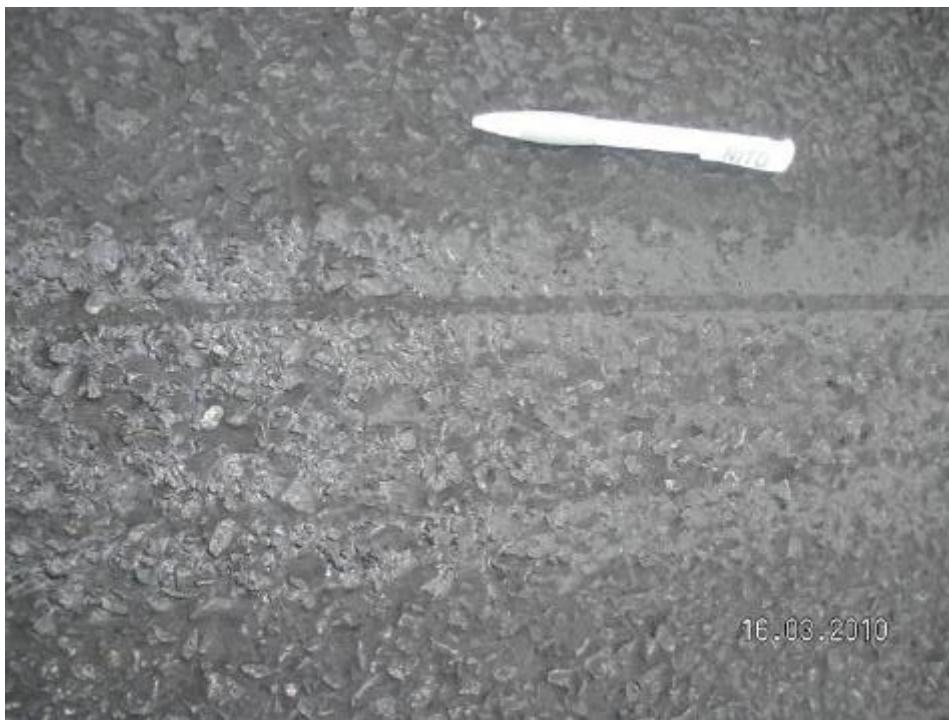
Figure 2 - Shiny wheeltrack, covered aggregate and filled-up voids

Appropriate fog sprays on chip seal surfaces are designed and diluted so that the bitumen settles into (and partially fills) the voids in the surface texture. An emulsion that is too thick may not properly penetrate into the surface voids and will leave behind an excess amount of bitumen on the surface after the emulsion breaks, causing a slippery surface. They are less commonly applied to HMA as the fog spray tends to cover the top of the pavement surface. Some practitioners use sand blinding to provide a grit cover and improve the microtexture. River sand is applied in excess just as the emulsion is breaking. It is rolled with 6 passes before the excess is broomed off. The sand should be graded with a high coefficient of uniformity. Sand further reduces macrotexture and this needs to be considered in assessing the suitability of a surface for a fog spray.

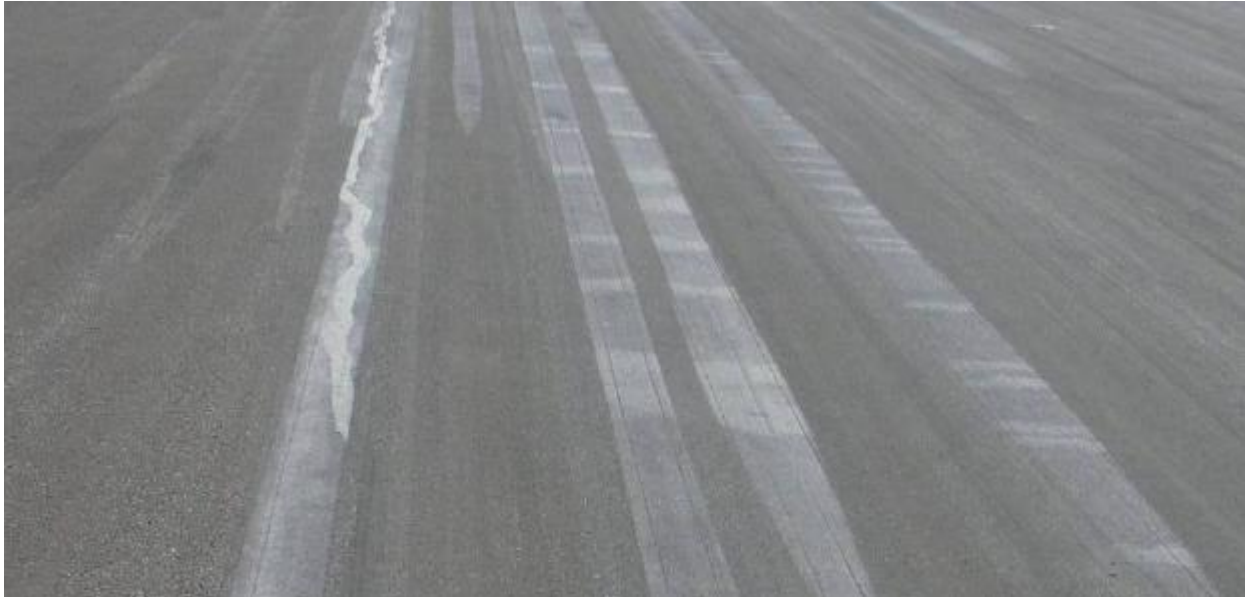
This would explain the shiny nature of the aircraft tyre tracks observed on the George runway. It could also explain the pattern in the tracks in Figures 3 and 4 as “mirrored anti-skid activity”. It could also explain why long shiny tracks appear on the runway. The theory could be that bitumen, softened or nearly melted are brought to the surface and displaced or smeared by the trafficking braking aircraft. If too much bitumen is ‘brought to the surface’ a planing situation may arise on the bitumen. Unlike aquaplaning which implies presence of water, dry planing occurs on the excess bitumen.

Figure 3 – shiny wheeltracks on George 11/29 runway

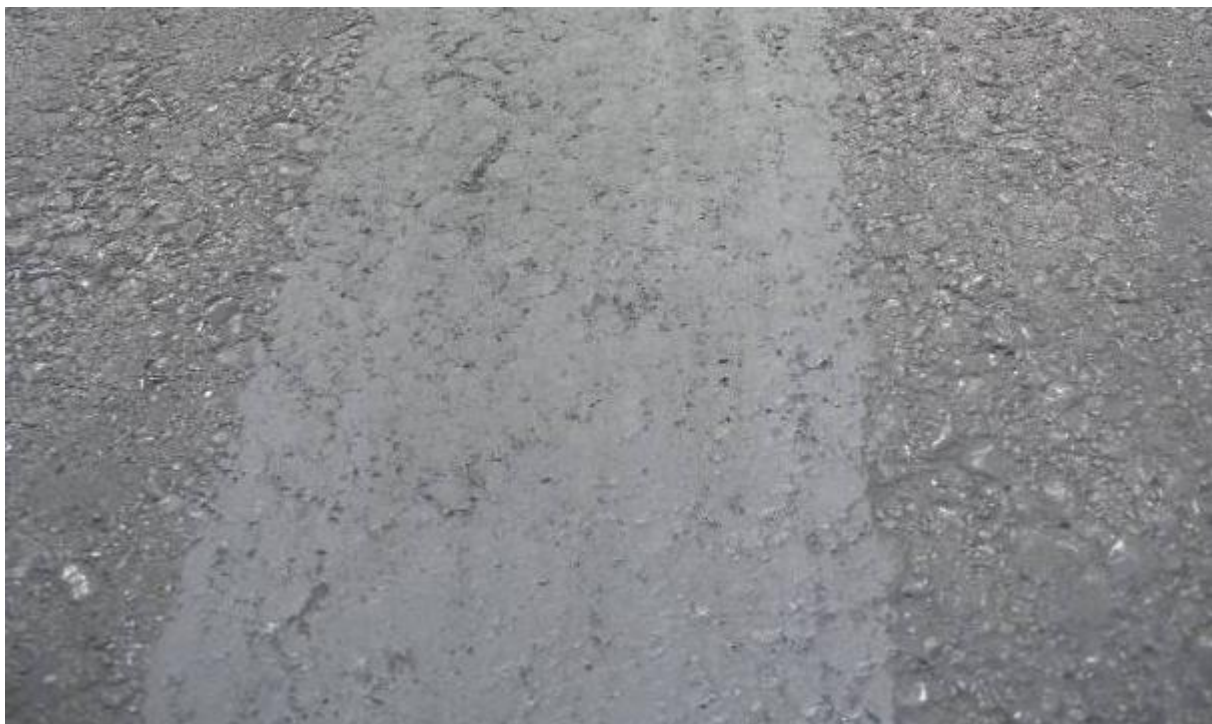
- Now there is a lubrication layer of steam and melting (or melted bitumen) which prevents the wheel spinning up. A rubber reversion aquaplaning situation is created on top of a bitu-planing situation. From observations of the runway at George more than three months after the accident, it was obvious that displacement of bitumen took place. By repeated displacement, a smoothing effect takes place that creates surfaces with less macrotexture. The bitumen being smeared by the braking aircraft causes the bitumen to in-fill the HMA voids leading to the creation of a bitumen-rich slippery surface. This can be seen in the shiny tracks on runway 11/29 (Figure 4).

Figure 4 – close up detail of shiny wheeltracks on George 11/29 runway

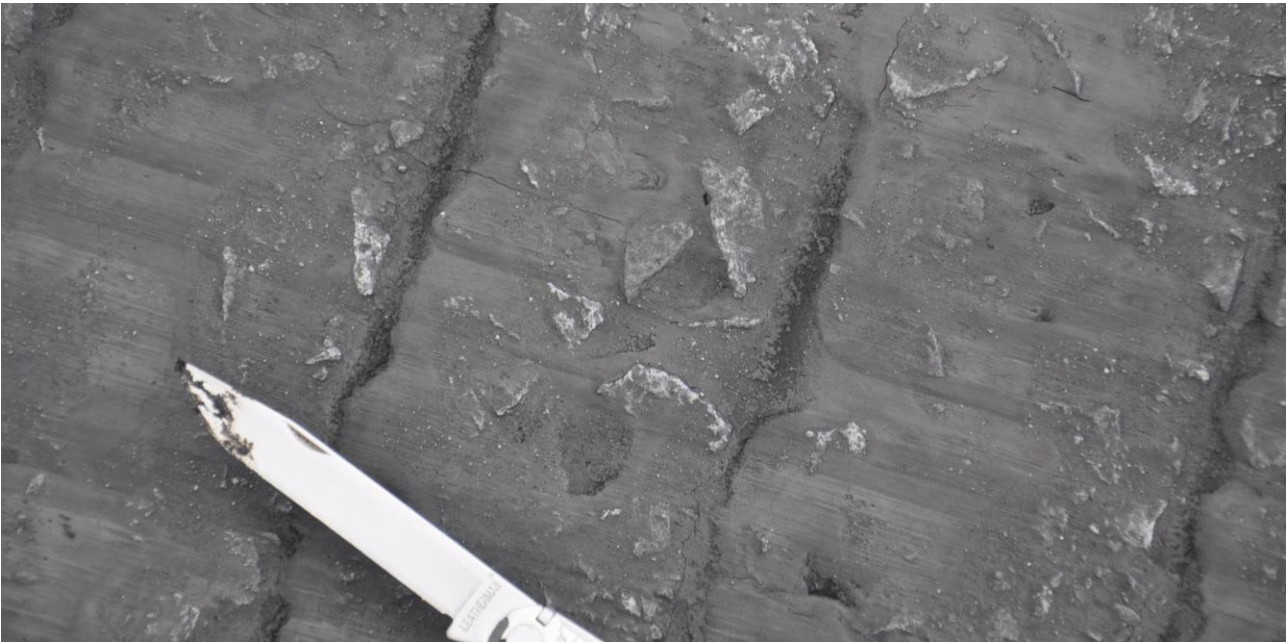
Figure 5 – close up of surface treatment rejuvenation with poor microtexture and worn inadequate grooves

Excess rejuvenation surface treatment should be considered as a contaminant causing hazardous conditions for aircraft operations and should be removed. In the interim, operational restrictions need to be urgently applied; or the runway closed. The removal of mis-applied rejuvenation is neither easy nor quick. The options are to cover the rejuvenation with a new surfacing or to remove it. The surfacings that could reasonably cover it are hot-mix asphalt, a friction treatment (porous asphalt or an ultra-thin friction course) or a chip seal (possibly with polymer modified bitumen and with careful attention to design to avoid loose stone [17]). A slurry seal is rarely suitable because it does not meet the macrotexture recommendation of a minimum of 1mm. The use of hot-mix asphalt will usually require a friction treatment on top such as grooving for the same reason.

Expensive options for the removal of rejuvenation treatments include milling off the top of the HMA (also termed planning or profiling) and laying a new surfacing, or the less expensive high pressure water blasting of the surface or aggressive brushing of the runway with rotating steel-brushes. The aim of the water blasting technique is not to totally remove the rejuvenator from the surface but to remove only a portion of the material so as to restore frictional capability to the runway surface. Water blasting requires trials in which the machine speed and water pressure are varied to achieve the desired result. Too much water pressure may also make things worse, by the action of "polishing" the aggregate which is the process of making the surface of the aggregate smooth. Too much pressure, or too-aggressive brooming, may also destroy surface integrity resulting in widespread ravelling.
