**XXIVth World
Road Congress
Mexico 2011**
Mexico City 2011.

The Great East Japan Earthquake Disaster

Keiichi Tamura

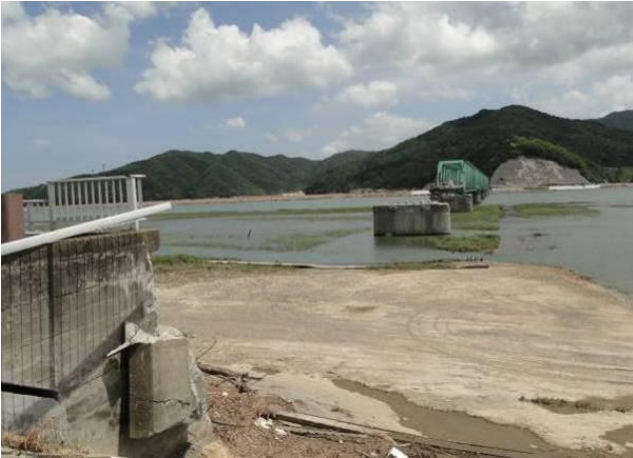
Shi-Kitakami Ohashi Bridge

- About 80 bridges collapsed due to tsunami.
- Backfill soils were washed out.

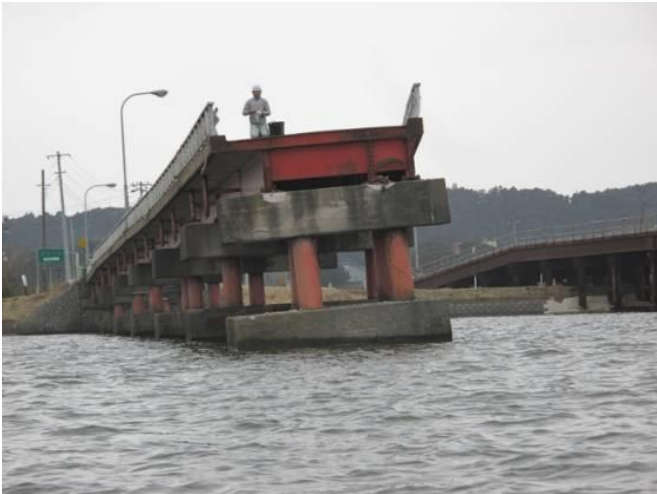
Collapse of bridge with pile-bent columns

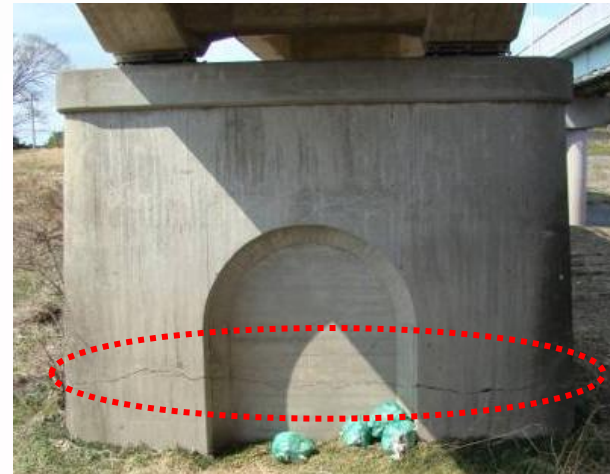
Damage to RC pier with small amount of reinforcement

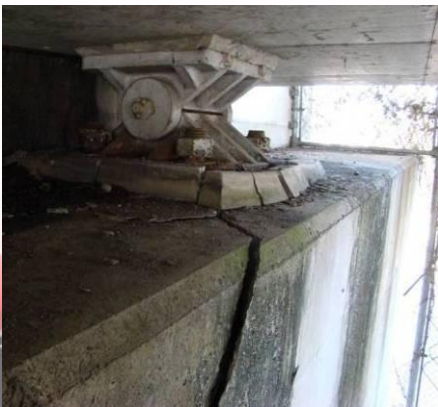
Damage to pier top

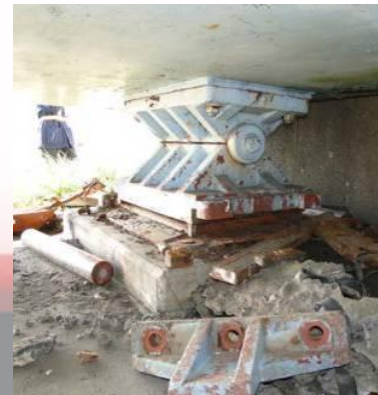
Damage to movable bearing

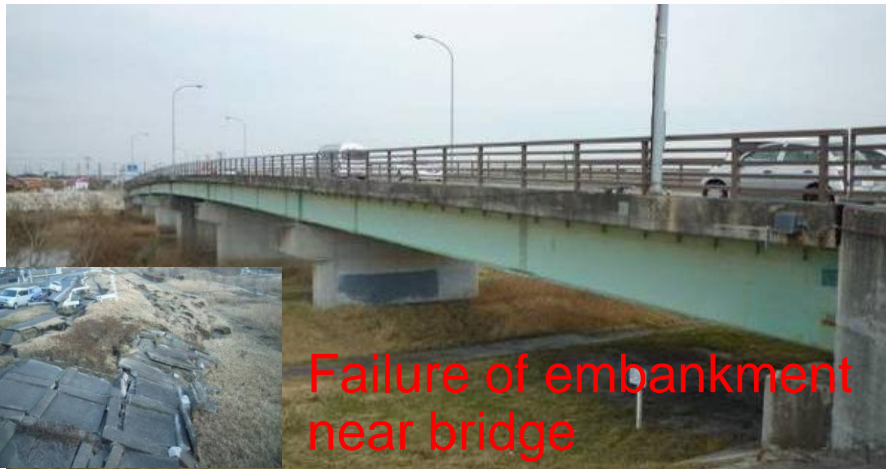
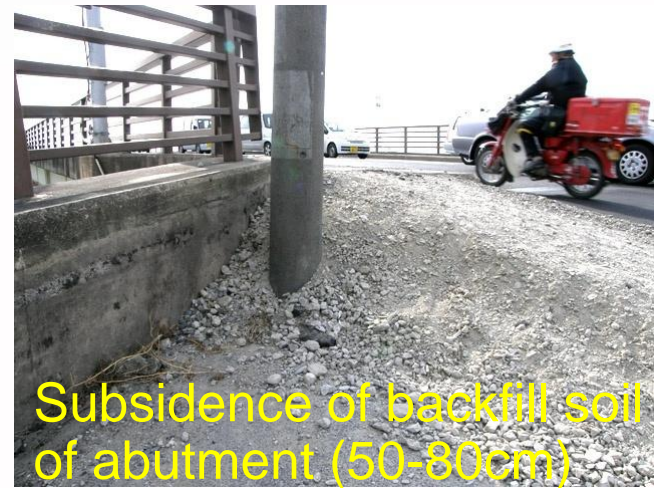
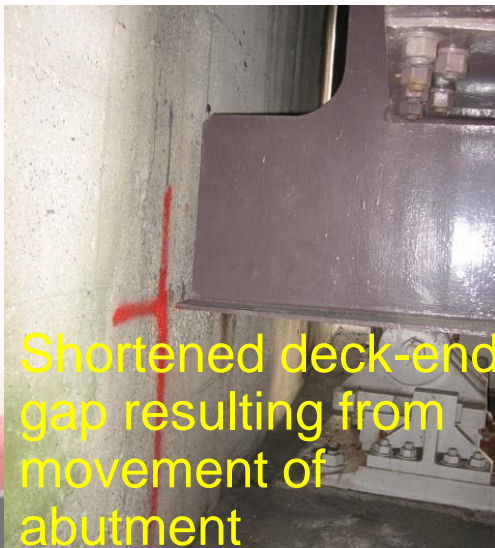
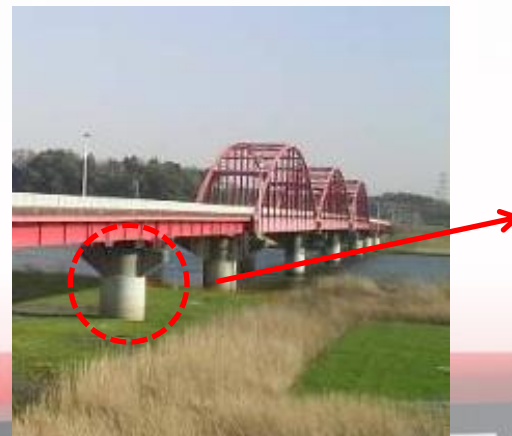
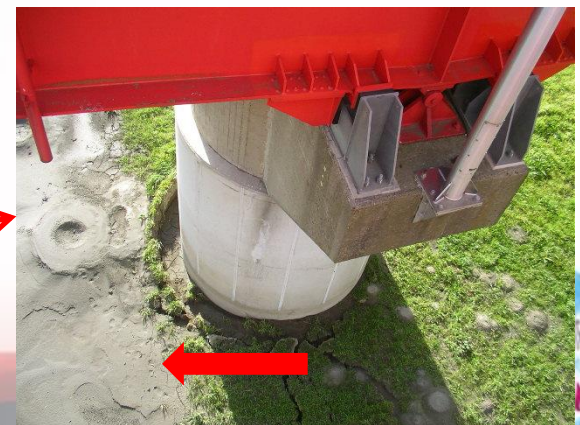
- Subsidence of backfill soil of abutment, shortening of deck-end gap resulting from movement of substructure, etc. occurred.

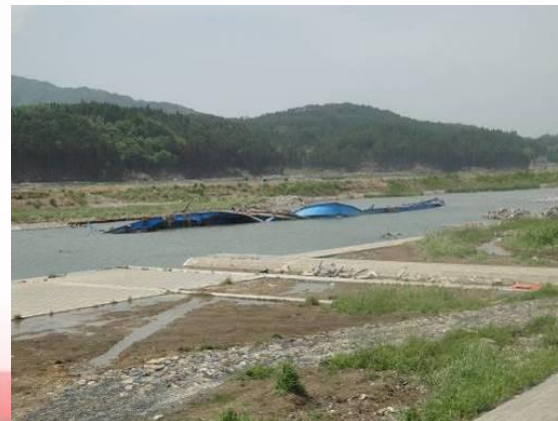
- 6-span steel girder bridge (two 3-span-continuous girders).
- All girders and one RC pier were washed away.

Steel girder washed away

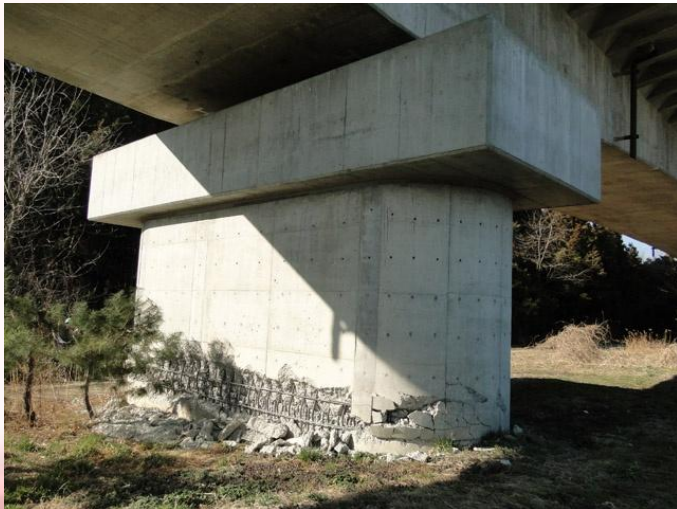
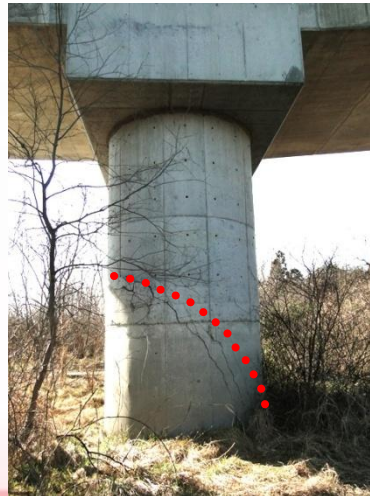
- 9-span PC box girder bridge designed by pre-1980 specifications
- Shear cracks, spalling off of cover concrete and buckling of longitudinal rebars at section of cut-off of longitudinal rebars

Damage to RC columns at section of cut-off of longitudinal rebars

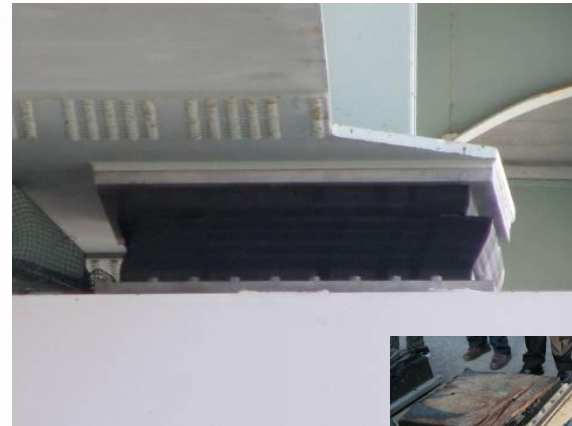
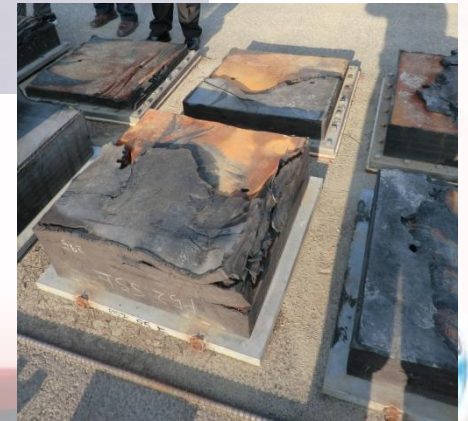
- 4-span steel box girder and 2-span steel girder bridge
- Designed by post-Kobe Earthquake specifications
- Elastomeric rubber bearings were ruptured.

Ruptured rubber bearings

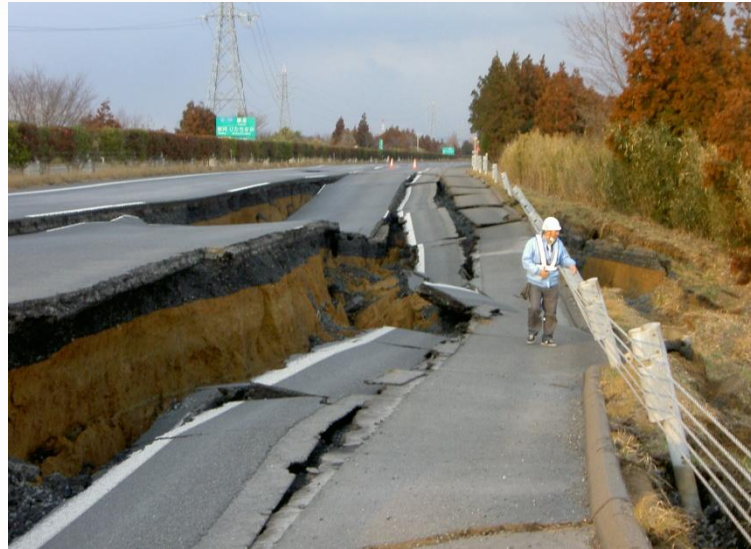
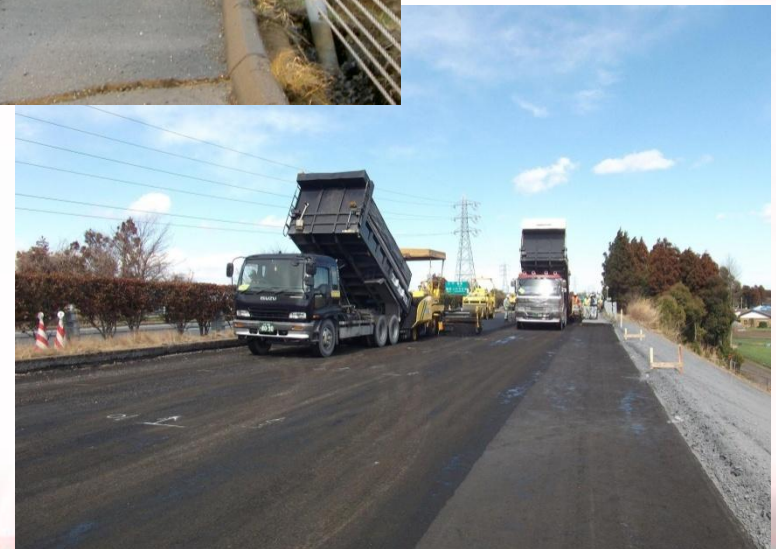
Subsidence of road embankment and temporary repair (Joban expressway)

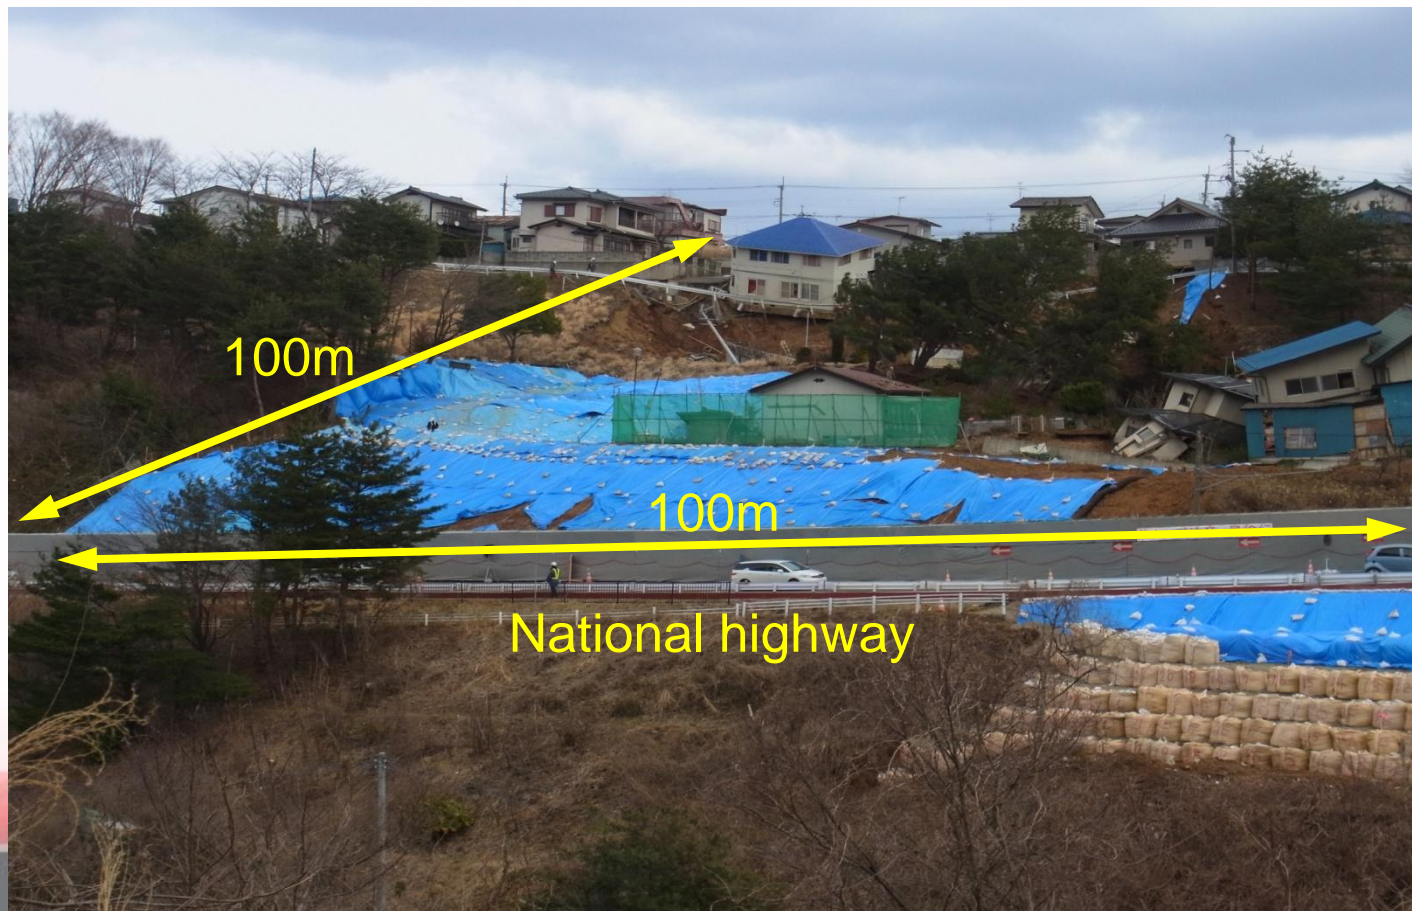
- Collapse volume was 11,000m³.
- The embankment was developed by filling up a valley for residential area about 40 years ago.

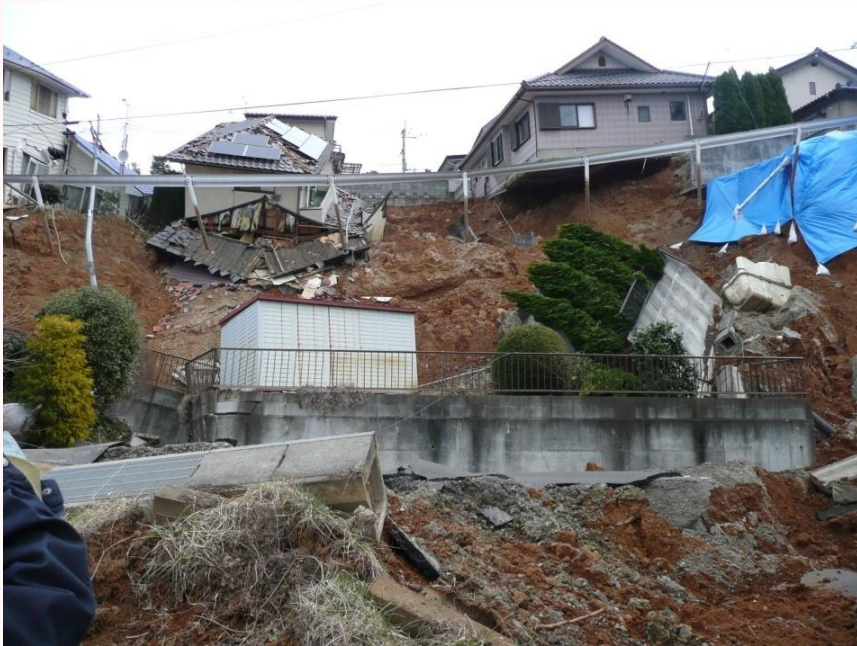
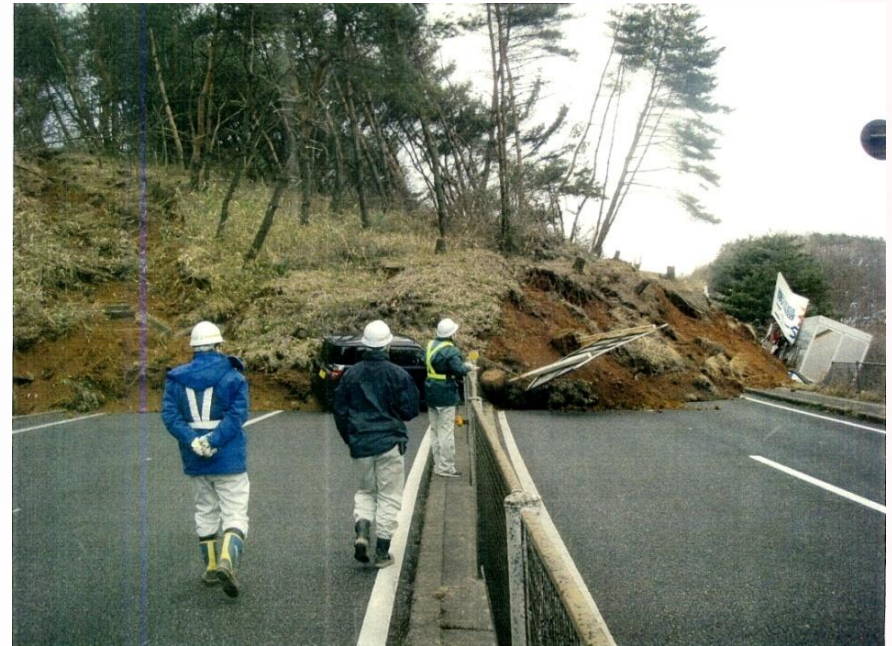
Upper part and toe of collapse

- Collapsed soils covered the entire width (4 lanes) of a national highway.

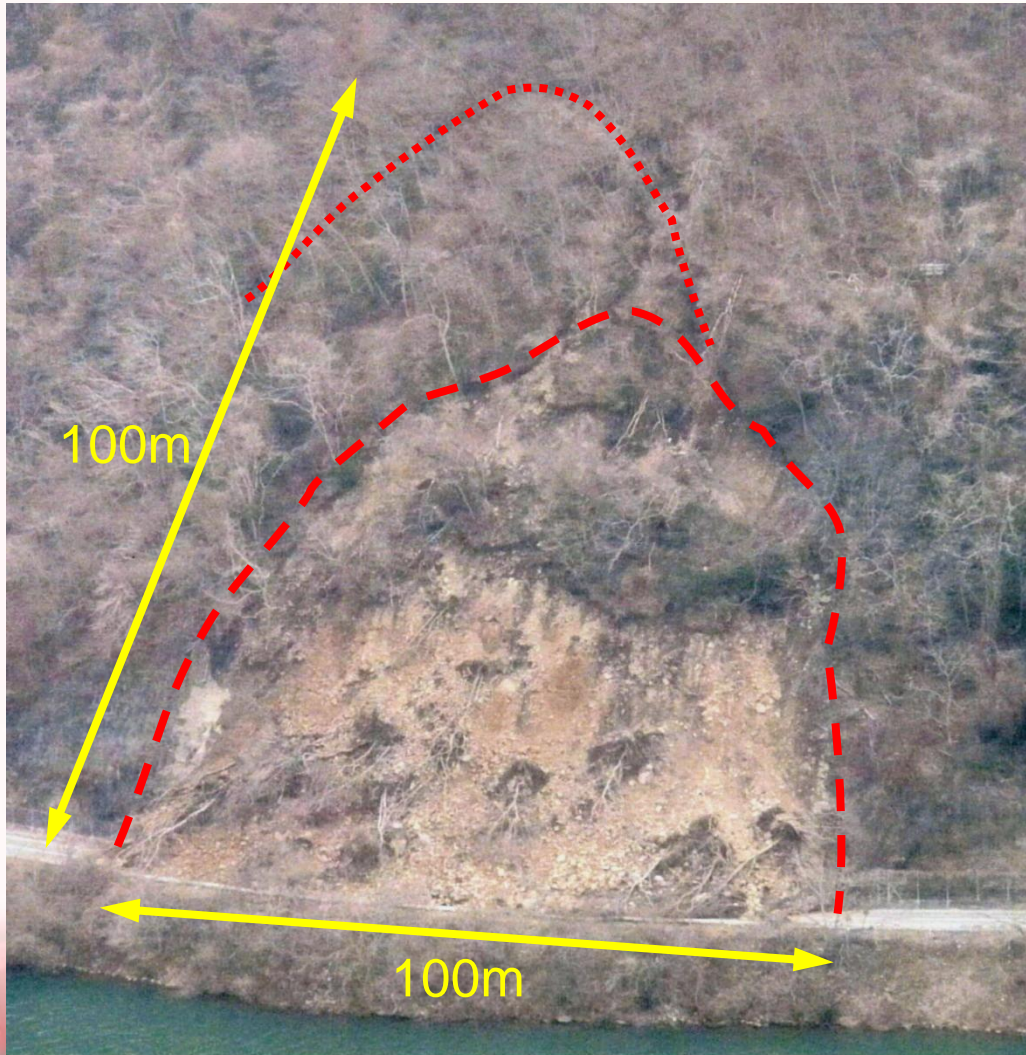
Slope failure of national highway

- Collapsed by the main shock on March 11, and collapsed again 3 days later.
- Slope consists of Triassic slate.
- Red broken line : collapsed area by the earthquake
Red dotted line : scarp in the upper slope

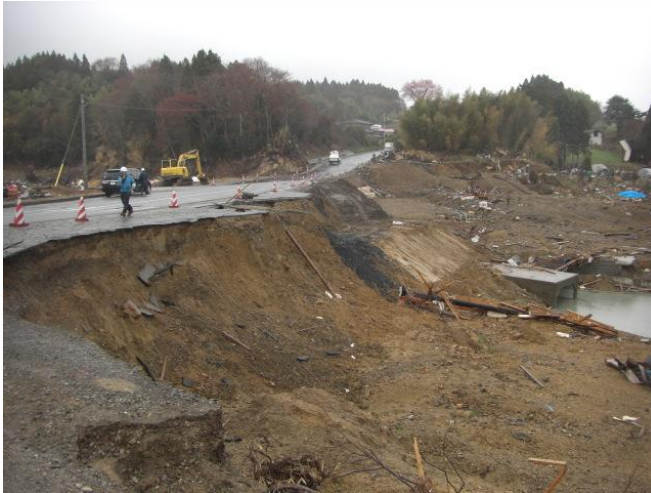
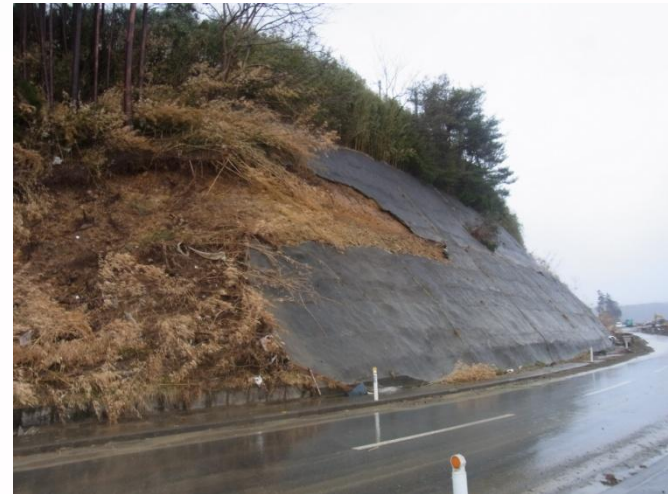
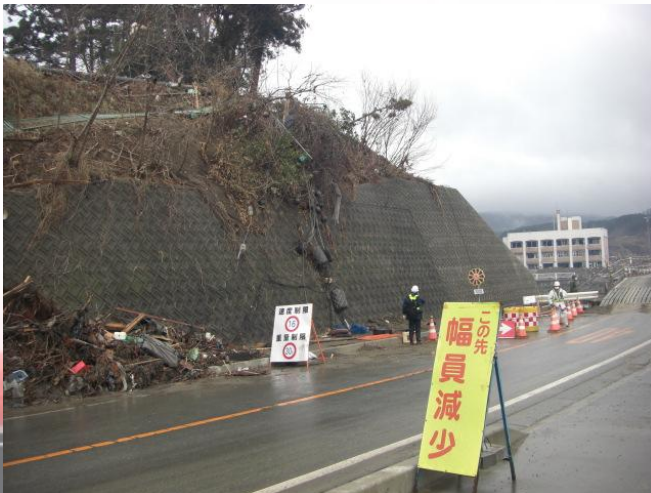
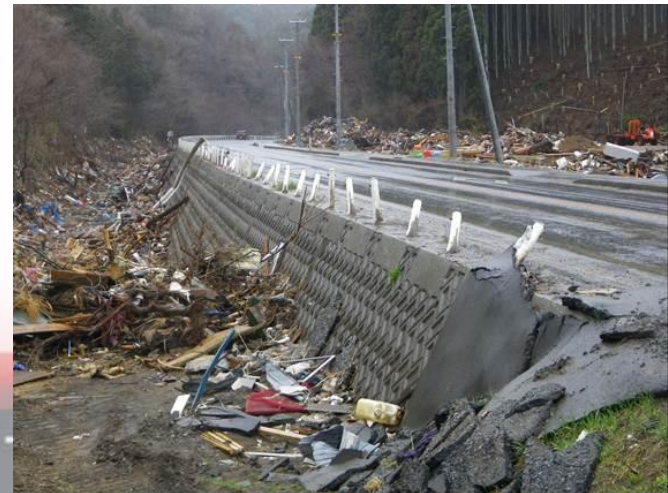
- Washed away embankment and stripping of the shotcrete on the cut slope.
- Undamaged concrete block retaining walls.
