**XXIVth World
Road Congress
Mexico 2011**
Mexico City 2011.

RÍO PAPALOAPAN BRIDGE: DESIGN AND SUCCESSFUL APPLICATION OF SPECIAL NON DESTRUCTIVE INSPECTION TECHNIQUES

José Alfredo López López

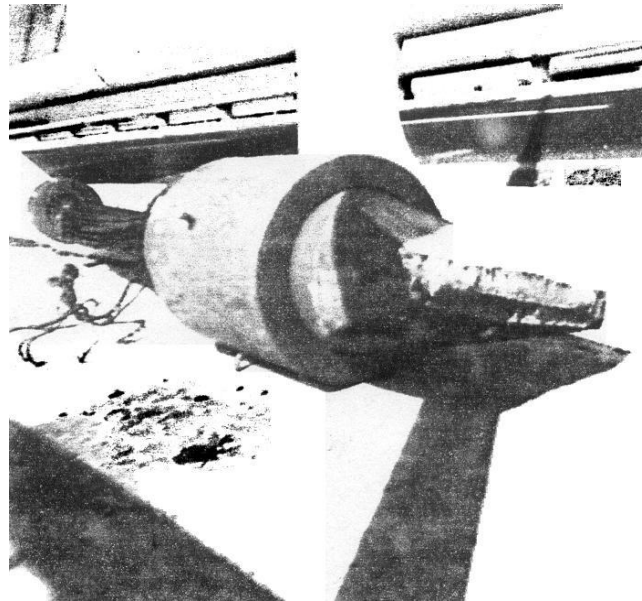
In January 2000, the failure of the upper anchorage element from cable 11, semi-harp 7

- Failure analysis conclusion: Constitutive material was structurally deficient

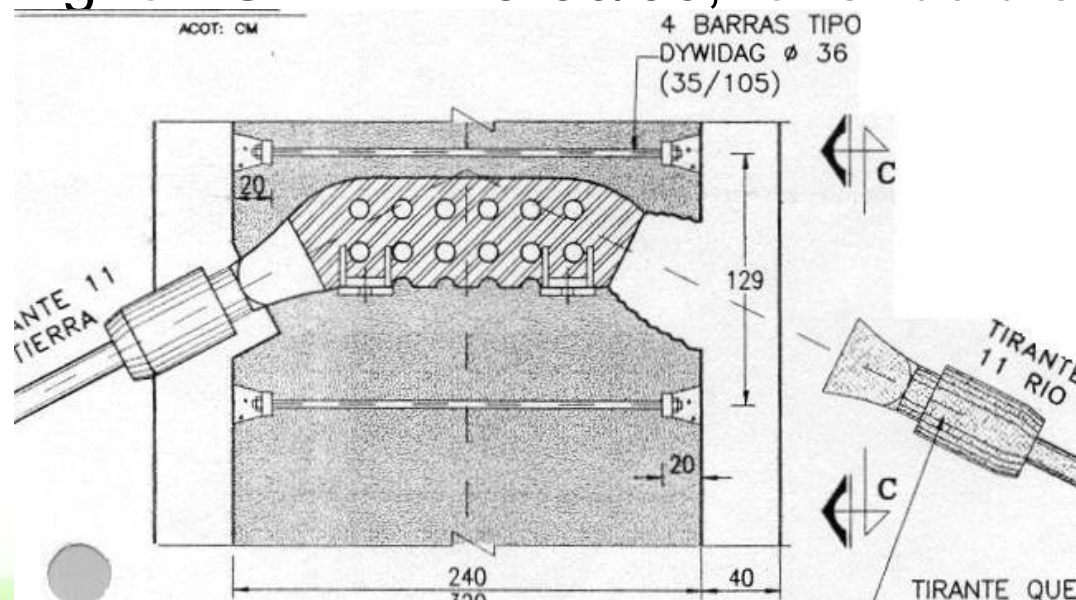
- ❑ The fracture took place close to the heat affected zone (HAZ)
- ❑ The chemical content of the material, and the yield and ultimate strengths were all within design specifications, according to ASTM A148-80/50, for structural steel.

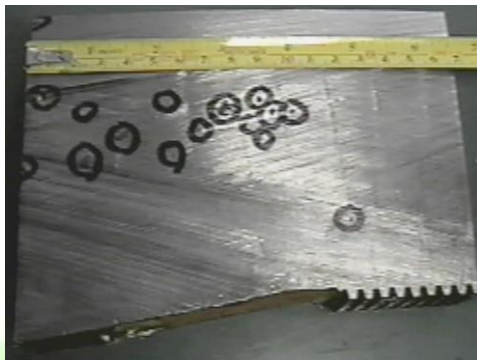
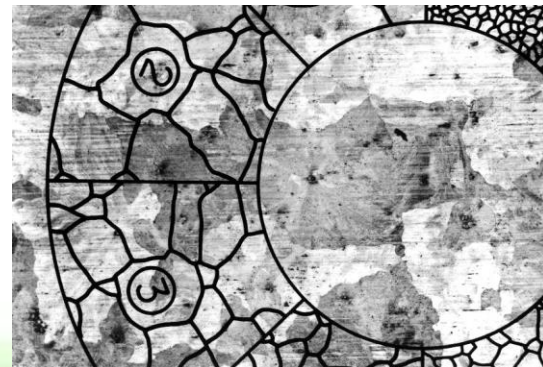
- The piece was manufactured from a cast process, 3 main problems were identified:
 - It had a high content of pores
 - The steel was not properly normalized with a large grain size microstructure (ASTM 2)
 - Elongation was 3%, far below to the 22% specification for the tension test.

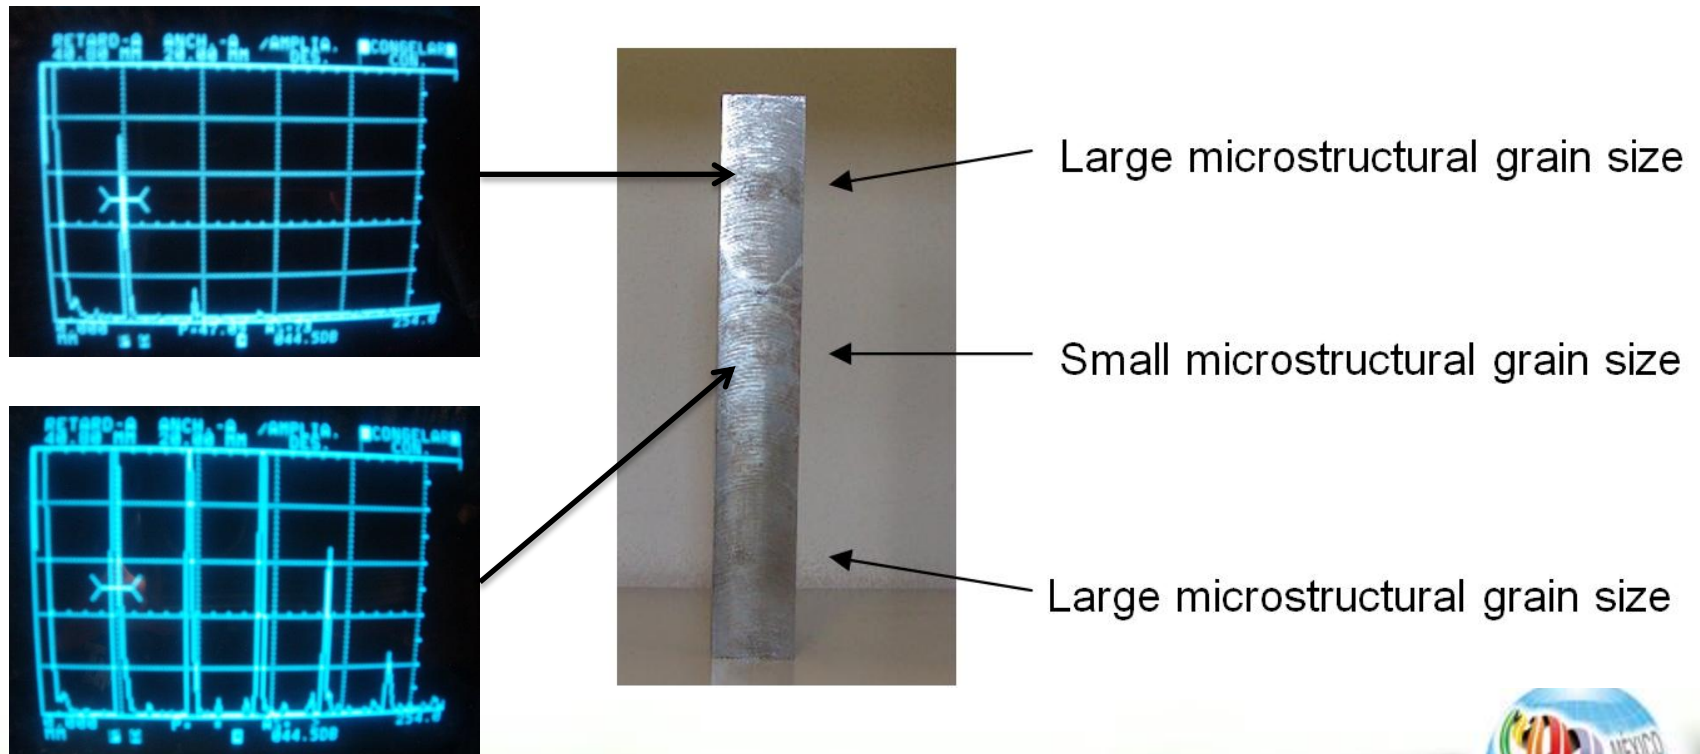
Comparison of the back wall reflections of the two different grain sizes in the reference block

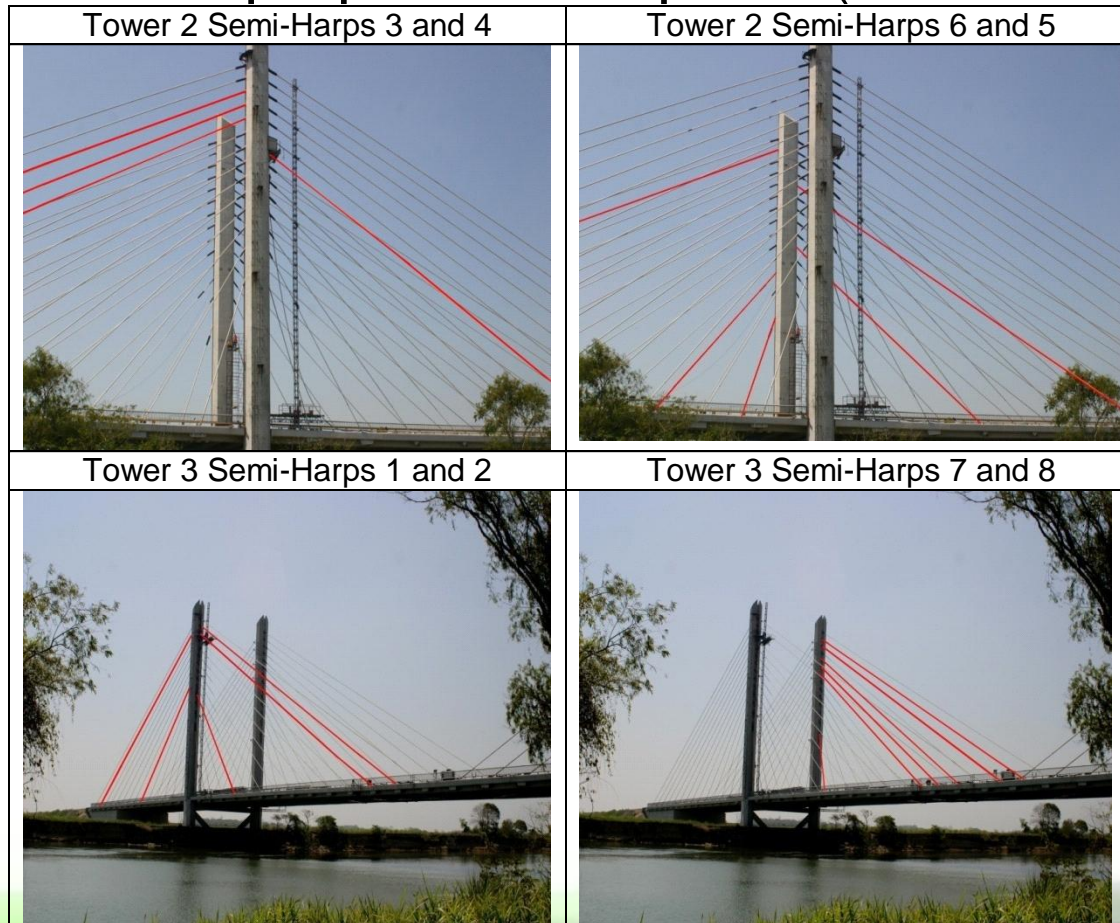
Elements proposed to replace (20 elements)

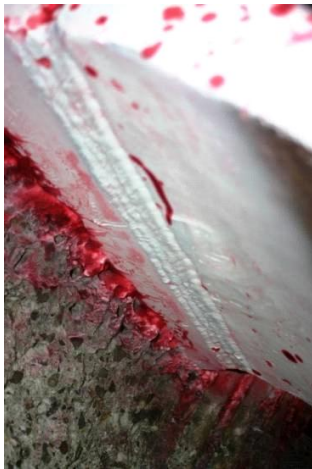
Cracks detected with liquid penetrant testing in the anchorage elements

(a) Element Id.
No. 5
Large grain size

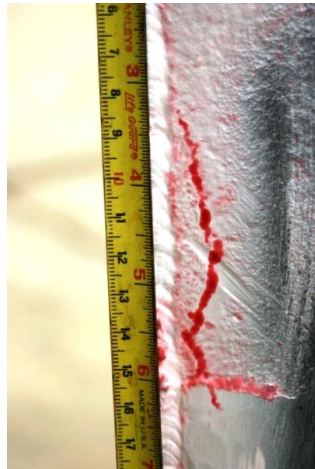
(b) Element Id.
No. 7
Large grain size

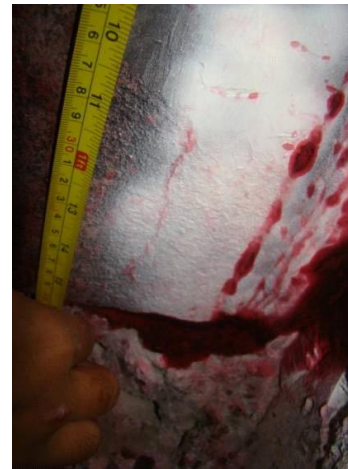
(c) Element Id.
No. 11
Fine grain size
w/pores

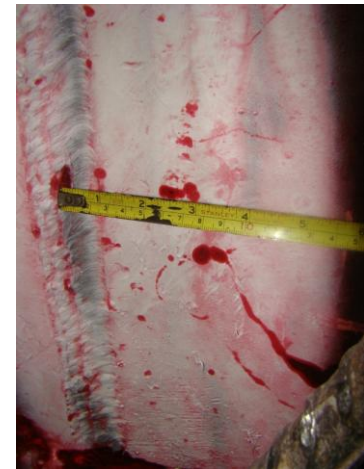
(d) Element Id.
No. 19
Fine grain size
