RECTIFY BLEEDING ROAD SURFACES USING HOT IN-PLACE RECYCLING METHOD: HOW SHOULD IT BE DONE (MALAYSIA EXPERIENCE)

Hamzah HASHIM & Mohd Hizam HARUN Road Facility Maintenance Branch Public Works Department of Malaysia hamzahh@jkr.gov.my & hizam@jkr.gov.my

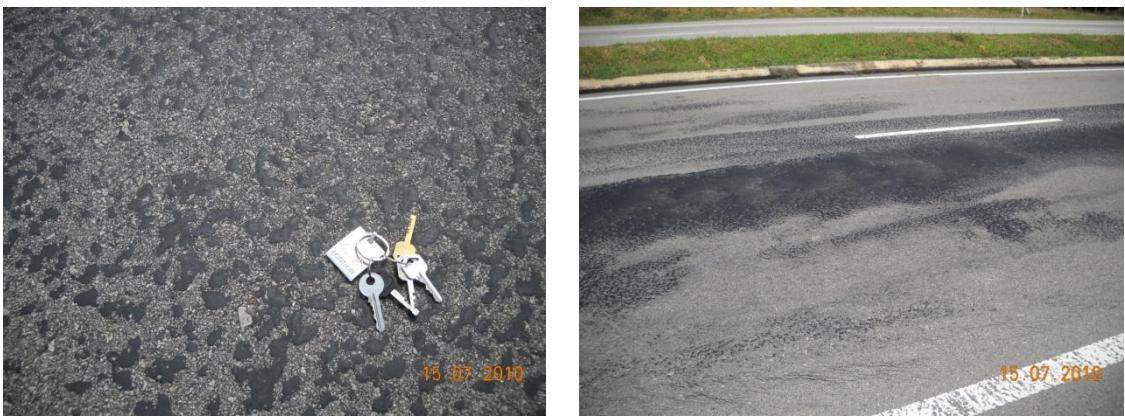
Bleeding is the presence of free bitumen binder on the surface resulting from upward migration of the binder, causing low texture depth and inadequate tyre to stone contact. It can be caused by excessive application of binder with respect to the stone size. If the air voids in the mix is according to specification, but with excessive binder content, traffic will force out the excess binder to the surface. If the binder is accordingly to specification of the mix, but the air voids is too low, the similar action by the traffic will also force the binder to the surface thus manifest bleeding.

Figure 2 - Bleeding at newly constructed Lebuh AMJ

From the results, it is concluded that, bitumen content was excessive at the time of samples acquired and most probable during the mixing process. Grading was also not fulfilling even the general gradation limits especially on the upper limit. This grading showed that the material having much fine material thus produced less air

voids and became one of probable causes of bleeding. With all the findings, all of this was assumed to be the main reason of the bleeding manifest at the area after the road was open to traffic for 1 year.

However, since the road was at the beginning of its service, and the length of roads that needed repair was quite substantial, the idea of using HIPR method for treating the defects was mooted. Through surface undulation and shallow cracking could be "removed" using this technique, bleeding offered entirely a new challenge altogether. Thus, all the parties involved had agreed that design should be carried out before proceeding with the HIPR method to rectify the bleeding surfaces.

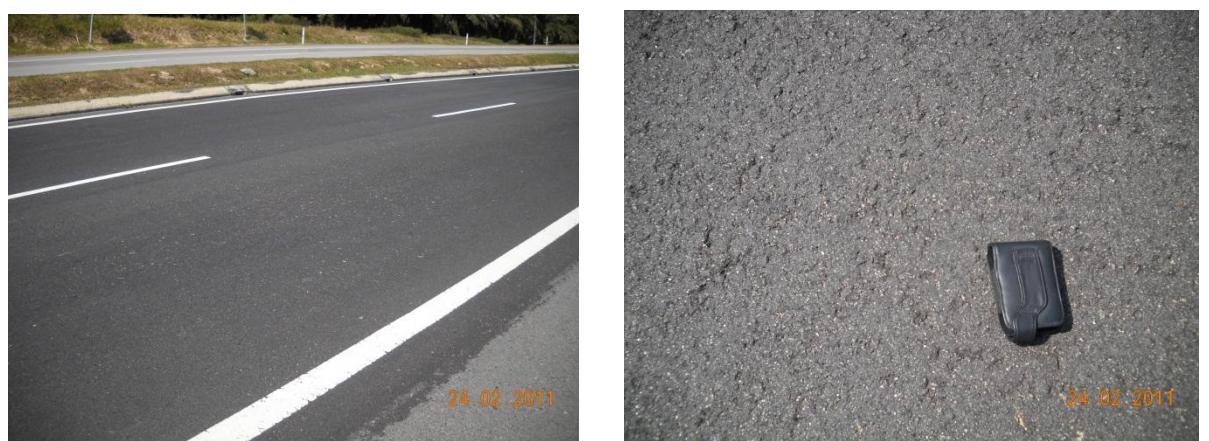
No bleeding was found within this section. Pavement surface was found to have a good texture.

Figure 7 - Pavement surface at the HIPR without addition of rejuvenating agent

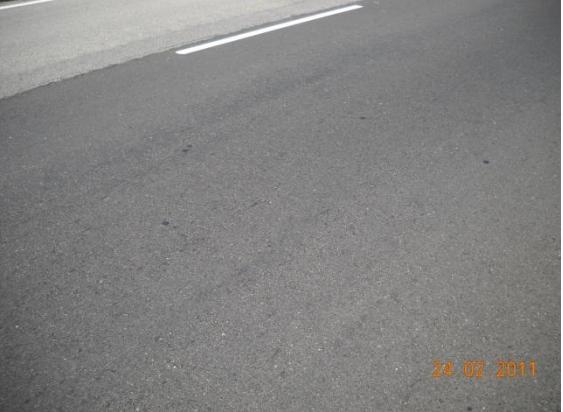
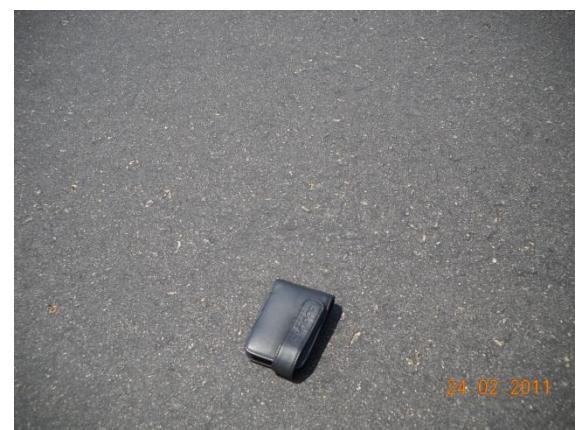
10.2 HIPR 50 mm depth with rejuvenating agent (0.3%) with addition of new mix Bleeding was found within this section with visibility of colouring of pavement surface.

Figure 8 - Bleeding at the HIPR with addition of 0.3% rejuvenating agent

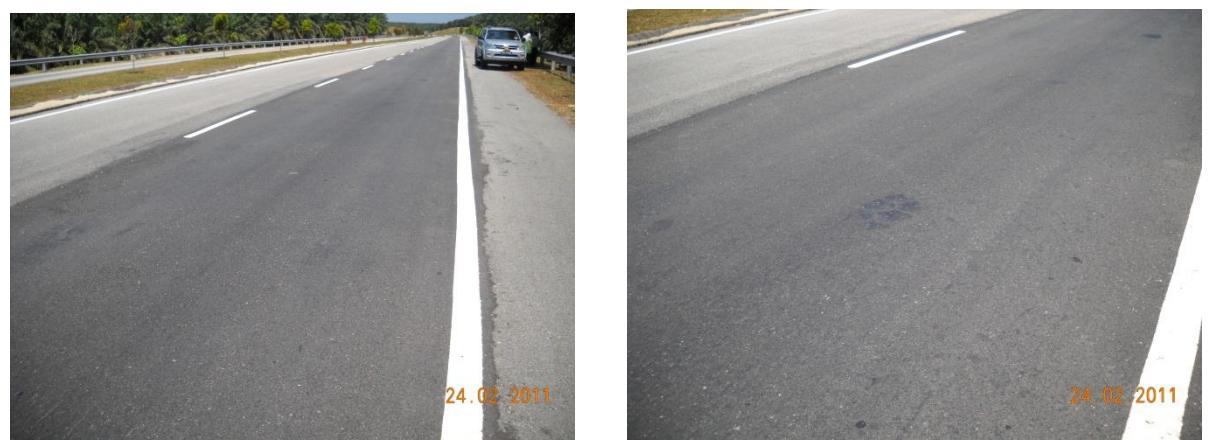
This section only contains of 50 meter length. During the work, recycled material looked wet and shining suspected from excessive binder content and addition of

rejuvenating agent. It is confirmed at this section, bleeding had became apparent even after 6 months.

Figure 9 - Apparent bleeding at the HIPR with addition of 0.5% rejuvenating agent

- 1. If HIPR method was to be used to rectify bleeding, rejuvenating agent should not be added. It was observed that bleeding did not re-appear after 6 months in the HIPR without rejuvenating agent section.
- 2. The addition of new asphaltic concrete mix would improve the gradation of the recycled mix.
- 3. The addition of new asphaltic concrete would also reduce the binder content in the existing material.
