# UNDERWATER PILE REPAIR USING FRP – STATE OF THE ART

R. SEN & G. MULLINS  
Department of Civil and Environmental Engineering,  
University of South Florida  
Tampa FL USA  
[SEN@USF.EDU](mailto:SEN@USF.EDU)

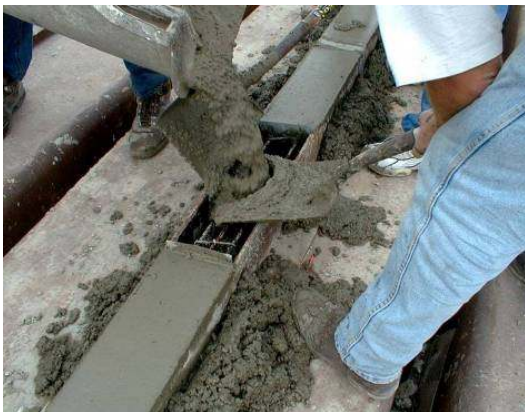
In laboratory investigations, one-third scale, instrumented prestressed pile specimens (Fig. 1) were cast in a commercial prestressing facility with built in chlorides to simulate the splash zone (Fig. 2). Subsequently, selected specimens were wrapped using FRP and exposed to simulated tidal cycles for extended periods. Their corrosion performance was assessed from gravimetric test methods in which prestressing strands were retrieved and the metal loss measured. Complete details may be found in [11].

Fig. 1 Specimen with chloride

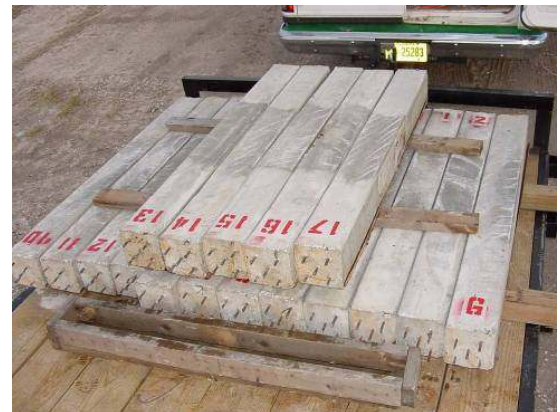
Fig. 2 Completed specimens

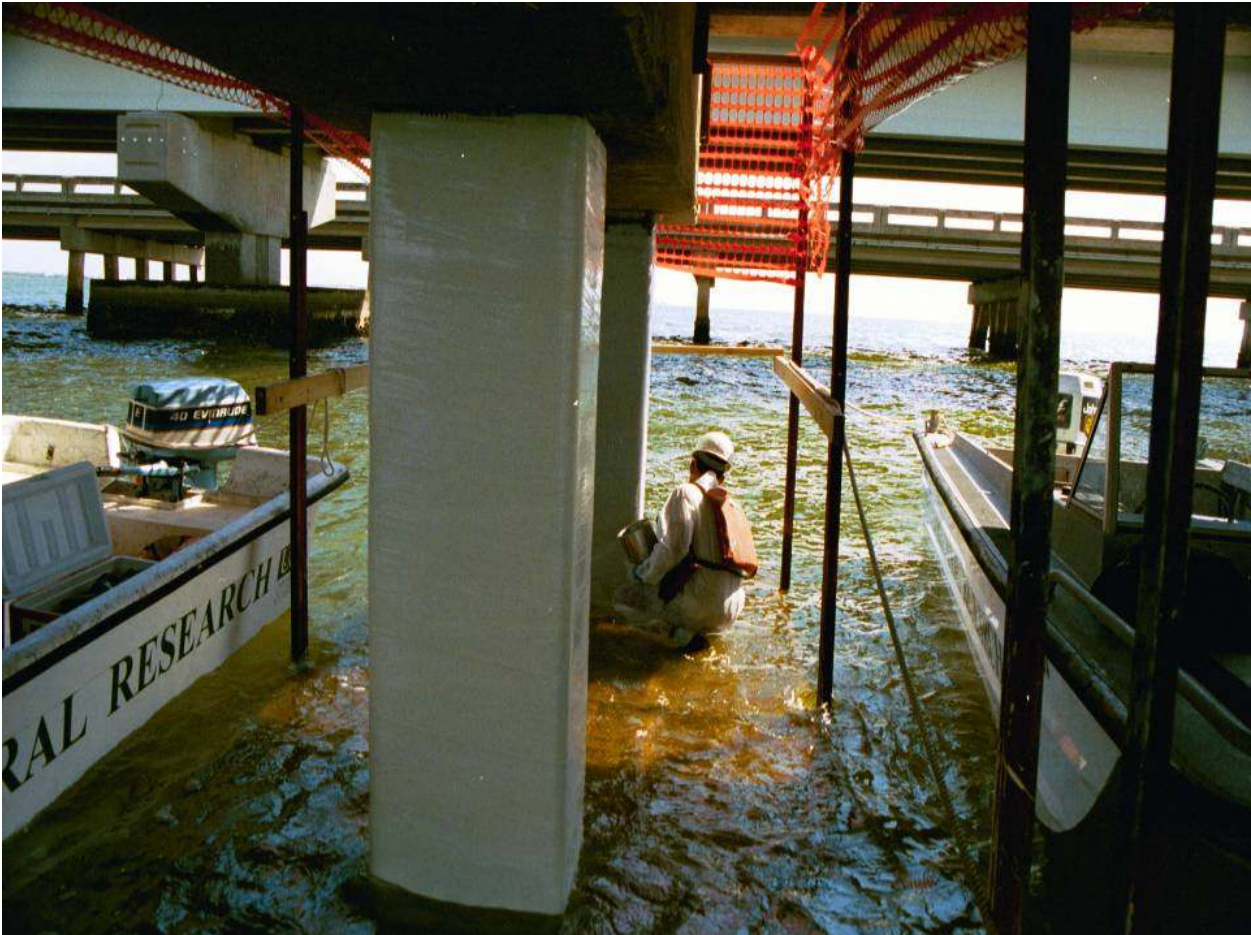
The first field applications were carried out in 2003 [6]. Subsequently there were three other applications [7,9,10]. A typical photo from a field demonstration project is shown in Fig. 3. These repairs were carried out on reinforced or prestressed piles located in

aggressive environments. In all cases, piles were instrumented to allow corrosion performance of the FRP to be monitored. Complete details may be found in [12].

Fig. 3 FRP repair of corroding pile, Tampa Bay, FL

The intent of the research project throughout was to explore the feasibility of field repairs. As a result, several demonstration projects were undertaken to demonstrate that it was feasible to carry out field repairs. In the initial application, piles in shallow waters were repaired [6]. Subsequently, piles located in deeper waters were repaired (Fig. 3). These required scaffolding that was suspended from the pile cap [7,9,10]. In all the field applications, selected piles were instrumented. Data from instrumented piles indicated that FRP was slowing down the corrosion rate [12].

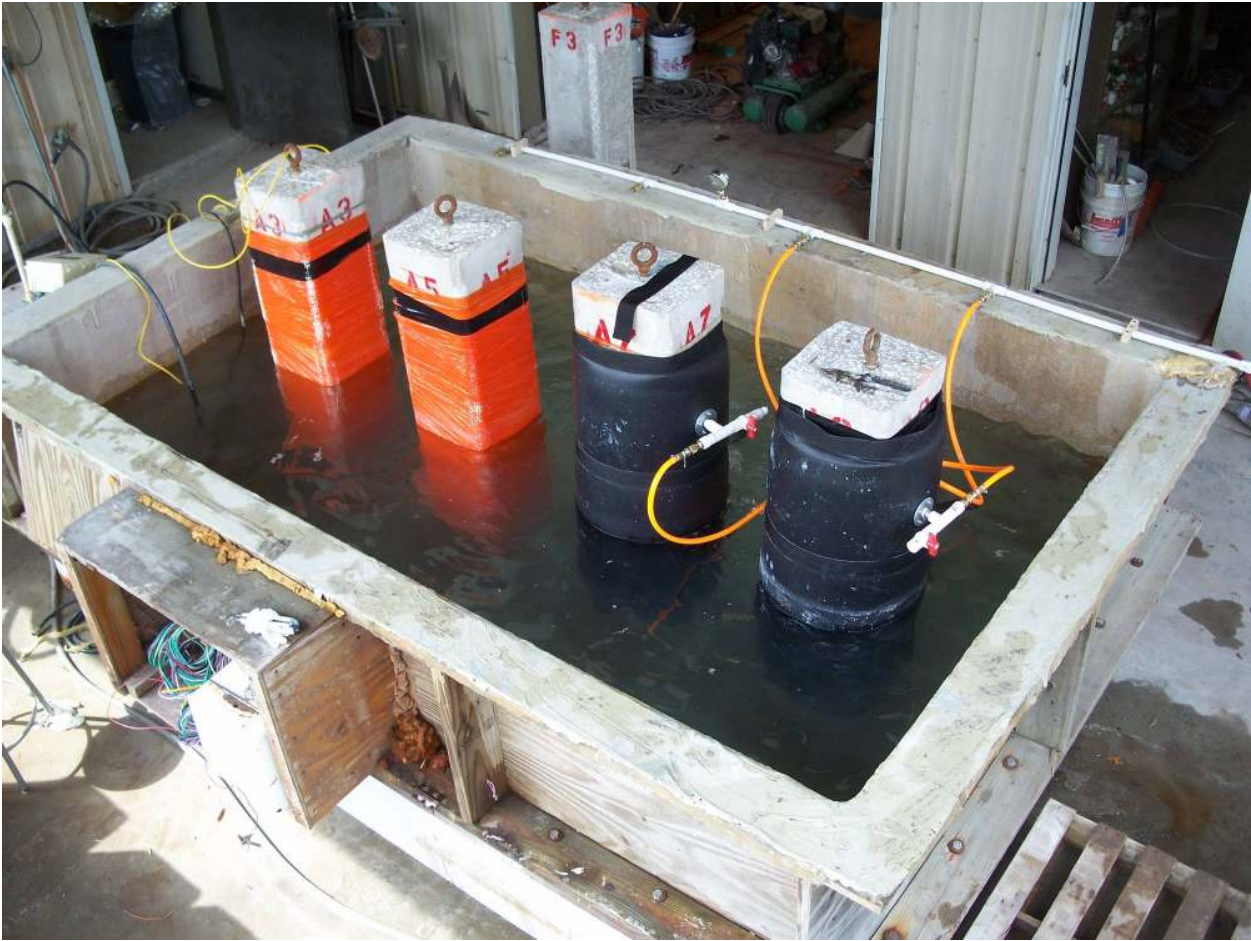
Surface preparation is always the key for good bond. However, even if recommendations in guidelines are met, bond can be poor unless there is continuous, intimate contact of the saturated FRP material and the concrete substrate while the resin is curing. Such contact may be lost in repairs involving vertical elements such as columns or the horizontal soffits of slabs, because gravity effects create tendencies for the resin-saturated FRP to separate.

Fig. 4 Current practice vs pressure bagging

The problem with the FRP-concrete bond was solved by employing vacuum / pressure bagging techniques widely used by the composites industry for fabricating specimens. Though both systems were demonstrated to improve bond in piles, pressure bagging was selected since incorporating a vacuum in a cracked pile can be problematic in the field. Fig. 4 shows full sized pressure bagged piles in an outdoor tank. Two other controls are shown in the same photo that were used for comparison. A comprehensive series of pullout tests were conducted and this showed that there was significant improvement in the FRP-concrete bond. This system was successfully implemented in field demonstration projects. Complete details in [1].
