LONGITUDINAL IRREGULARITY OF ROAD SURFACES: DEPTHS UNDER ROLLING STRAIGHT-EDGE VERSUS INTERNATIONAL ROUGHNESS INDEX

MOHD HIZAM HARUN, FAZLEEN HANIM AHMAD KAMAR
& NORSAKINAH MOHD AMIN

Public Works Department, Malaysia

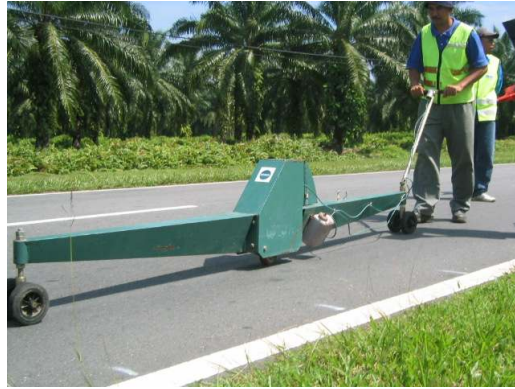
Figure 1 - Rolling Straight-Edge

The rolling straight-edge is a relatively simple device to measure surface regularity. It has wheels at both ends, supporting a frame that acts as a straight-edge with a measuring wheel in the middle. It is hand-pushed manually along the road and irregularities in the forms of bump and dip on the road surface are either recorded automatically on a profile paper or manually. This equipment measures surface deviation relative to a moving datum. The wavelengths measurable are limited by the base length of the datum viz. the length of the straight-edge which is normally three metres.

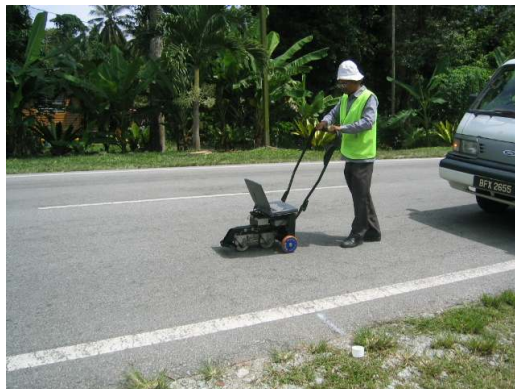
Figure 2 – ARRB Walking Profiler

The Australian Road Research Board (ARRB) Walking Profiler is a precision, compact and easy to use instrument designed to facilitate efficient collection and presentation of continuous road or runway profiles. It also enables accurate measurements of IRI, complying with the World Bank Class 1 profilometer requirements⁸. This compact device is pushed over the surface to be surveyed and the on-board computer calculates and displays results in graph and table formats.

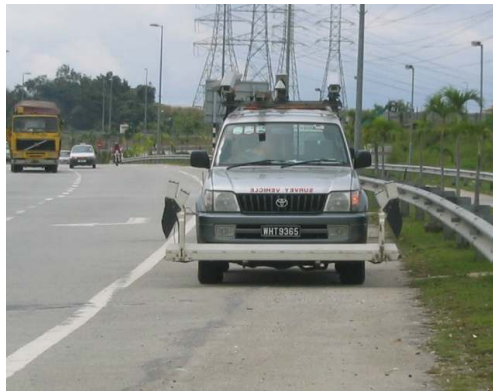
Figure 3 – IKRAM Road Scanner

The IKRAM Road Scanner (IRS) is one of the survey vehicles developed by ARRB to capture pavement condition data, survey mapping information and roadside asset details while traveling at high speeds. It is capable of capturing elements for road roughness, rutting, texture and surface conditions. The IRS consists of four main systems namely the Multi Laser Profiler (MLP), Gipsi-Trac, Global Positioning System and digital imaging system. The MLP is used to calculate the IRI value.

The MLP uses 13 laser height transducers mounted in a beam in front of the vehicle. These transducers measure the distance from the beam to the pavement surface. Accelerometers located in each wheelpath are used to measure vehicle bounce and vertical movement of the beam and compensate any interference accordingly. Outputs from the accelerometers and lasers are then combined mathematically to produce a longitudinal elevation profile of the pavement surface.

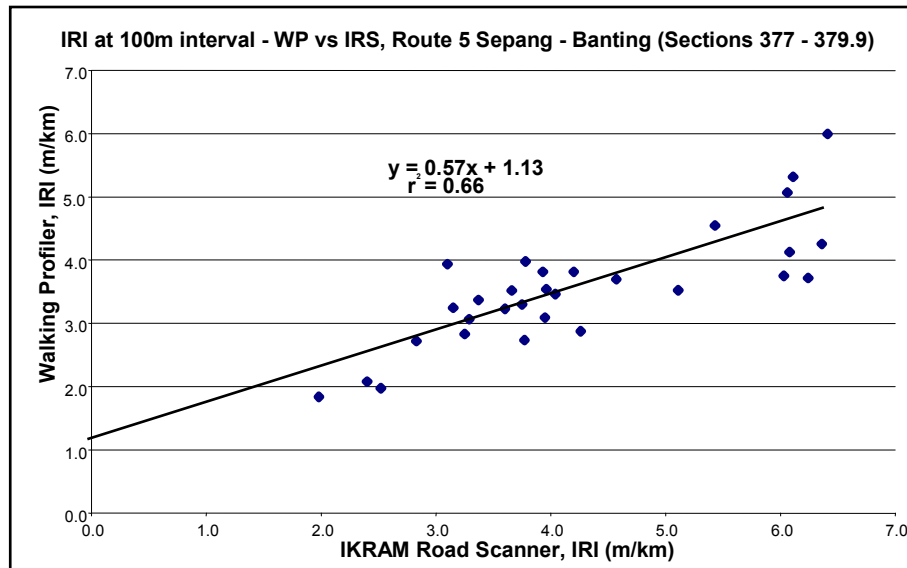
Figure 4 – Correlation between IKRAM Road Scanner and ARRB Walking Profiler, Route 5 Sepang - Banting, Sections 377.0 - 379.9.

Figures 4 and 5 are direct comparison between the IRI results acquired from the IRS and the Walking Profiler at two different locations namely Route 5 Sepang – Banting, Sections 377.0 - 379.9, and Route 5 Sepang – Banting, Sections 357.0 - 364.0 respectively. Figure 4 gives a linear equation $y = 0.57x + 1.13$ with $r^2 = 0.66$ whereas Figure 5 yields a linear equation $y = 1.06x$ with $r^2 = 0.63$, which consistently indicate a good correlation between the two equipments.

A higher degree of correlation could be achieved if this comparison exercise was done in a controlled environment as was done in a previous study on the North – South Expressway. In the controlled environment test run, a 500-meter stretch of the expressway was closed to traffic. The IRS and Walking Profiler were then run on exactly similar wheelpaths. The coefficient of variation obtained for that exercise was 0.96.

2. Direct comparisons between IRI acquired from a high speed survey vehicle (the ARRB - developed IKRAM Road Scanner) and the ARRB Walking Profiler consistently indicate a good correlation between the two equipments.

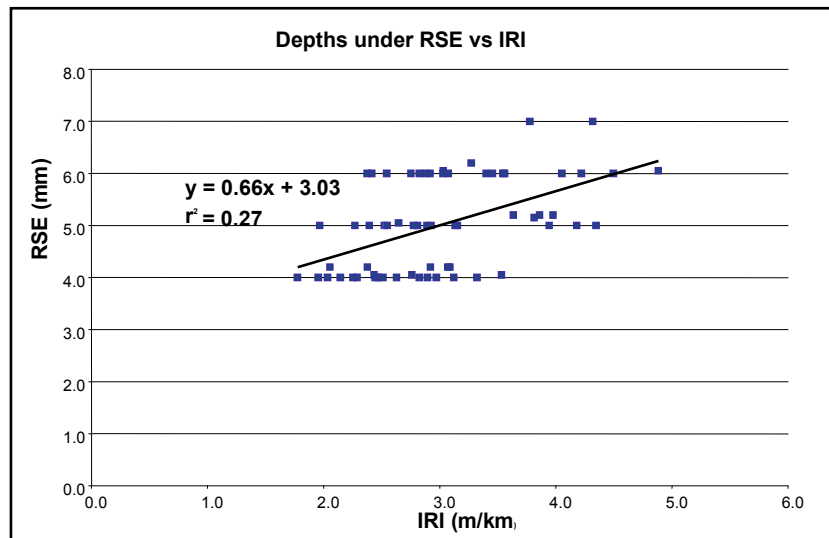
Figure 8 – Depths under RSE vs IRI at Route 5, Sections 357.0 - 364.0.

Figures 8 and 9 are a plot of average depth under the rolling straight-edge against average IRI (acquired by the IKRAM Road Scanner) over 100-meter length traversed at the same chainages along Route 5, Sections 357.0 – 364.0 and Sections 377.0 – 379.9 respectively.

Figure 8 yields a linear equation $y = 0.66x + 3.03$ with $r^2 = 0.27$ whereas Figure 9 exhibits a linear equation $y = 1.39x + 0.80$ with $r^2 = 0.56$, where y = average absolute depth > 4mm under rolling straight-edge in mm, and x = IRI in m/km.

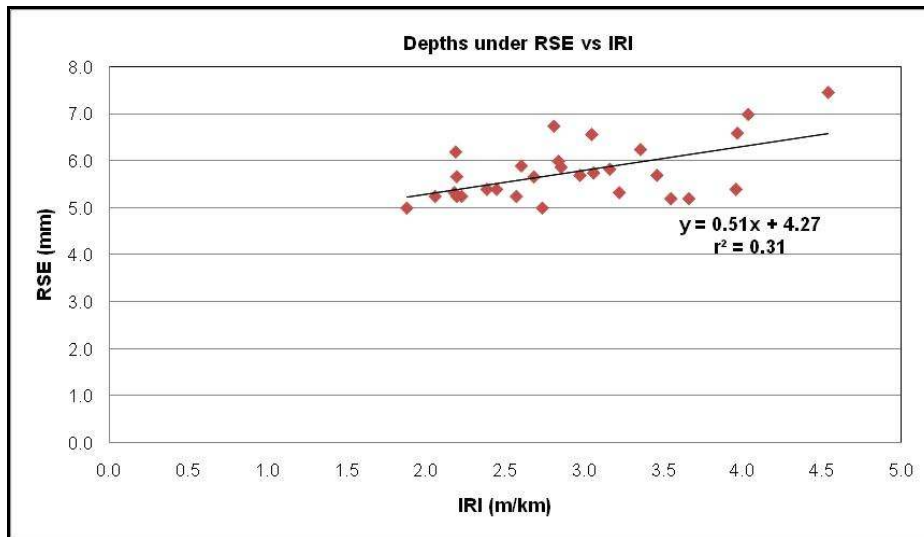
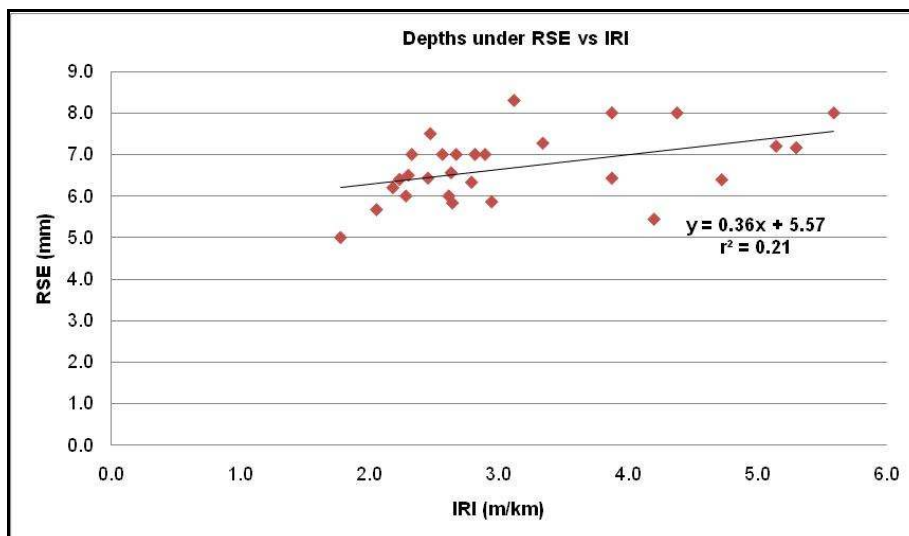
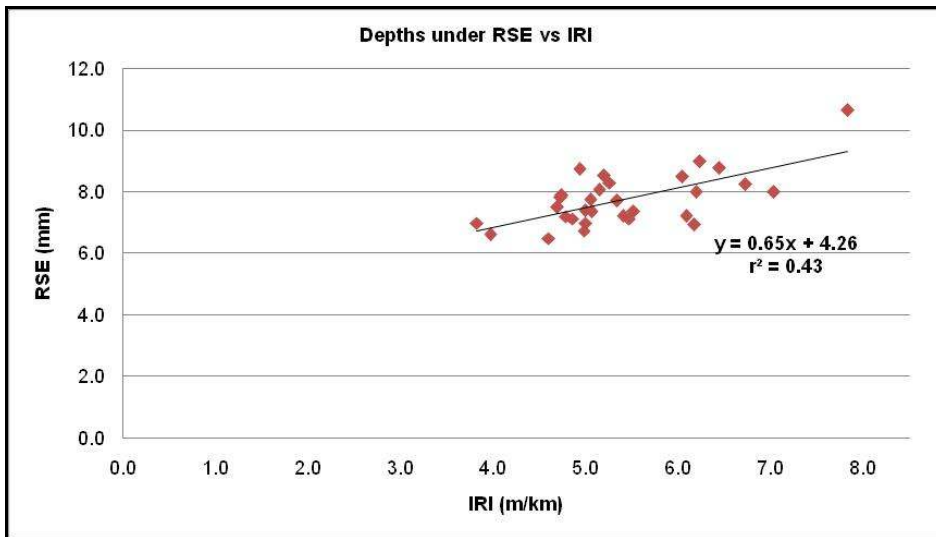
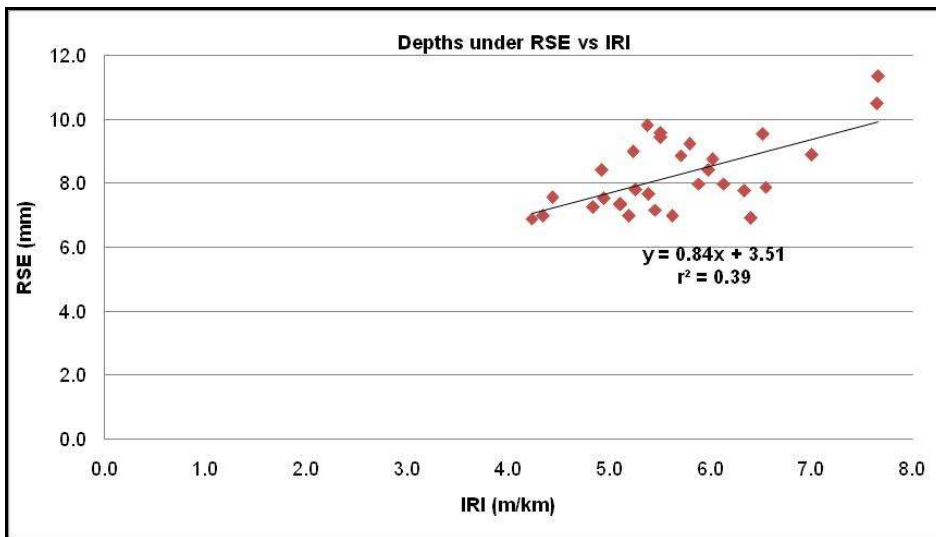
A similar exercise was repeated at another site which was a totally new road namely the Padang Terap road. The analysis was carried out for every 3 km stretch between Section 3.0 and Section 18.0. The resulted linear equations and r^2 values are as shown in Table 5, where y = average absolute depth > 4mm depth under rolling straight-edge in mm, and x = IRI in m/km.

There exists a similar linear trend between 'y' and 'x'. Averaging the 'm' and 'c' values in the linear equations results in an equation $y = 0.62x + 4.3$, with $r^2 = 0.34$.
