MONITORING INTEGRITY AND CORROSION DAMAGE ON STAY CABLE BRIDGE SYSTEM IN MEXICAN HIGHWAYS

In this research we present preliminary results of Dovali bridge and some results of Mezcala bridge . The field of investigation was carried out using systematic, organized, and efficient procedures to minimize the risk of leaving out any elements of the bridge, in Figure 1 presents a general view of Mezcala and Dovali bridges.

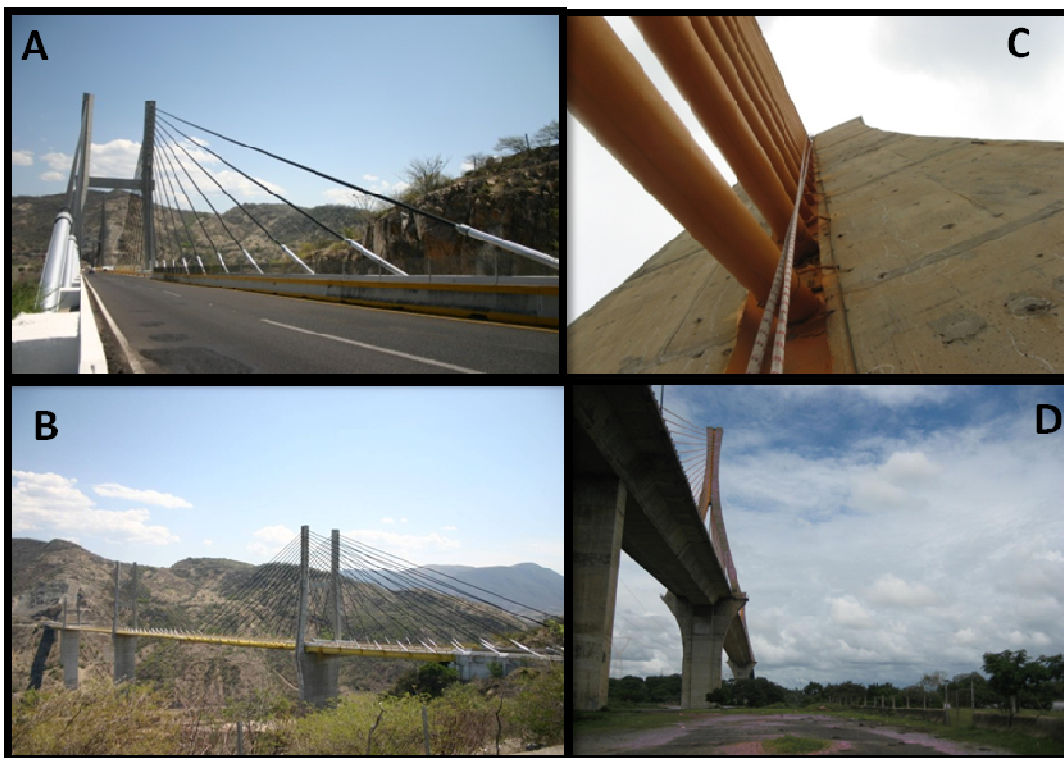
Figure1 photographs A) deck and strands Mezcala, B) Strands Dovali, C) profile Mezcala and D) profile Dovali

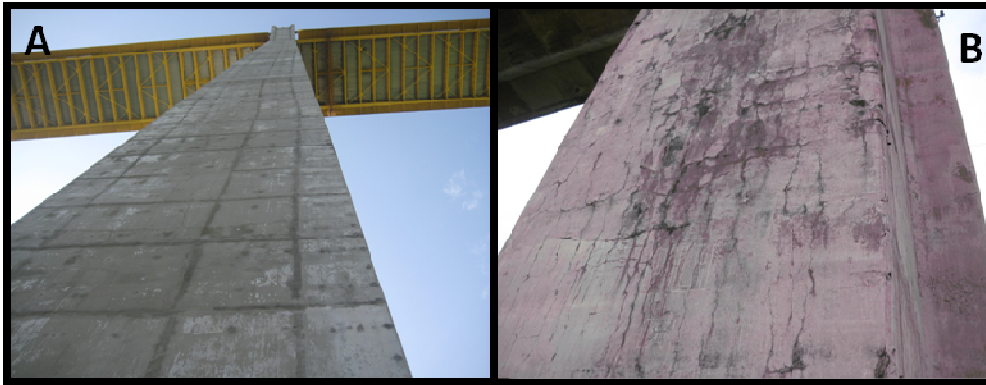
Figure 2 photographs A) pile 4 Mezcala and B) pile 5 Dovali

According detailed visual inspection Dovali bridge has corrosion damage and Mezcala bridge does not present damage.

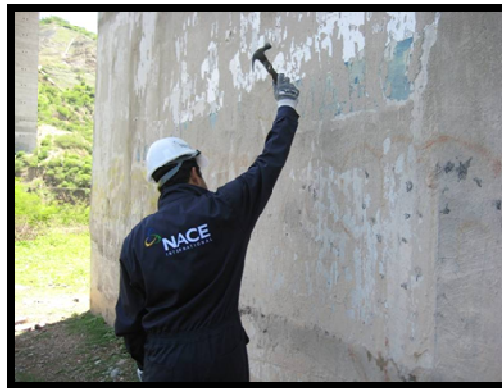
Initially, the effects of the damage by corrosion in steel may not be seen at a glance, since the delamination happens internally and does not manifest on the exterior surface of the structure. When a delamination exists, the space between the solid and loose concrete produces a particular sound that allows identification of the affected area. Mezcala acoustic inspection result does not sound cavities, in Figure 3 show test.

Figure 3 Detection of hidden corrosion in pile 3 Mezcala Bridge

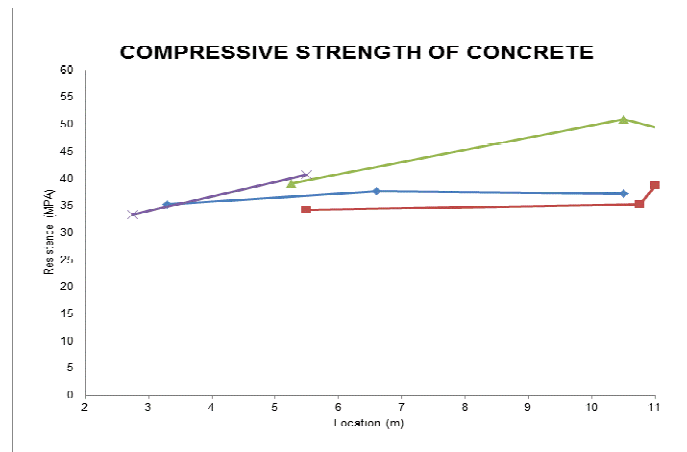
The mechanical strength of concrete is preserved, impact test of concrete shown that Mezcala does not have damage by corrosion; this test is shown in Figure 4

Figure 4 Compressive strength of concrete.

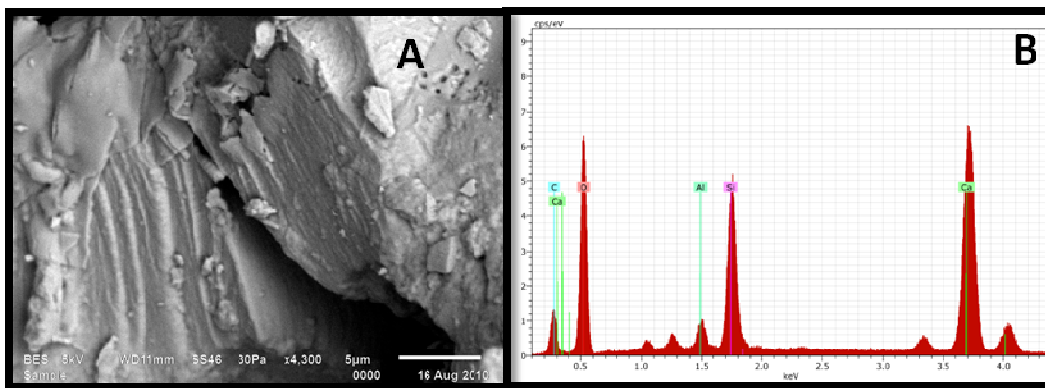
The morphology and composition of steel strands Figure 5 and concrete samples were analyzed by SEM these results are shown in Figure 6. The sample of concrete shows porosity and a fracture. In Figure 5B and 6B present the spectrum EDS.

Spectrum of energy Dispersive X-ray Spectroscopy (EDS) indicating the presence of Ca, O, Si, and Al, this elements belong to part of concrete, does not show Cl content and C belong to a tape using during the test.

Figure 6 A) SEM micrograph of concrete and B) EDS microanalysis to concrete sample
