INSPECTION OF PRESTRESSED CONCRETE ROAD BRIDGES BY ULTRASOUND 3D TOMOGRAPHER SYSTEM

Eng (technical university) G.Rapaport
Ramboll Finland Oy, Infrastructure & Transport, Bridge Engineering, Finland
GUY.RAPAPORT@RAMBOLL.FI

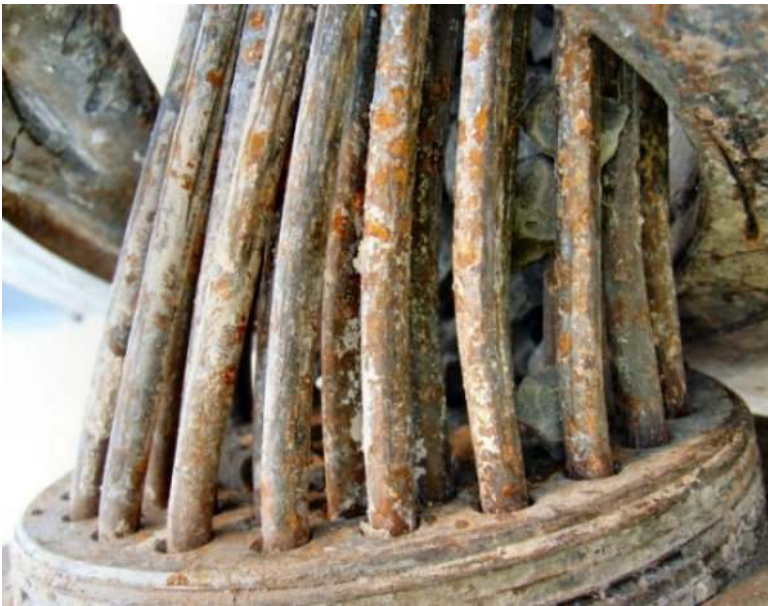
The main difficulty in these cases is that the corrosion process occurs inside the “internal prestressing system” and is not noticed by normal visual observation from near the bridge. Results of the above presented damage mechanism are shown for example in figure 1. In this photo it is possible to see pitting corrosion (relatively mild) of prestressing steel in an anchor unit due to chloride penetration (confirmed). The photo was taken from the demolished Mälkiä channel bridge in Finland.

”Figure 1 – Mälkiä channel bridge, corroded prestressing steel”

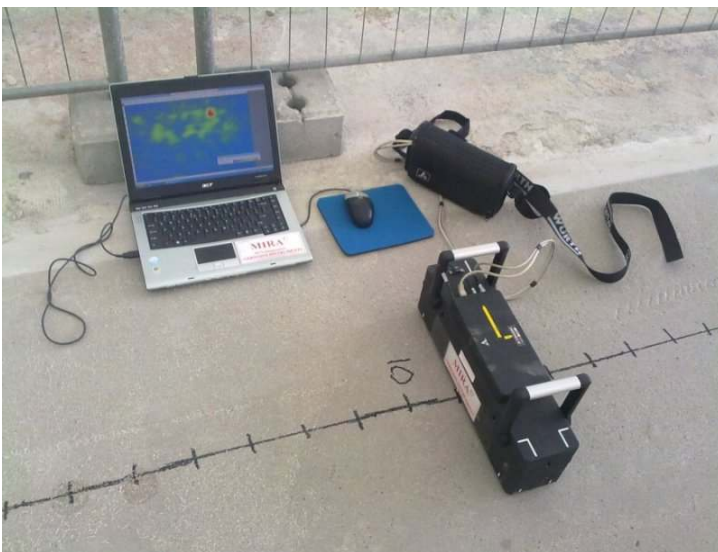
1. The 3D TOMOGRAPHER system has a phased antenna array which is composed of a 4 by 10 array of dry point transducers (DPC) and a control unit that operates the transducers. The transducers act as transmitters and receivers in a sequential mode.
2. Laptop with the 3D TOMOGRAPHER software, a SAFT (Synthetic Aperture Focussing Technique) algorithm based software.
3. The power unit of the antenna equipped with a wireless net-transmitter.

"Figure 2 – The 3D TOMOGRAPHER components"

The components of the 3D TOMOGRAPHER system are presented in figure 2.

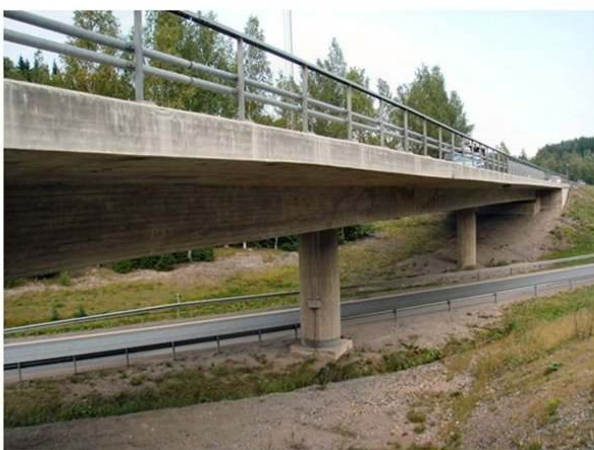
Lieviö overbridge is located in the south of Finland on motorway no. 1 between Helsinki and Turku. The bridge type is continuous prestressed concrete box-girder bridge and it was constructed in the year 1971. The bridge overall length is 102,0 m. The bridge general side view and the bridge cross-section are presented in figure no. 6.

“Figure 6 – Lieviö overbridge side view and cross-section”

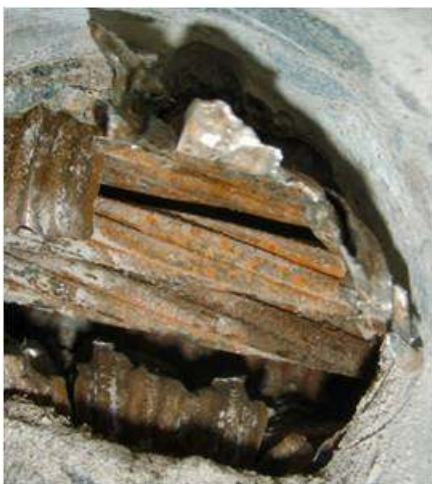
The opening of duct no. 5 revealed that the duct was completely empty of injection grout and the cables were severely corroded, yet only mildly pitted. See figure 8.

"Figure 8 – Exposed prestressing steel, drilling location in accordance to 3D TOMOGRAPHER scanning"

Opening was carried out by diamond drilling till touching the duct. The duct was opened by lighter drilling and chiselling equipment.

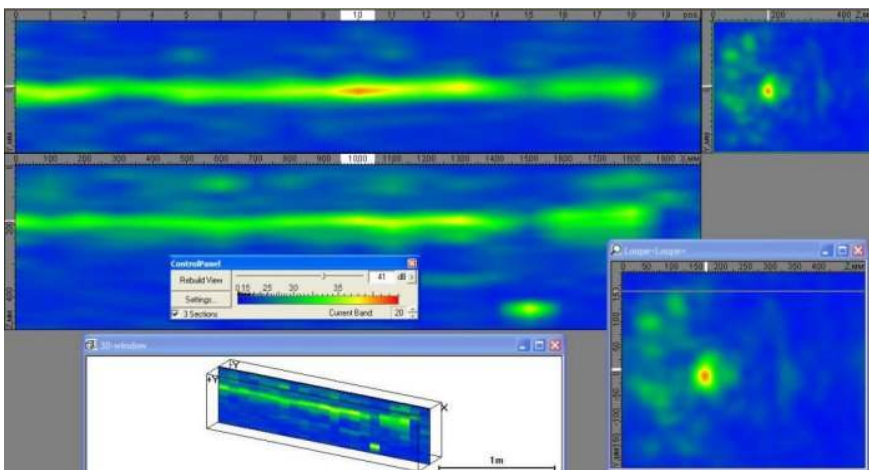
The 3D TOMOGRAPHER scanning revealed no intensive and continuous wave reflections along the scanned ducts which might indicate of significant air existence in the ducts, see scan’s print screen 1 at figure 10.

“Figure 10 – 3D TOMOGRAPHER scan print screen 1, Vanaja bridge”

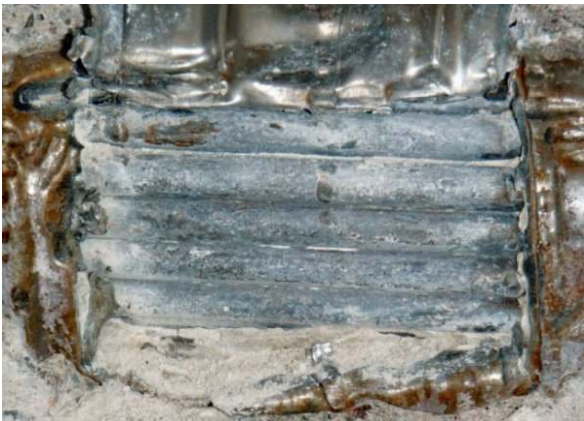
The 3D TOMOGRAPHER scanning results were confirmed by opening (diamond drilling) of one duct in the relatively most suspicious point according to the 3D TOMOGRAPHER scanning. By the opening it was confirmed that the duct is injected by cement grout. No indication of air voids or moisture was found in the duct. The prestressing steel was only slightly corroded. Due to the relative small diameter of the duct and the large amount of

prestressing steel in the duct, the injected cement grout layer was very thin, 0-4 mm. See figure 11.

“Figure 11 – Exposed prestressing steel, drilling location in accordance to 3D TOMOGRAPHER scanning”
