# THE INFLUENCE OF THE EYJAFJALLAJÖKULL HAZARDOUS VOLCANIC ERUPTION IN APRIL 2010 ON ROADS AND AIR TRAVEL

H. HARALDSSON, PhD  
Icelandic Road Administration, Iceland  
hreinn.haraldsson@vegagerdin.is

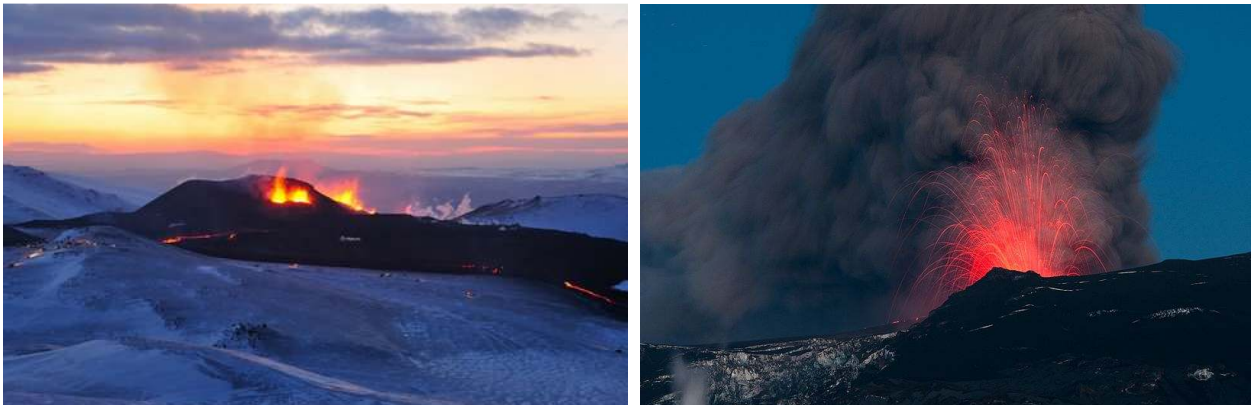
Figure 7 – First eruption, March 2010

Seismic activity started at the end of 2009 and gradually increased in intensity until on 20 March 2010, when a small eruption started in the mountainside, which lasted until 12 April. The 2010 eruptions are the culmination of 18 years of intermittent volcanic unrest but without any eruptions. Before the eruption, a  $\sim 0.05 \text{ km}^3$  magmatic intrusion under the volcano grew over a period of three months, in a complex manner, as revealed by GPS (Global Positioning System) geodetic measurements and analysis of satellite radar images. In early January 2010, the rate of deformation and the number of earthquakes began to increase. As the deformation and seismic unrest continued, the researchers installed more GPS stations near the mountain. Just a few weeks later, the instruments detected more rapid inflation, indicating that magma was moving upwards through the “plumbing” inside the volcano. This rapid deformation stopped as soon as the eruption in the summit began.

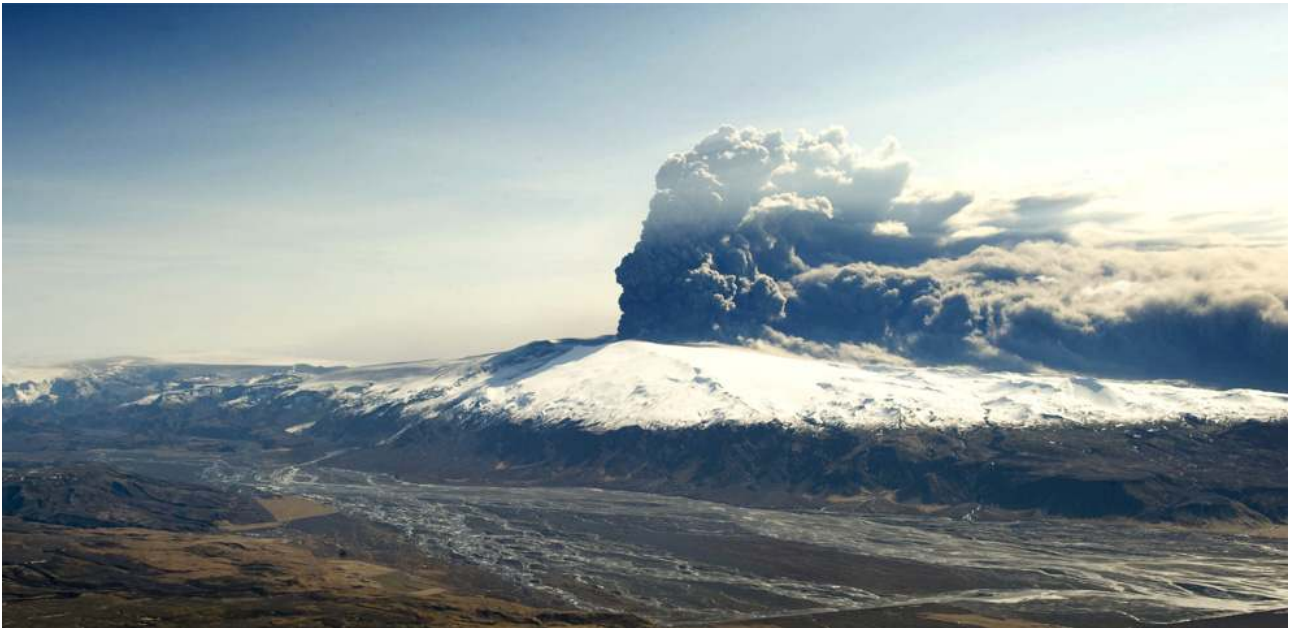
Figure 9 – Eyjafjallajökull eruption in April 2010 and the Markarfljót glacial river

The explosive eruption lasted for 39 days but extensive melting in the vent area mostly occurred in the first two days, leading to repeated jökulhlaups towards the north into the river Markarfljót. Melting continued after that, but drainage was continuous and the rate was not sufficient to cause jökulhlaups.

The eruption under the centre of the glacier, below the initial ice thickness of 200 m, almost immediately released meltwater which caused flooding in nearby rivers by the morning of 14 April as it travelled in two flows down either side of the volcano, forcing the evacuation of around 800 people. The main flood entered the glacial river Markarfljót on

the northern side of the volcano and at its maximum around noon the discharge reached 2700 m<sup>3</sup>/sec, where the usual discharge is 100 m<sup>3</sup>/sec. A second somewhat smaller jökulhlaup travelled down the Markarfljót valley in the evening of 15 April.

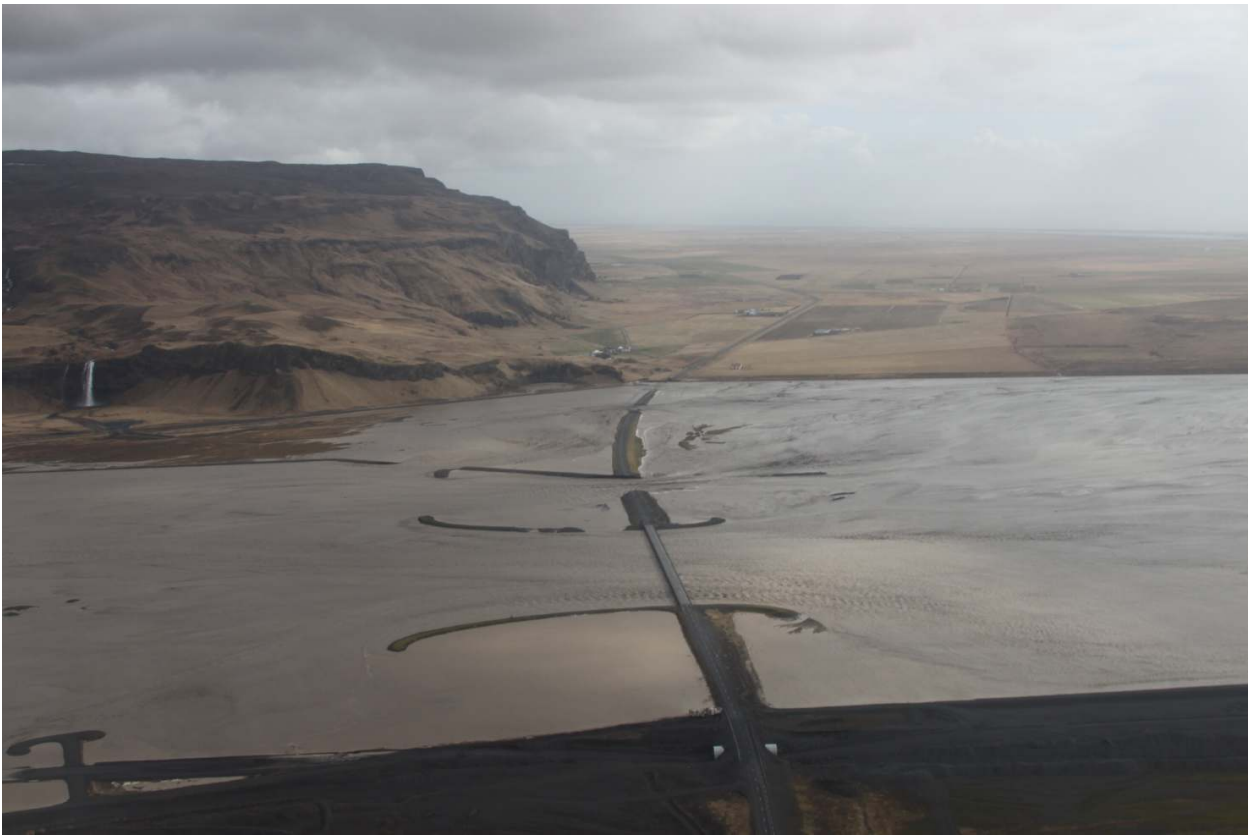
Figure 10 – The flood at maximum discharge at Route 1. Roads and dams were damaged.

A flood control embankment system of armourstone protecting dams in the Markarfljót valley diverts the river under the bridges and protects vegetated land from river over flooding and erosion. The 250 m long bridge across Markarfljót river on the important Route 1 was designed to withstand a flood of around 2500 m<sup>3</sup>/s, but scientists estimated in the beginning of the eruption that the flood could exceed 10000 m<sup>3</sup>/s at its culmination. When the meltwater started to run along its path in the morning, the Icelandic Road Administration closed roads to all traffic and started to prepare to save the highway infrastructure, knowing that there were some 2-3 hours before the flood entered the location of the bridge. Channels were excavated through the armourstoned river embankments and the roads on both sides of the main bridge, to try to divert the flood away from the much more valuable concrete structure.

The maximum discharge of 2700 m<sup>3</sup>/s might have been carried by the bridge opening, but specialists believe that it probably would have suffered some damage. The decision to cut through the road and divert the flood away from the bridge therefore proved right.

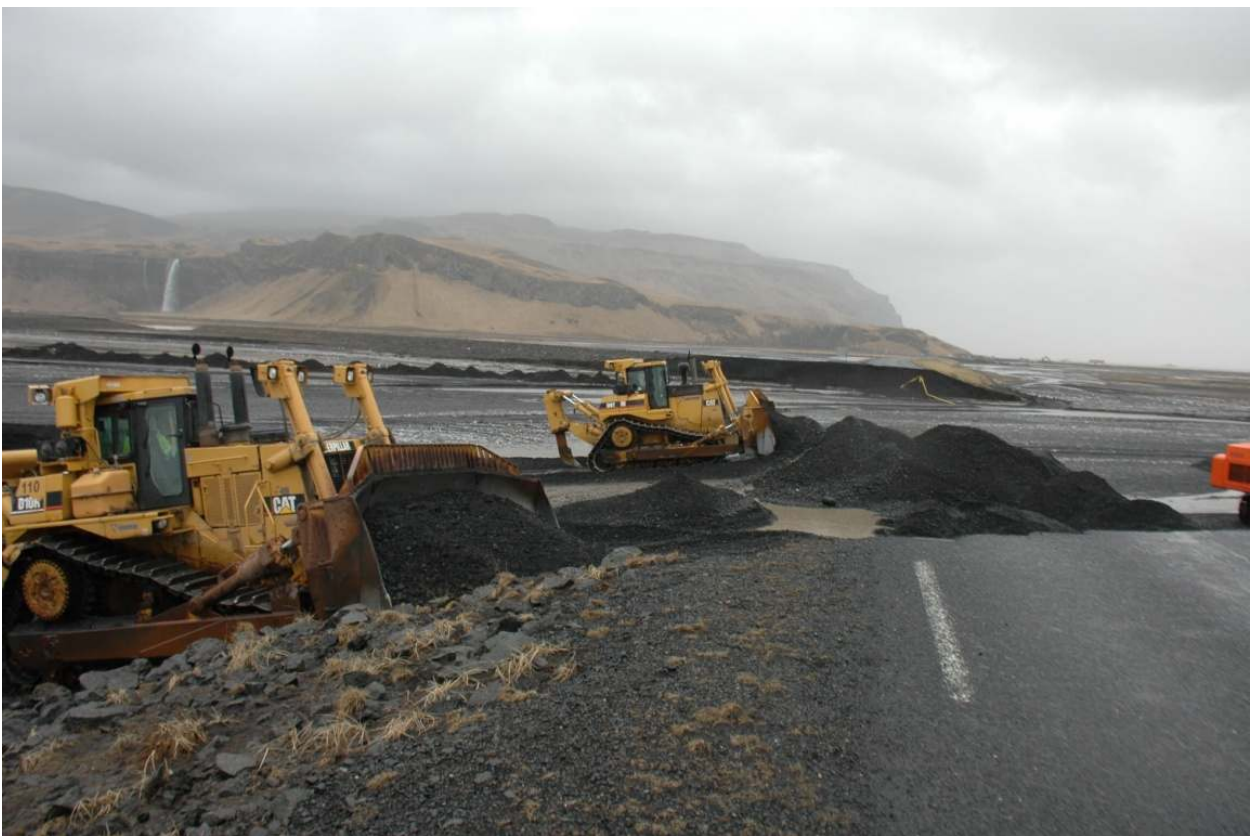
Figure 11 – Rebuilding of roads started already the day after the catastrophic flood.

On 17 April the road cuttings had been filled up and emergency drive through was allowed. Provisional reparations went on day and night and as early as 18 April the road was opened for all public traffic, even though the volcano was still very active and there was always the risk of yet another flood. Warning systems with water level and water conductivity gauges were set up, together with emergency plans, in close co-operation with the police and local authorities. Fortunately, no larger floods followed, as the volcanic eruption had already melted most of the ice in the vicinity of the crater. Final reparations and paving of the the damaged sections of Route 1 were completed in early summer 2010.

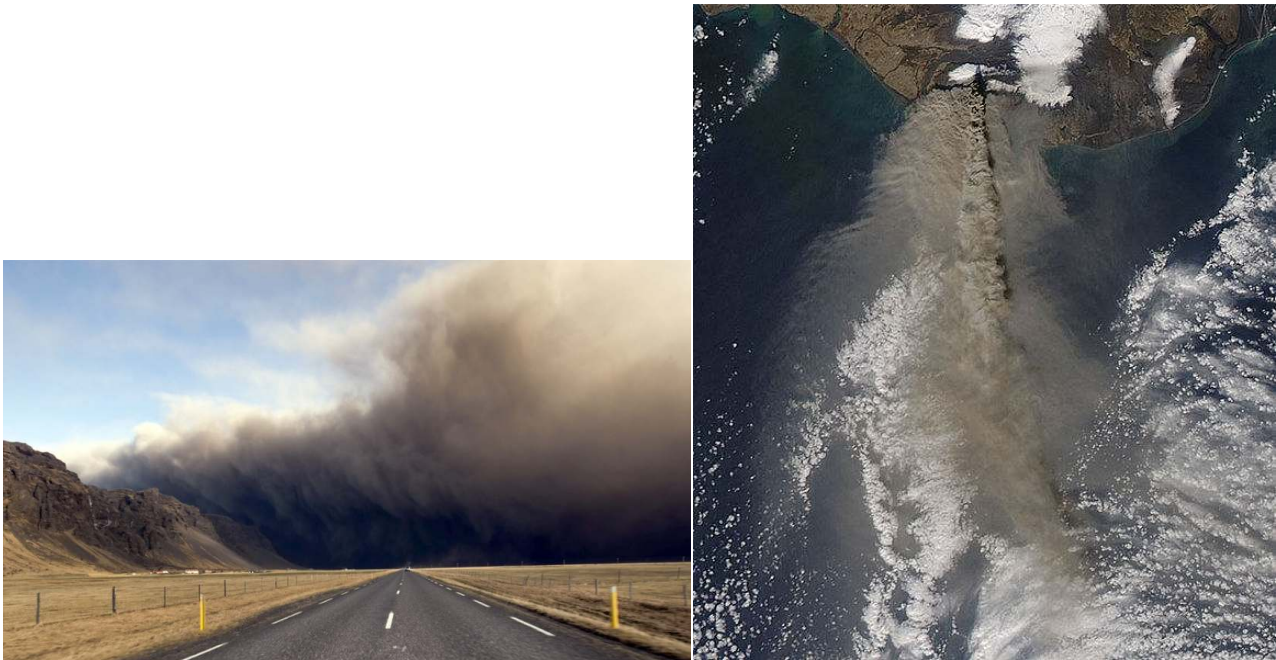
Figure 13 – A photograph and a satellite image of the ash plume 17 April 2010

1. The volcano is located directly under a jet stream (jet streams are fast-flowing, narrow air currents found in the atmosphere at around 7–12 km above sea level, the strongest being the polar jets).
2. The direction of the jet stream was unusually stable at the time of the eruption, maintaining a continuous south-easterly heading.
3. The eruption took place under 200 m (660 ft) of glacial ice. The resulting meltwater flowed back into the erupting volcano which created two specific phenomena:
  1. The rapidly vaporising water significantly increased the explosive power of the eruption.
  2. The erupting lava cooled very rapidly, which created a cloud of highly abrasive, glass-rich ash.
4. The volcano's explosive power was sufficient to inject ash directly into the jet stream.
