COLD IN-PLACE RECYCLING OF MARGINAL MATERIALS IN MALAYSIA

This paper describes pavement evaluation and structural design processes, mix design and construction methods, and presents the performance test results for two project sites, namely Felda Pekoti Timur and Felda Krau, in Pahang, Malaysia.

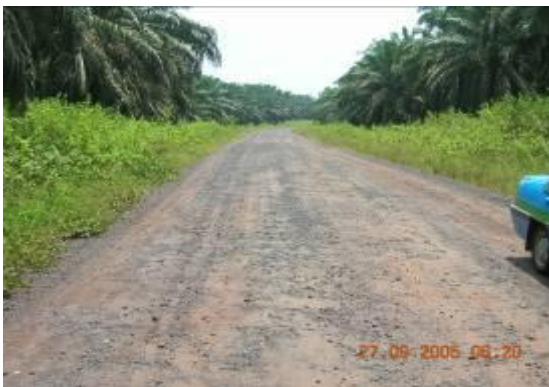
Figure 1 - Felda Pekoti Timur

Since the two sites consist of combination of laterite and gravel roads, Falling Weight Deflectometer (FWD) test and International Roughness Index (IRI) measurement were not carried out prior to construction stage. Based on the visual surface condition survey, several localized sections had recorded depression of more than 40mm. From Dynamic Cone Penetrometer (DCP) test, Subgrade's California Bearing Ratio (CBR) was found to be ranging from 6% to 16% during the dry season. Figures 1 and 2 depict the photos taken from the two sites.

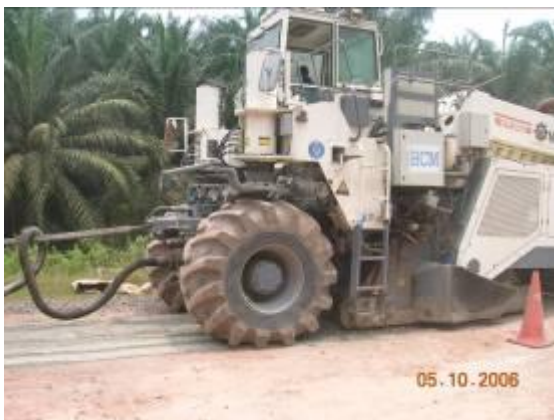
Figure 3 - Recycling machine

The area was thoroughly investigated and checked for the presence of any underground utilities especially cabling work to avoid being damaged during the recycling work. The percentages of stabilizing agents and/or water contents were first determined during the mix design stage at the laboratory. The required quantity of Ordinary Portland Cement (OPC) or lime was spread manually over the identified recycling sections. The area was then recycled using a recycling machine to a depth ranging from 150mm to 200mm depending on the pavement structural design. Figure 3 depicted the recycling machine used at one of the site.

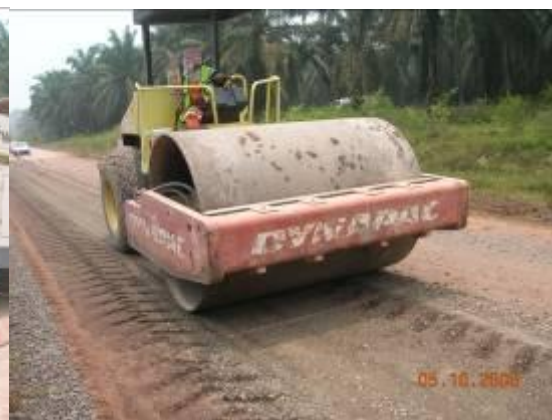
Figure 4 - Vibratory roller

Immediately after break-down compaction using a smooth drum roller, a grader was used to re-profile the finished recycled layer. Further compaction by vibratory roller (Figure 4) was carried out to achieve the required degree of compaction. The recycled materials that have been stabilized needs to be properly cured to achieve the minimum strengths prior to opening to traffic.

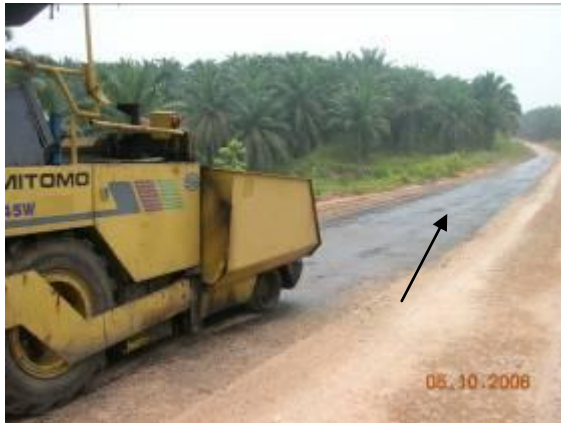
Figure 5 - Prime coating

The surface to receive the asphaltic concrete layer was to be cleaned, free from loose materials and standing water. It has been a standard practice in Malaysia, and as required by the specification that the bituminous overlay be carried out 3 days after recycling works is completed. Prior to overlaying of asphaltic concrete wearing course (ACWC), a layer of prime coat was applied and allowed for curing within 24 hours (Figure 5). After the

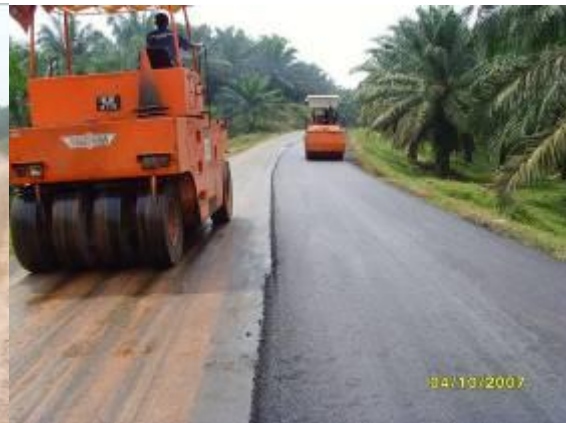
Figure 6 - Compaction of ACWC

specified ACWC thickness was laid, the road was not allowed to be trafficked until compaction has been completed and the material cooled thoroughly (Figure 6). This cooling down process normally takes about 4 hours from the initial compaction process.

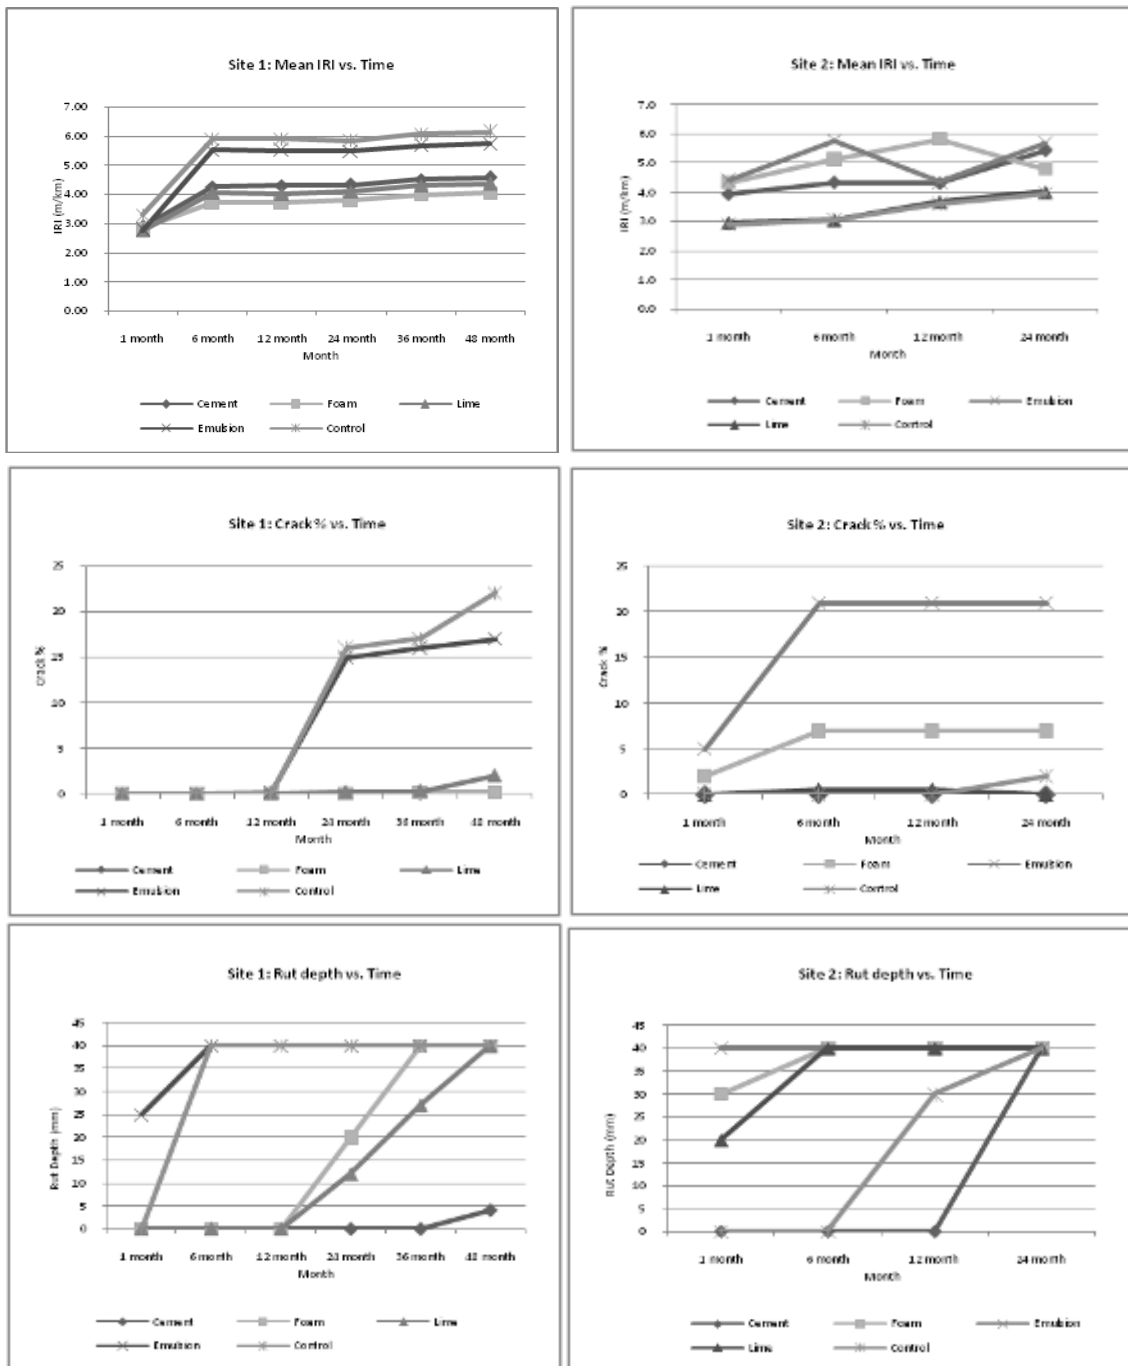
Figure 7 - Pavement Functional Performance

The data from site 1 indicated fair to poor riding quality in the form of International Roughness Index (IRI) with values ranging from 2.6 m/km to 3.3 m/km after rehabilitation. These IRI values gradually increase with varying rate of change. After 48 months, control section recorded the highest IRI value of 6.1 m/km, followed by emulsion, cement, lime and foamed sections. Localized cracks started to appear on control and emulsion sections after 24 months. On top of that, maximum rut depth of 25mm was also observed on emulsion section as early as one month followed by 40mm rut depth on control section after 6 months. Further observation reveals that cement section only recorded rut depth of 5mm after 48 months.

For site 2, IRI values ranging from 3.0 m/km to 4.5 m/km was recorded after recycling. As at 24 months, emulsion section recorded the highest IRI value of 5.8 m/km. The high IRI values could be due to the existing profile, surface type and initial pavement roughness which are known to have a significant effect on the future roughness level of the pavement [4]. Localized cracks were observed on foamed and emulsion sections, with area of cracks covering up to 21 percent of the section. Nonetheless, no significant cracks were observed on cement and lime treated sections after 24 months. Localized rut of 25mm to 40mm was recorded on sections treated with emulsion, foamed and lime, after one month of recycling. In general, the performance of cement and lime stabilized sections was superior than the other sections, with no fatigue cracking at least until 48 months for site 1 and no crack recorded thus far for site 2. Figure 7 illustrates the functional performance of each section over 48 months and 24 months period for sites 1 and 2, respectively. Further monitoring is necessary to relate the long-term pavement functional performance to the treatment types.

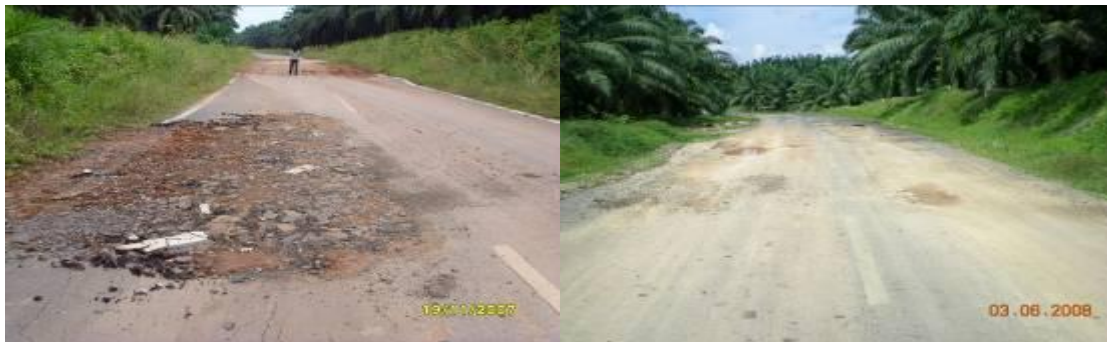
Figure 8 - Pavement defects

Based on the construction site records, rainy season experienced during the recycling process at site 2 could have resulted in higher than the optimum/ideal moisture content. As a result, the pavement at 2 sections namely foamed bitumen and emulsion might not gain the required strength and offer a satisfactory interfacing layer for the asphaltic course. With the marginal materials susceptibility to moisture, this could have led to a breakdown of materials, in which under heavy trafficking causes the materials to crack or shoved to the sides as shown in Figure 8. Inadequate drainage or poor drainage system might have aggravated failure at both sites.

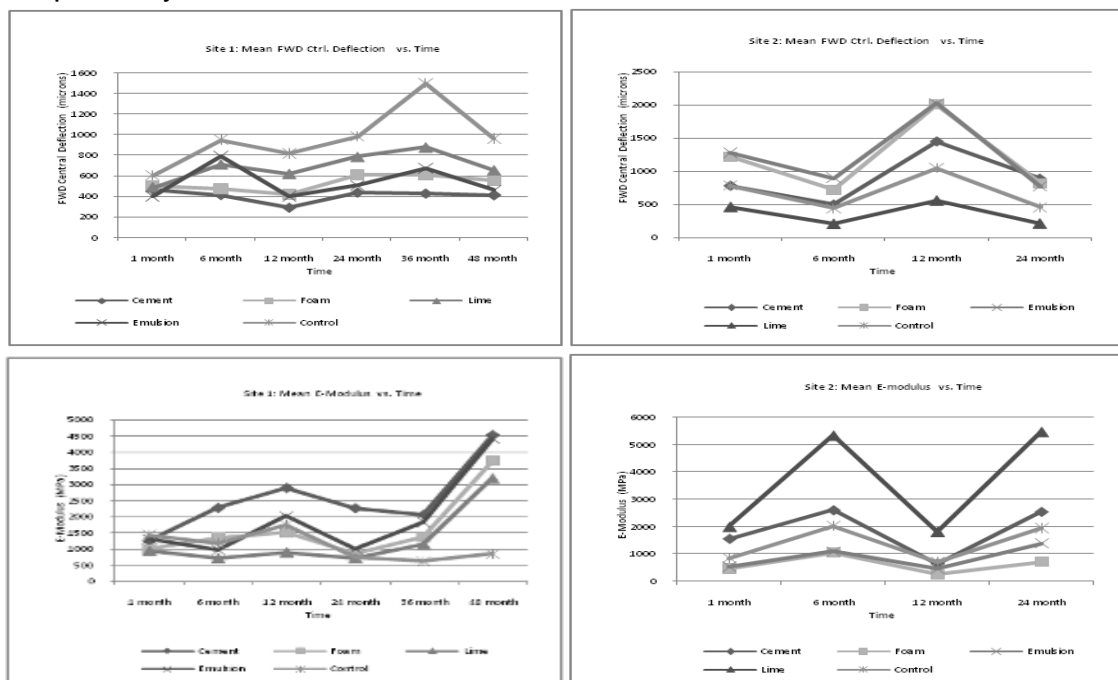
Figure 9 - Pavement Structural Performance

Most of the sections on site 1 were in relatively fair to poor structural condition based on the FWD central deflection data. Control section was observed to record the highest central deflection exceeding 700 microns after 6 months of recycling. From Elastic Modulus data, cement section was found to record the highest values at 4,500 MPa.

It was also observed that majority of the sections on site 2 was in relatively poor structural condition with FWD central deflection of greater than 700 microns. With respect to the cement and lime stabilized layers, high E-modulus values were recorded at both sites.

Figure 9 summarizes the structural performance of the 2 sites over 48 and 24 months period, respectively.

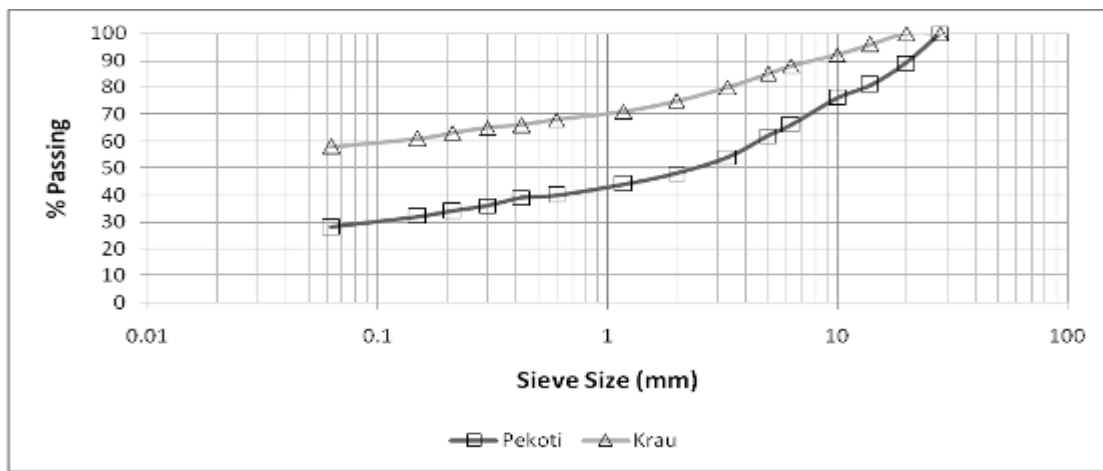
Figure 10 - Aggregate Gradation

From the sieve analysis, it was found that high clay/silt content of more than 55 percent was observed from site 2 as shown in Figure 10. Both samples were also observed to have a PI of 20 as tabulated in Table 4. The high PI readings generally indicated clayey soils that are known to be susceptible to moisture and consequently could have affected the performance of sections with high moisture content.

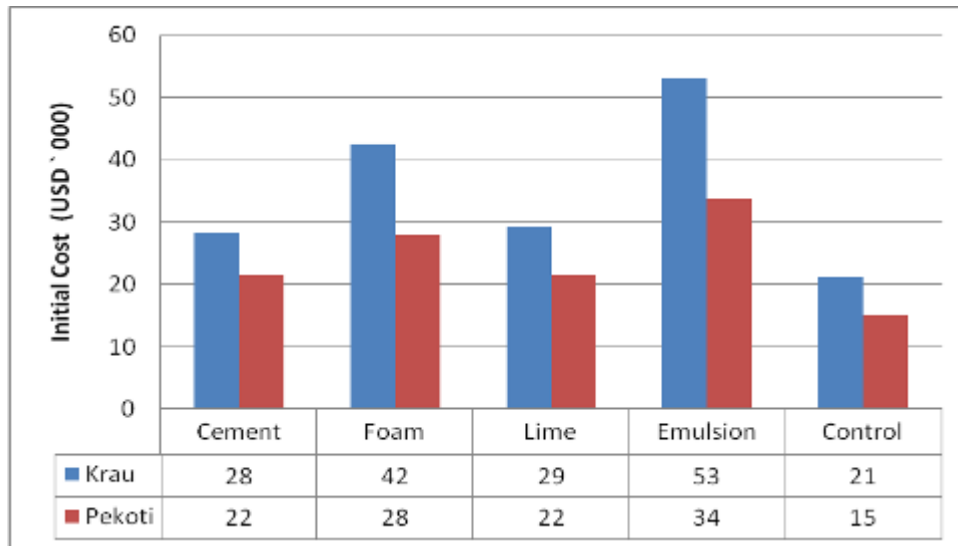
Figure 11 - Initial Construction Cost (1 USD = 3.04 MYR)

Since the deterioration models for CIPR pavement stabilized with various stabilizing agents have not been established up to this stage, the cost analysis was based on initial construction cost for different treatment types. Difference in cost is due to the different design, which varies in the thicknesses of asphaltic, crushed aggregate and recycled layers, as tabulated in Table 1. It was noted from both sites that control section produce the lowest cost, followed by CIPR with cement, lime, foamed bitumen and finally CIPR with emulsion as shown in Figure 11. However, from the data collected, it was observed that the premature distress or failure on control, foamed bitumen and emulsion sections were high and this would in turn increase the maintenance cost in the long run.
