ROAD SAFETY AUDITS IN MEXICO

E. ABARCA, A. CENTENO & A. MENDOZA

Transport Safety and Operation Coordination, Mexican Transportation Institute, Mexico
eabarca@imt.mx, acenteno@imt.mx, mendoza@imt.mx,

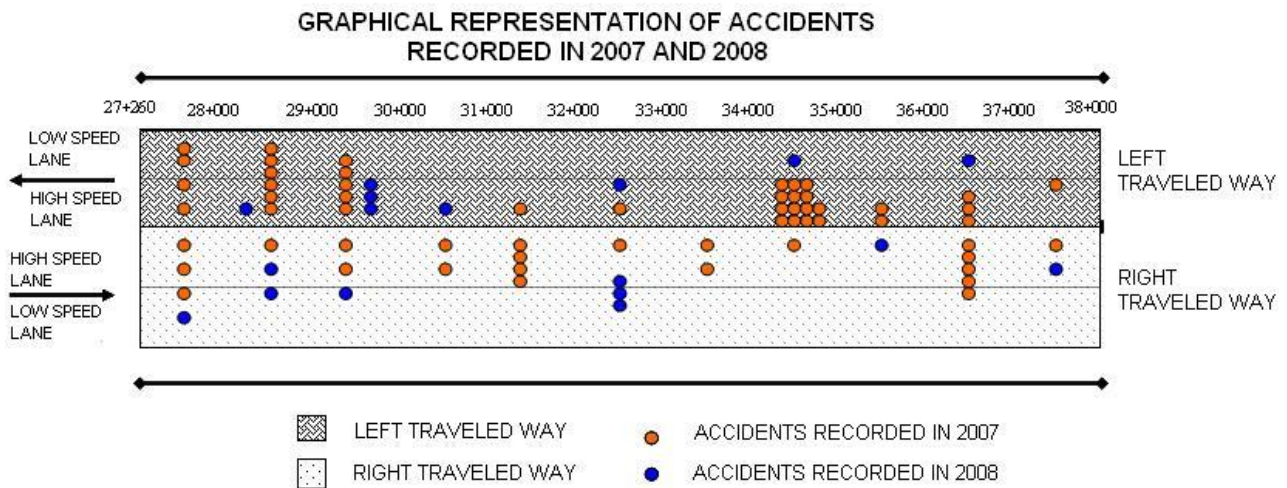
Figure 1 - Graphical Representation of Accidents

As it can be observed in Figure 1, this highway registers an incidence of accidents between the pairs of kilometers 27-28, 28-29, 29-30, 34-35 and 36-37. The site with the largest incidence can be found in the pair 34-35 with 16 accidents, most of them occurring at the left traveled way, in the direction opposite to the stationing, and in the high speed lane for year 2007.

The location of the accident associated to the cause, class and meteorological condition during the event, facilitate the determination of potential sites in which a high incidence of accidents could be expected (“black points”), namely, places already evidencing safety problems and where the auditing staff has to focus its attention during the field visits. With these data a two-dimensional graph can be developed that shows, with no scale, the total length of the highway, stationing, traveled way, traveling directions and lanes, indicating with a point the location of each accident registered. This graph is known as “Graphical Representation of Accidents”. Figure 1 shows a “Graphical Representation of Accidents” corresponding to a highway with the accidents recorded in 2007 and 2008.

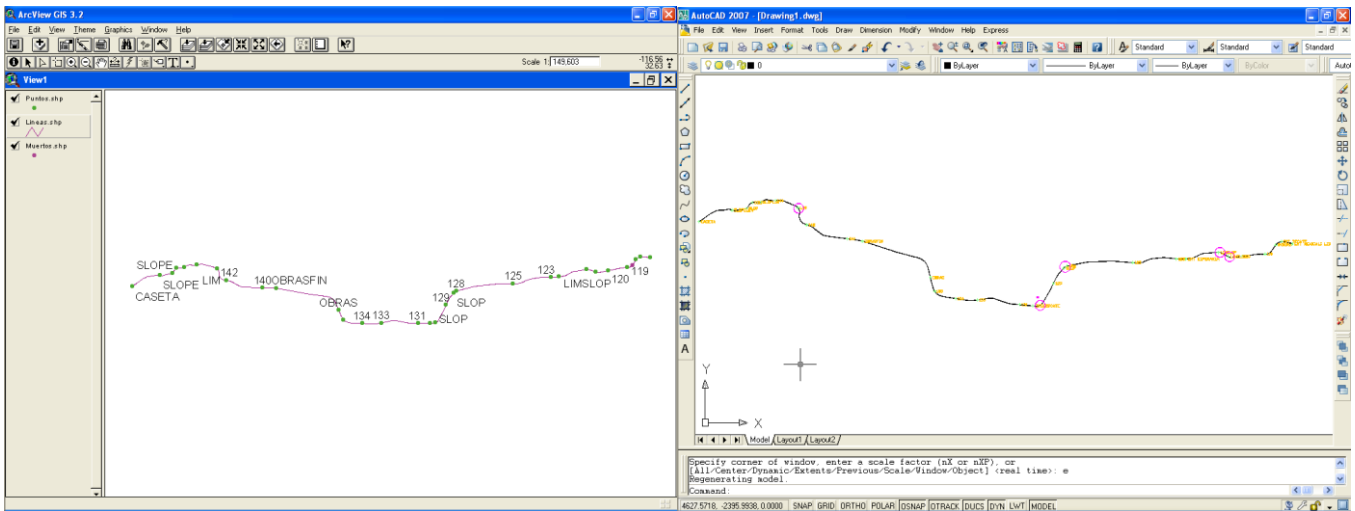
Figure 2 - Information registered with the GPS and subsequently processed in AutoCAD

The information registered with the GPS is processed and visualized in AutoCAD, generating a drawing for each highway. The AutoCAD software facilitates an accurate verification of each highway element such as the total length, distance between curves, degree and radius of curvature, gradients, and so forth. Figure 2 shows how the information obtained with the GPS can be downloaded into the AutoCAD.

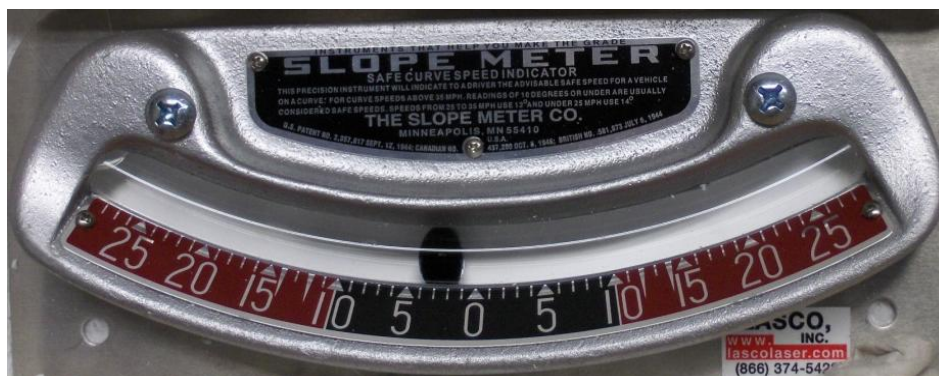
Figure 3 - Safe Curve Speed Indicator

The “Safe Curve Speed Indicator” is an instrument to measure the lateral acceleration (in degrees) of a vehicle running at certain speed while negotiating a horizontal curve. Depending on the radius and on the superelevation of the curve, the “Safe Curve Speed Indicator” is capable of showing whether the speed for negotiating the curve does not represent any risk of overturning or of loss of control of the vehicle. This device is fitted with a small steel ball placed inside a glass tube filled with water mounted on a graduated steel plate that is fastened to the car. Figure 3 depicts a “Safe Curve Speed Indicator”.

The area colored in red (from 10 to 28 degrees) indicates that the speed to negotiate the curve can represent a certain risk of overturning or running off the road, whereas the intermediate zone shown in black (from 0 to 10 degrees) represents a safe speed to negotiate the curve.

A first complete run (round trip) was carried out following the whole length of the highway at the maximum speed limit. During the survey, one person of the auditing team kept on taking readings of the degrees marked by the instrument when negotiating each curve. If the reading registered by the steel ball inside the device fell within the range covered by the red zone, such reading was registered and annotated, whereas another person of the same team located the site with a point in the GPS indicating the reading taken. With this

As it was previously mentioned, during the surveys with the “safe curve speed indicators”, points were located with GPS whenever the indicator of the instrument fell in the red zone (higher than 10 degrees) this meaning that the combination between the radius and the superelevation in those curves even traveling at the maximum speed limit could represent the possibility of the vehicles to experience overturning or run off of the road.

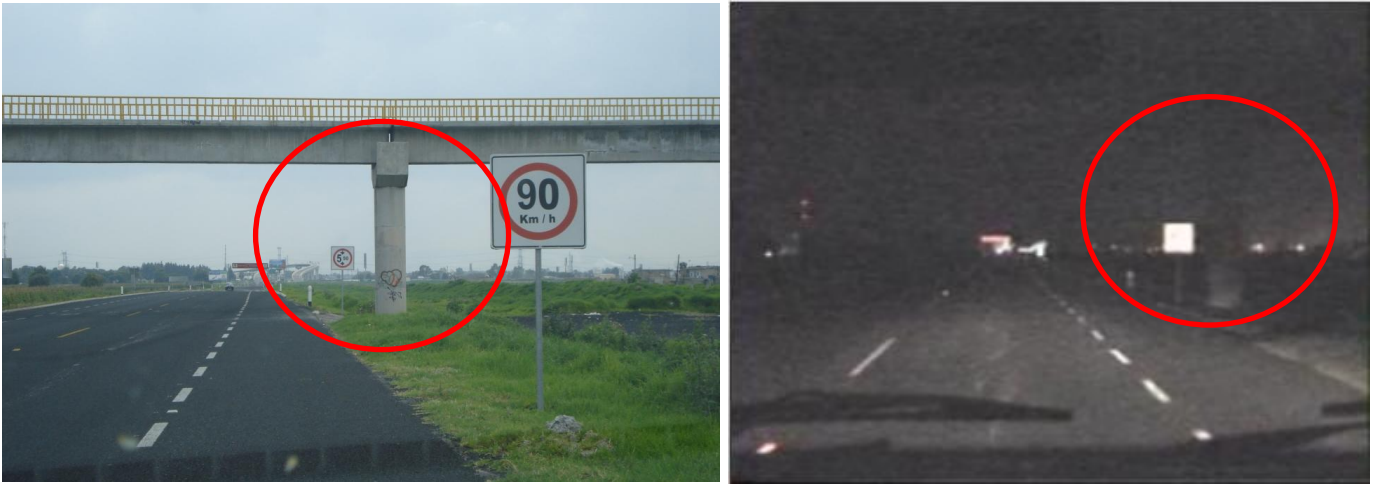
Figure 4 - Visibility comparison of a structure during the day and at nighttime conditions

With the nocturnal video it is possible to detect elements at the lateral zone that can be seen during daylight without difficulty but that in conditions of scarce lighting require a certain type of retroreflecting device to improve their visibility. In Figure 4, the picture at the left shows the pier of a pedestrian bridge at the lateral zone that, during the day can be observed with no problems; at night, however, the picture at the right that corresponds to the same bridge pier evidences poor visibility.
