# HIGHLY DURABLE LIGHT-COLORED EPOXY RESIN ASPHALT COMPOUND FOR PAVING TUNNELS IN COLD SNOWY AREAS

T. SAKAMOTO & J. NOGUCHI  
Watanabesato Co. Ltd., Miho, Ibaraki, Japan  
[sakamoto-toshinobu@watanabesato.co.jp](mailto:sakamoto-toshinobu@watanabesato.co.jp)  
[noguchi-junya@watanabesato.co.jp](mailto:noguchi-junya@watanabesato.co.jp)

For highway tunnels that are exposed to such severe conditions, we have developed a light-colored epoxy resin asphalt compound and have applied it to roads.

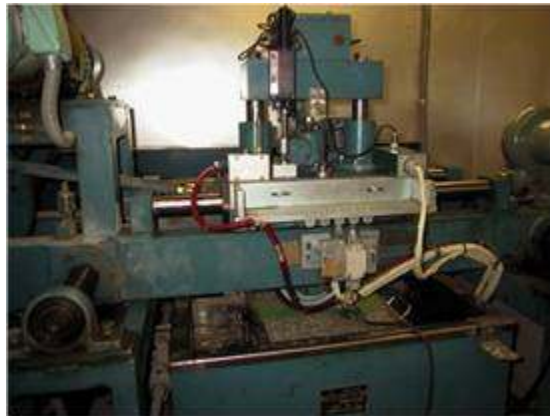
Flow resistance was evaluated by determining the dynamic stability (number of passes/mm) in the Japanese wheel tracking test (Photo 1). Figure 2 shows the dynamic stability values of ordinary straight asphalt concrete, concrete and CERAM. Larger values mean higher flow resistance and reduced rutting. Figure 2 shows that CERAM has much better dynamic stability than ordinary asphalt concrete although it was slightly lower than that of concrete pavement.

Photo 1 - Wheel tracking test

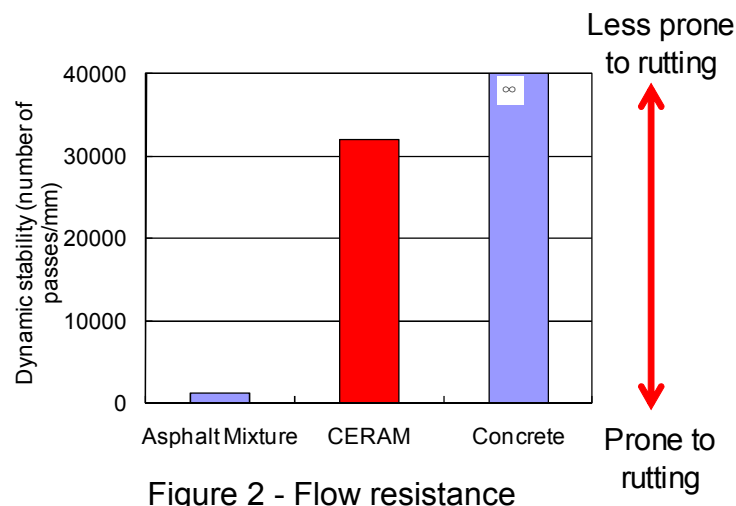
Figure 2 - Flow resistance

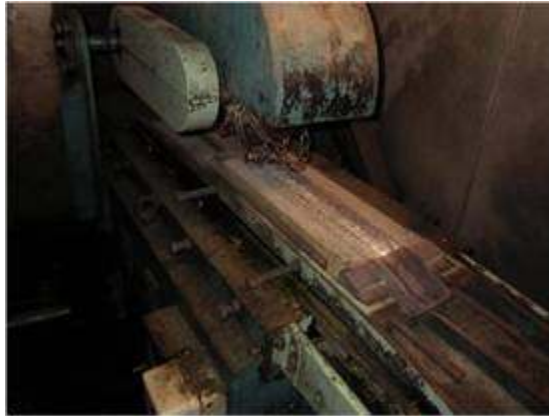
In Japan, abrasion resistance is evaluated by conducting the labeling test (Photo 2). The test is usually performed at a test temperature of  $-10^{\circ}\text{C}$  for a duration of 90 minutes, but we tripled the duration to 270 minutes in order to emphasize the difference. Figure 3 shows the abrasion of straight asphalt concrete, concrete and CERAM. Smaller abrasion values mean better abrasion resistance and less rutting. The figure shows that CERAM is more abrasion resistant than ordinary asphalt concrete and concrete.

Photo 2 - Labeling test

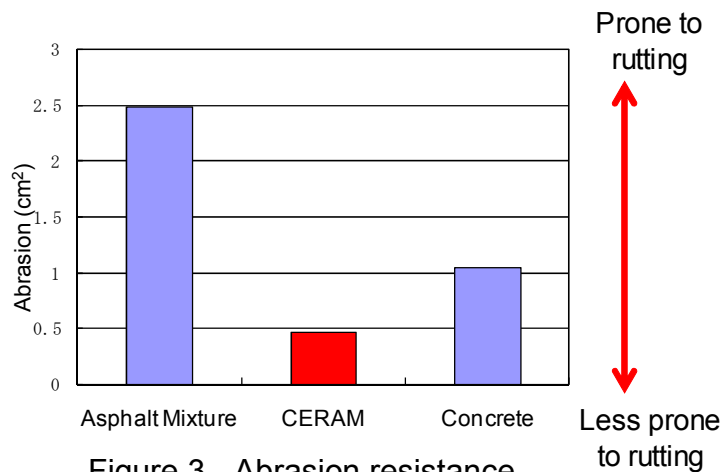
Figure 3 - Abrasion resistance

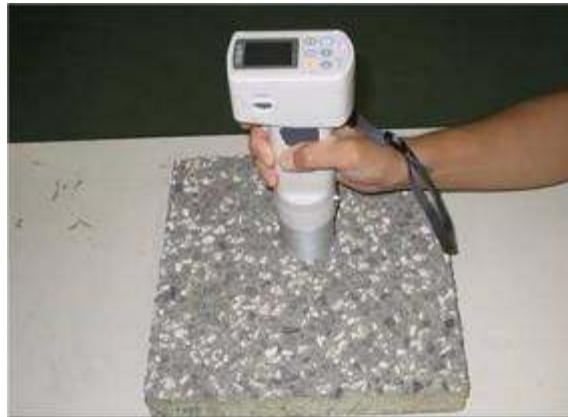
The light color was evaluated by measuring the luminosity with a colorimeter (Photo 3). The luminosity is shown in Fig. 4 for asphalt concrete, concrete and CERAM. Lower values mean darker color, and larger values mean lighter appearance. The figure shows that CERAM is lighter than asphalt concrete and as light as concrete.

Photo 3 - Measuring luminosity

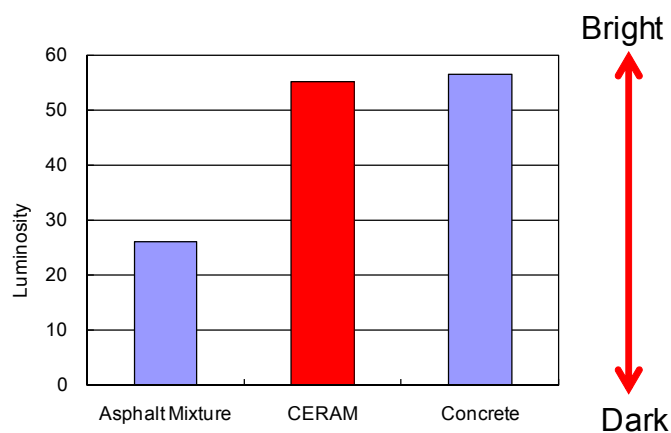
Figure 4 - Luminosity

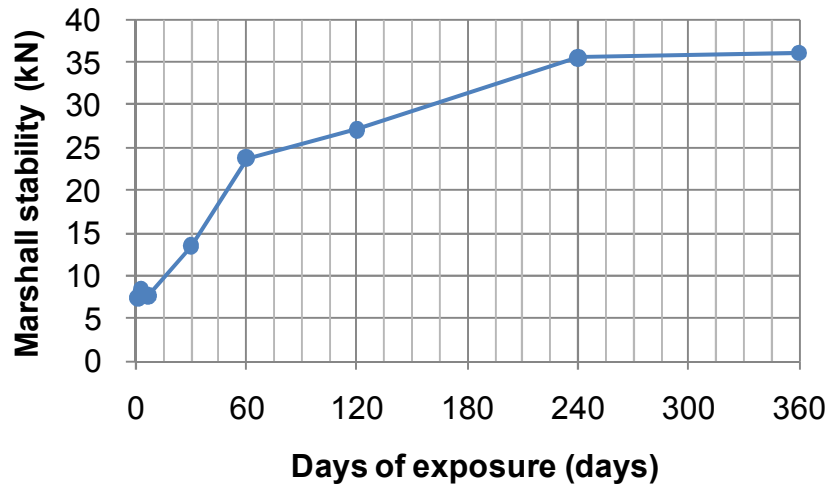
The changes in Marshal Stability are shown in Fig. 5. The stability was almost constant until Day 7, increased gradually thereafter, and reached 30 kN on around Day 180 (equivalent to the stability value for the specimen cured at 60°C for 1 week in the mix design test).

Figure 5 - Changes in Marshal stability

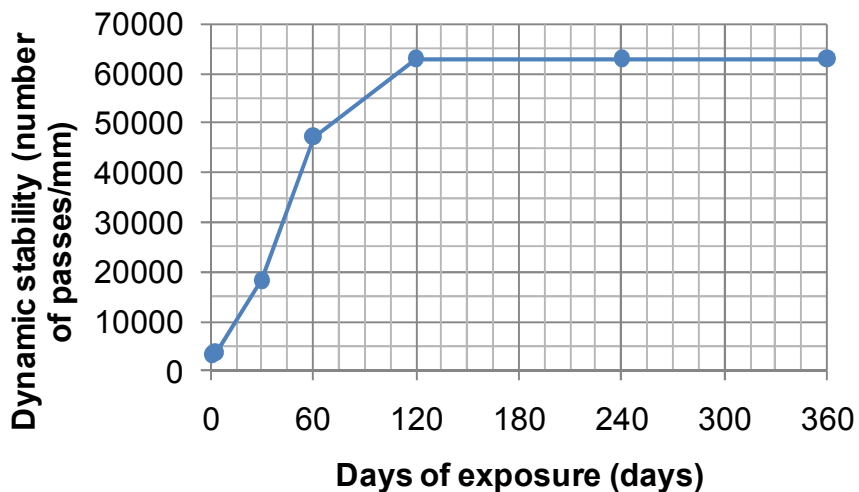
Figure 6 plots the changes in dynamic stability in the wheel tracking test, which shows flow resistance. As shown, the dynamic stability was almost constant until Day 7, gradually increased thereafter, and stabilized at about 60,000 passes/mm on about Day 120 (60,000 passes/mm is the upper limit of the test; measurement is impossible above this).

Figure 6 - Changes in dynamic stability

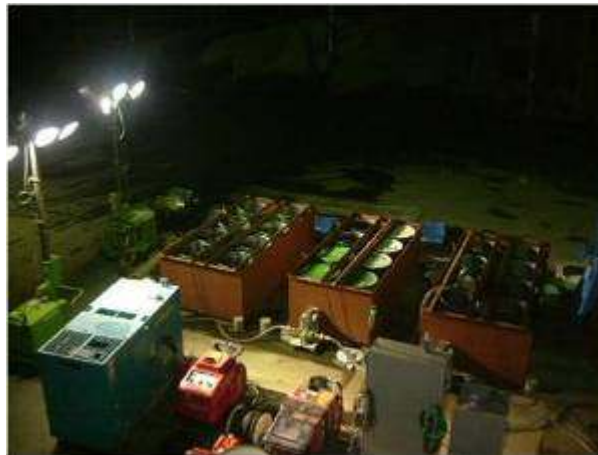
CERAM is produced and applied in almost the same manner as ordinary asphalt concrete pavement. It is produced in an asphalt plant, and is spread and compacted using an asphalt finisher and a roller. Because special materials such as epoxy resin are used, thermostatic tanks and measuring tanks must be installed in the asphalt plant (Photo 4) and an exclusive-use inlet must be installed on the wall of the mixer (Photo 5).

Photo 4 - Thermostat and measuring tanks for epoxy resin

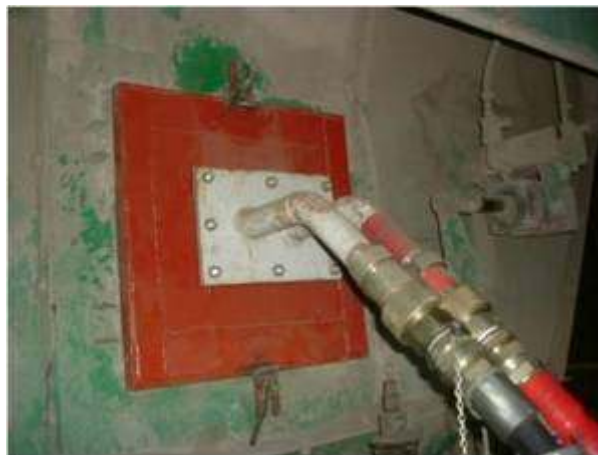
Photo 5 - Inlet of epoxy resin

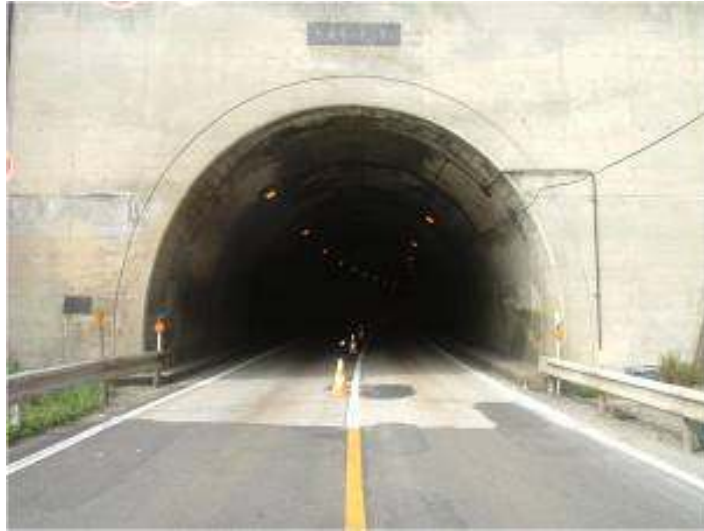
CERAM was used to pave a tunnel on National Highway Route No. 13, which passes under the Kuriko Pass (Photo 6). The pavement in the tunnel is prone to rutting because:

Photo 6 - Tunnel of CERAM construction (before CERAM construction)

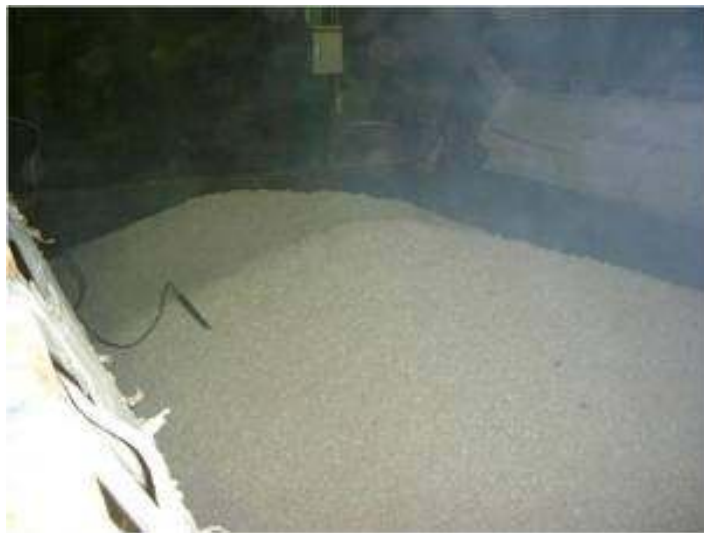
CERAM was produced and constructed at the site. Views of the production and construction are shown in Photos 7 and 8, and views after CERAM construction are shown in Photos 9, respectively.

Photo 7 - Mixing and laying CERAM

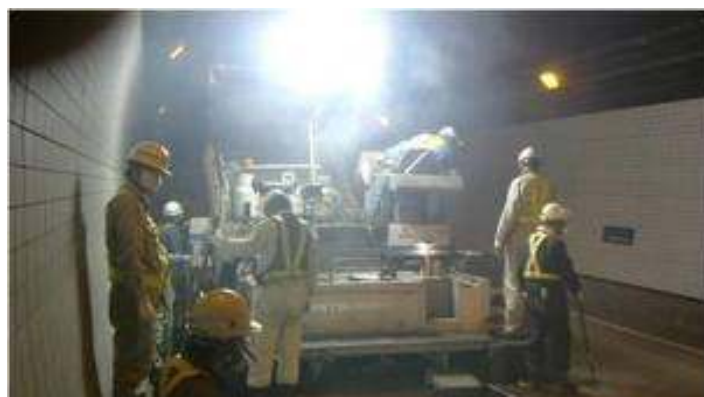
Photo 8 - Spreading

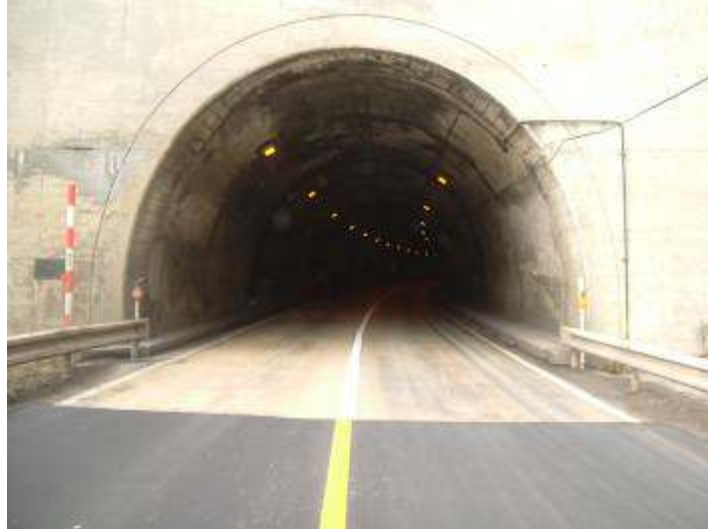
Photo 9 - Completed CERAM pavement

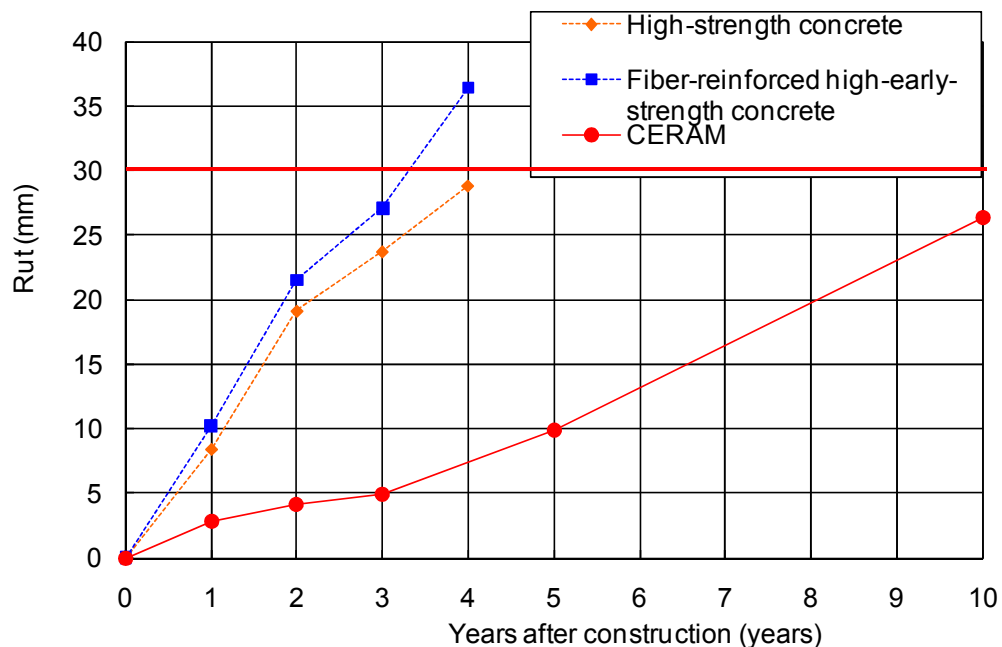
The CERAM pavement was monitored for 10 years, and the changes in rutting are shown in Fig. 9. The rutting on CERAM during the 10 years was only about 30 mm, while high-strength steel-fiber-reinforced high-early-strength concrete suffered rutting exceeding 30 mm in about 4 years.

Figure 9 - Results of follow-up survey
