EVALUATION OF HIGH FRICTION SURFACING FOR REDUCING CRASHES AT HORIZONTAL CURVES

David K. Merritt, P.E.
Project Manager, The Transtec Group, Inc., USA
dmerritt@thetranstecgroup.com

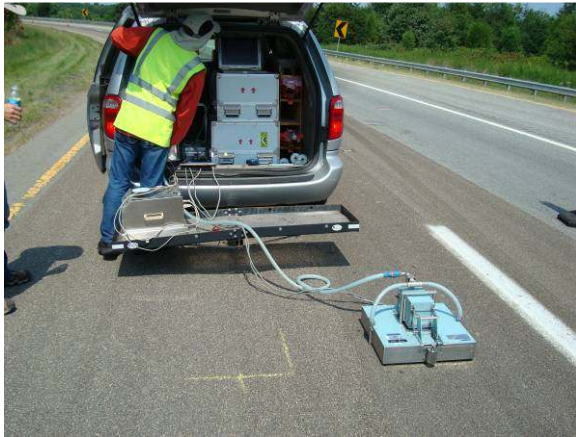
Friction testing (Figure 1) consists of the Dynamic Friction Tester (DFT), GripTester, and if provided by the state highway agency, locked-wheel friction trailer. The DFT is a stationary device which provides a complete speed vs. friction curve from 0 km/hr to 80 km/hr. The GripTester is a fixed-slip device which operates at highway speed and measures friction at a 14.5 percent slip ratio using a small scale smooth test tire. The locked wheel trailer provides friction readings for a fully-locked test wheel (100 percent slip) using ribbed and/or smooth tires. Friction measurements with the DFT are taken at 2-4 locations along each curve (depending on the length of the curve) in both the right wheel path and center-lane. GripTester measurements are conducted in both wheel paths and center-lane over the full length of the HFS section. Locked-wheel trailer measurements

Figure 1: Friction testing devices for SEAHC demonstrations.

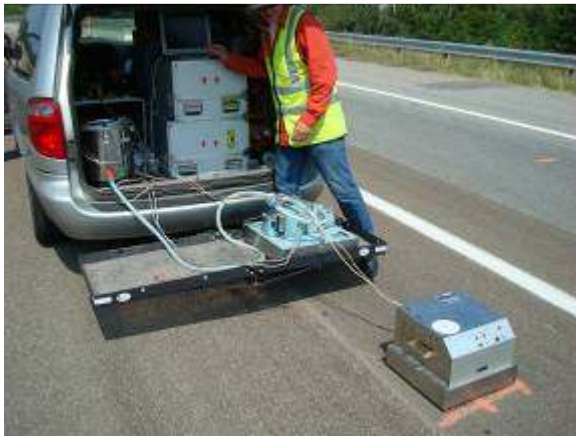
Circular Track Meter

Texture testing (Figure 2) consists of measuring the mean profile depth (MPD) using the circular track meter (CTM) and RoboTex device, and mean texture depth (MTD) using the ASTM E965 "Sand Patch" test [4]. CTM measurements are collected at the same locations as the DFT tests. RoboTex measurements, which provide a continuous, 100 mm wide texture profile of the pavement surface, are collected in the right wheel path and center lane over the full length of the section. The RoboTex texture profile can then be used to compute a more comprehensive MPD.

Figure 2: Texture testing devices for SEAHC demonstrations.

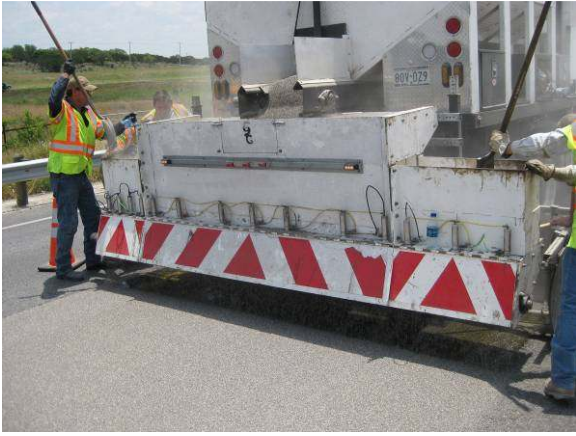
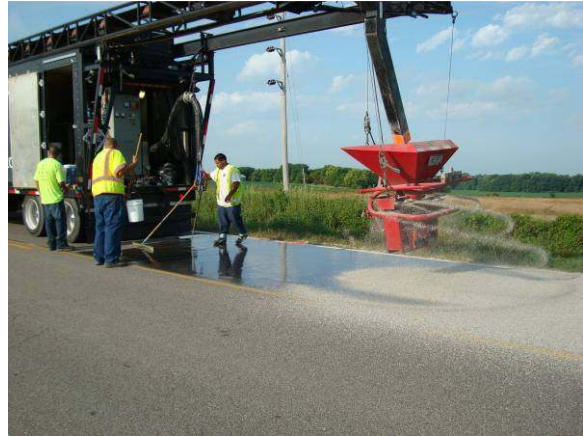
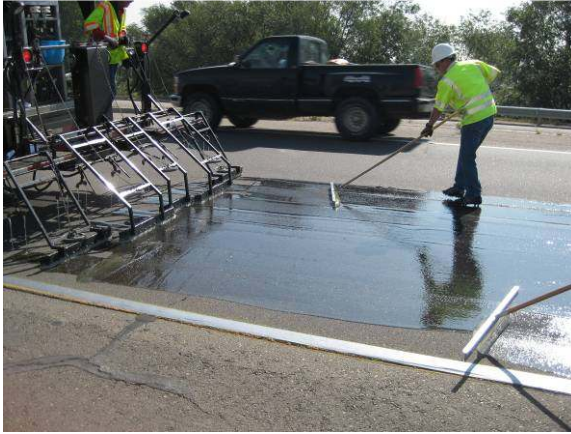
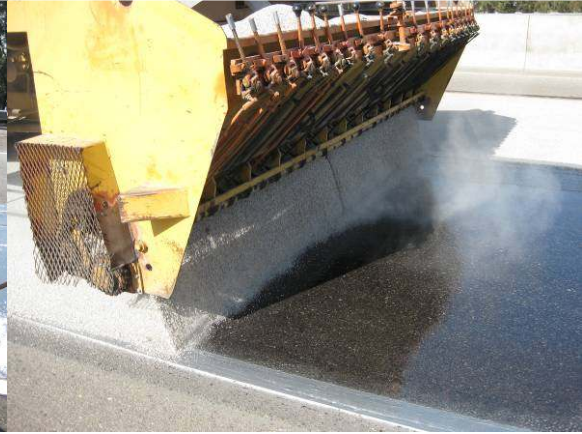
Figure 3: Machine application techniques used for SEAHC demonstrations.

All installations and testing have been completed during short (6-10 hour) closures of the lane or ramp. Six of the installations were completed during nighttime closures in order to minimize the impact of installation on traffic. All installations to date have utilized machine application, as shown in Figure 3. While installation procedures and processes have varied between HFS vendors, virtually no problems have been experienced with installation, and the final product at each site has been very consistent and uniform. Figure 4 shows some typical pavement surfaces before and after HFS application.

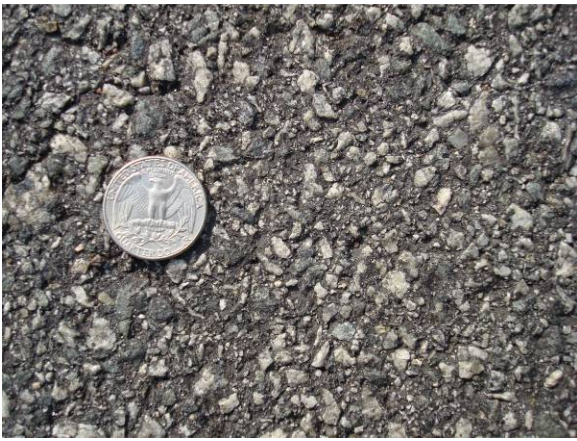
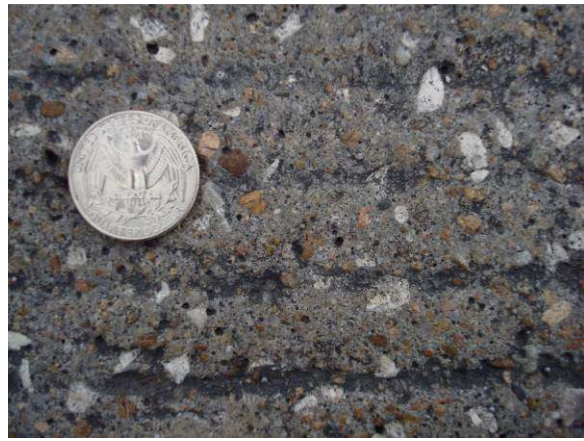
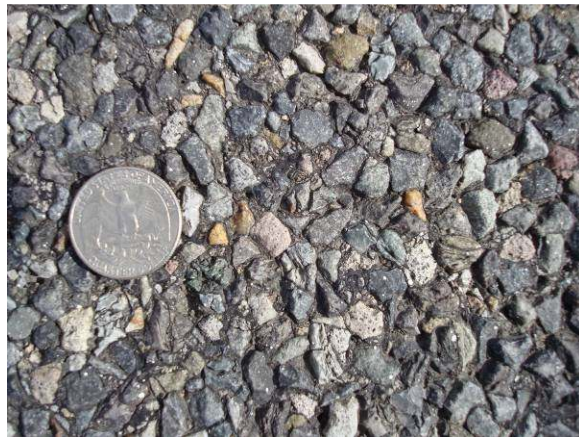
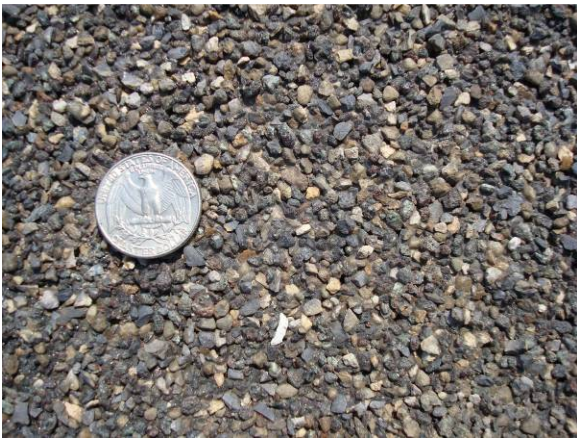
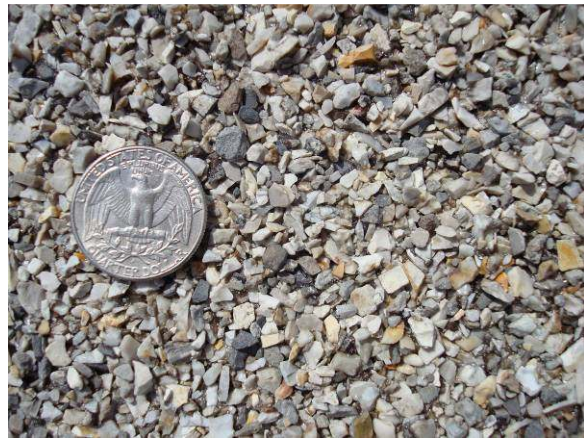
Figure 4: Pavement surfaces before and after prior to HFS application: (a) dense graded hot-mix asphalt pavement; (b) portland cement concrete; (c) bituminous chip seal; (d) calcined bauxite aggregate HFS surface; (e) flint aggregate HFS surface.
