# INTRODUCTION OF NON-DESTRUCTIVE HIGHWAY INSPECTION METHODS USING HIGH DEFINITION VIDEO AND INFRARED TECHNOLOGY

Overseas Business Department, West Nippon Expressway Company Ltd

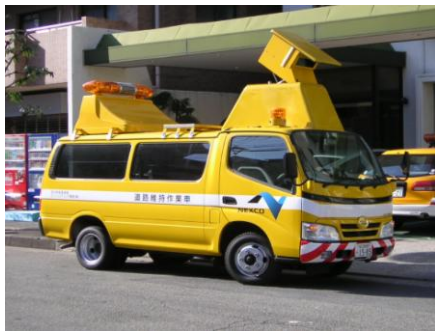
Figure 2 - HDV-Equipped Inspection Vehicle      Figure 3 - Mechanism of Image Processing

Figure 1 schematically shows the mechanism of pavement crack detection using HDV. The technology is the combination of GPS, GIS and HDV image pictures. The GPS navigation system, HDV and laptop computer are included inside the inspection vehicle. The HDV camera is attached on top of the inspection vehicle to record the surface condition (Figure 2).

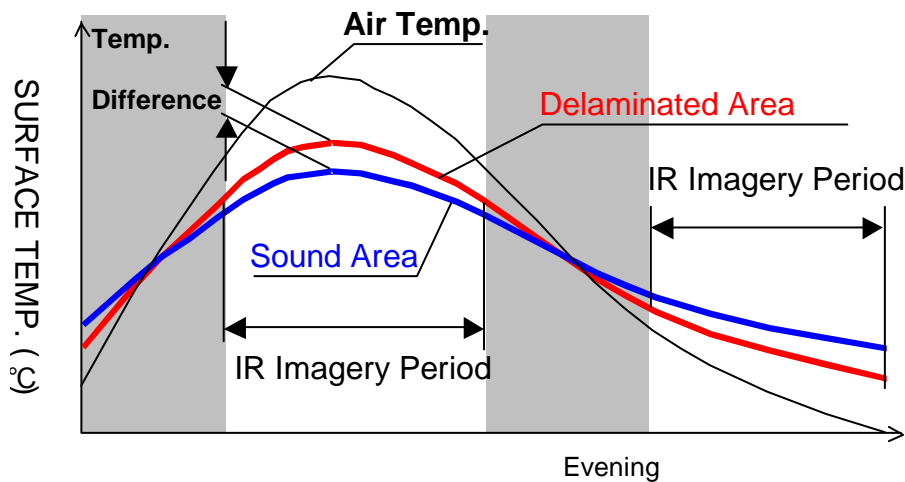
Figure 4 schematically shows the mechanism of infrared thermography method. The red line shows daily temperature variation for delaminated concrete, while the blue line shows the daily temperature variation for concrete in good condition. The delaminated concrete surface shows different temperature variation (see Figure 5). Infrared imagery technology is applicable during the periods when temperature differentials are detectable over time (IR imagery period A and B in Figure 4). It is not always possible to detect delamination of concrete only from the colour variation of infrared imagery since the concrete structure itself tends to have a temperature gradient depending on location and orientation with respect to the sun. Akashi et al. [1] performed the statistical and analytical study on the relationship between characteristics of temperature variation and inherent damage of the concrete, and developed an automatic damage classification system (J-System®) that can classify the damage rate into three categories; the classification categories being “Critical” (crack exists on concrete surface and immediate attention is required), “Caution” (crack exists within 2cm from the concrete surface and close monitoring is recommended) and “Observation” (currently satisfactory) (see Figure 6). In Japan, spalling of concrete debris from expressway bridges has become a serious issue. In order to prevent hazards to the third parties, comprehensive sounding tests have been performed on all potentially hazardous concrete surfaces exposed to motorist and pedestrian traffic. Using IR thermography technology, engineers can check the delamination and/or spalling of concrete about three times faster than they can by conducting conventional sounding tests because IR technology applications require significantly less staging to secure adequate site access and correspondingly less traffic control to collect the required field data. Concurrently IR versus traditional sounding tests offer a 40% cost savings.

Figure 4 - Temperature Variation During the Day

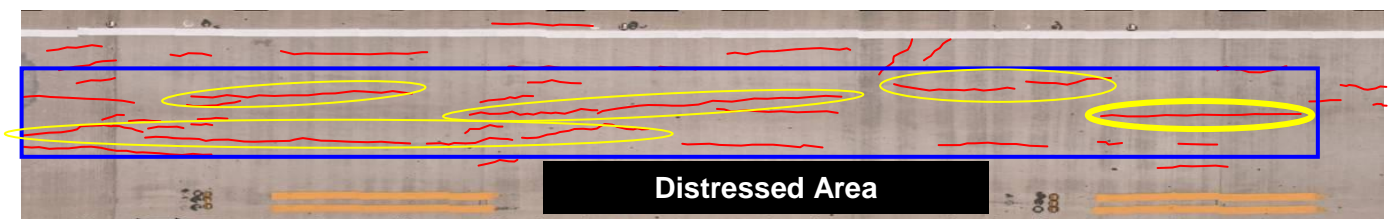
Figure 8 shows an example of a crack map for a concrete deck surface. Cracks of 3mm or greater were detected by a software supported automatic crack detection program, followed by supplemental manual crack checking by an experienced engineer. Manual crack checking successfully detected cracks of 0.8mm or greater. According to the Bridge Inspectors Field Guide [2], cracks should be classified into three categories as shown in Table 2, and the NBI (National Bridge Inventory) specified “Distressed Area” is calculated for the rectangular area including “Significant,” “Moderate,” or “Severe” cracks. Inspectors are responsible for proposing priorities on rehabilitation to the bridge owners by comparing the “Distressed Area” for each span or bridge. The results of pilot area bridge deck surface inspections proved the accuracy of crack detection using HDV technology to be satisfactory for routine in-service deck inspections. The new inspection technology provides additional benefits by increasing the level of safety for both inspectors and motorists and storing position recorded historical inspection data for monitoring of crack propagation. The digital crack map database can be a powerful tool for supporting those engineers responsible for maintenance plan preparation and work task priority decision-making.

Figure 8 - An Example of Crack Map for Concrete Deck Top
