FULL-SCALE TEST TRACK FOR THE EVALUATION OF RC CONSTRUCTION MATERIALS WITH A HIGH PERCENTAGE OF BRICKS FOR USE IN UNBOUND LAYERS

D. Jansen
Federal Highway Research Institute BAST, Germany
JANSEN@BAST.DE

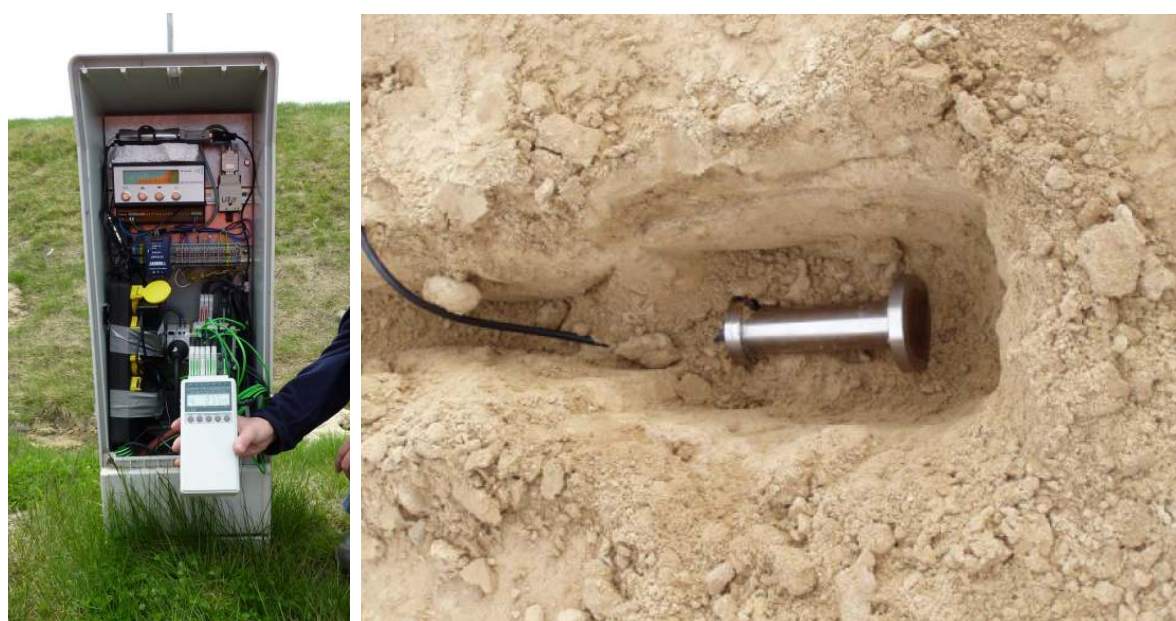
Figure 6 – Weatherproof cabinets for data logging (left) and moisture sensor (microwave head / right)

Temperature sensors (thermocouples) have been installed at 24 positions of the test track. At each section two positions have been chosen to install five thermocouples at different depths, see table 3. At 12 positions, one per section, two moisture sensors (microwave sensor) have been installed into the frost blanket course and into the subgrade, see table 3. The data logging interval is one hour and takes place in weatherproof cabinets, which are installed beside the pavement, see figure 6. The thermocouples run on battery power, the moisture sensors are supplied by the traffic light power supply at the end of the test track.

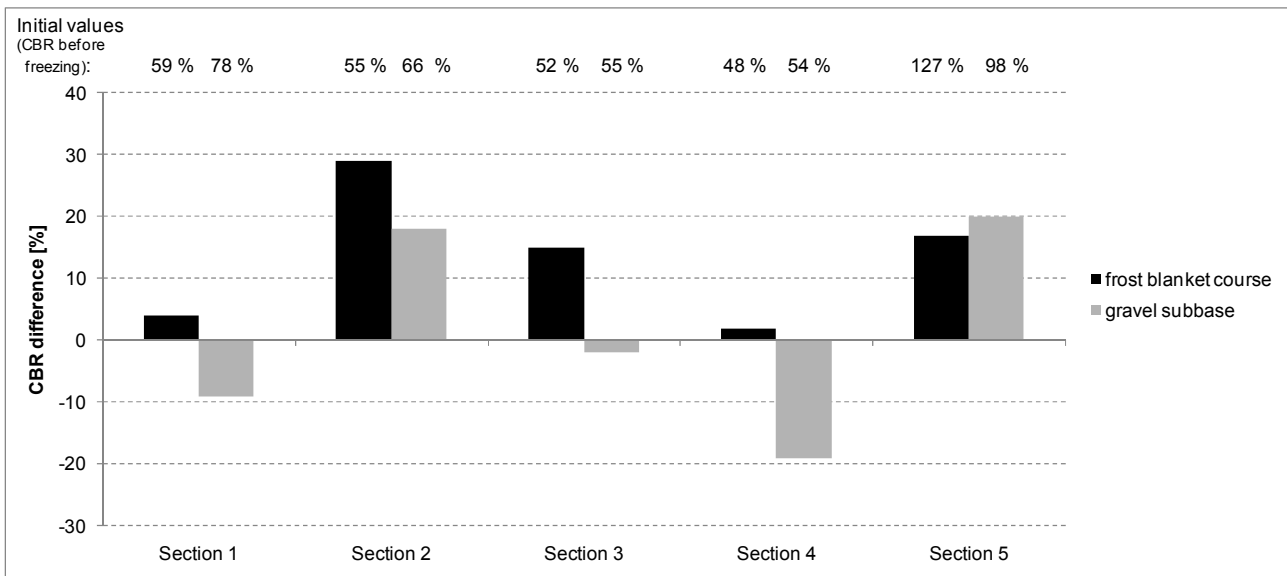
Figure 16 – CBR difference before and after frost-heaving test

The California-Bearing-Ratio (CBR) before and after freezing has been measured on all RC-materials (Section 1 to 5). Figure 16 shows the changing of the CBR and the initial values (before freezing). Systematic trends cannot be identified and there is no correlation between the brick content and the change in CBR value.

Therefore the assumption that higher brick content has relevant influence on the frost-heaving sensitivity of unbound layer pavement materials cannot be confirmed.
