**XXIVth World
Road Congress
Mexico 2011**
Mexico City 2011.

Asset Management of Japanese Expressways after the Earthquake

Nippon Expressway Research Institute

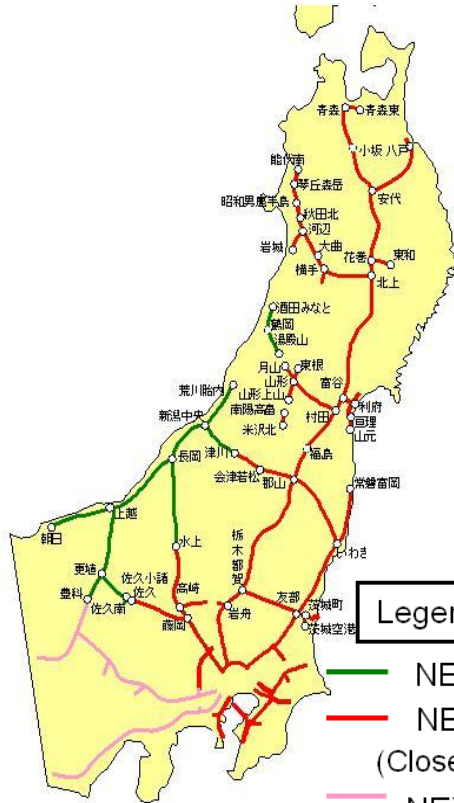
Road closures caused by the Earthquake

- NEXCO East (in service)
- NEXCO East (Closed immediately after earthquake)
- NEXCO Central (in service)

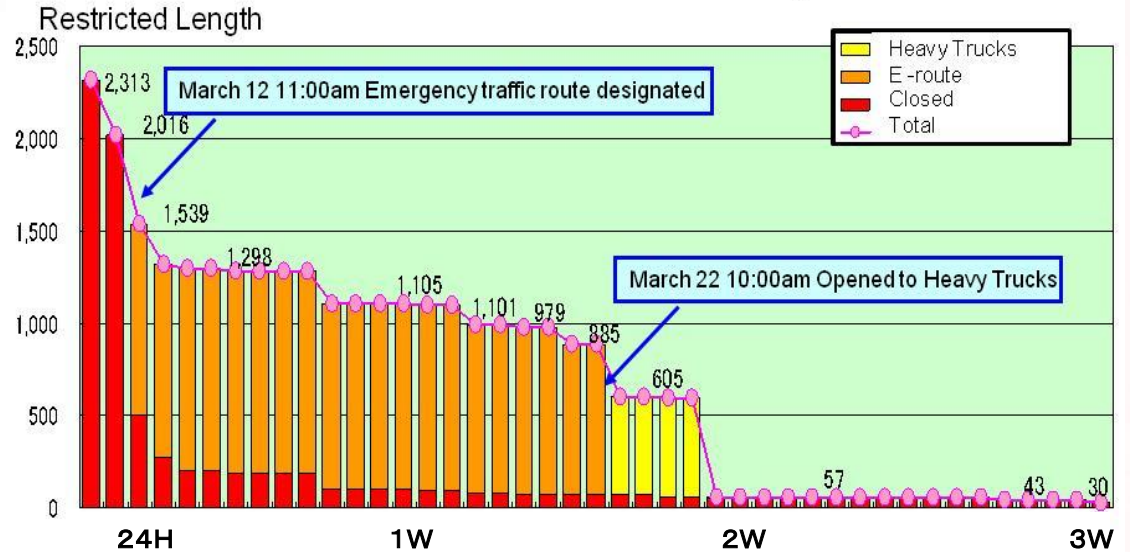
Transition of Restricted Length

- NEXCO East Expressway closed : 2,300km (Max) (Tohoku Branch Office 96%, Kanto Branch Office 89%)
→ Restrictions had been lifted on approx. 770km by 24 hours later
- Emergency traffic route : 1,090km (Max)

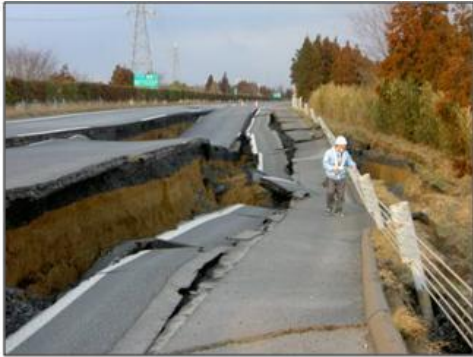
Collapse 3/11 16:00

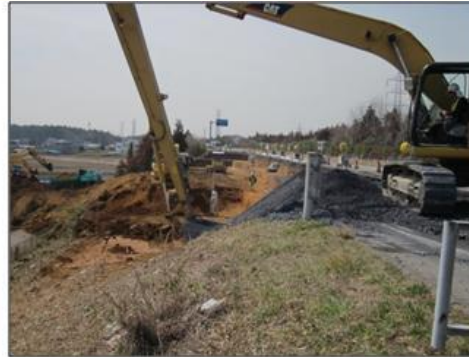
3/14 11:00 Removing collapsed embankment

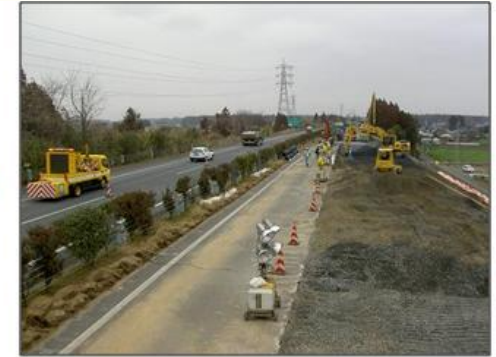
3/15 13:00 Constructing subgrade

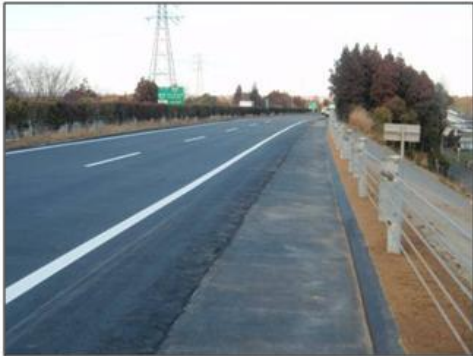
Completion 3/17 19:00

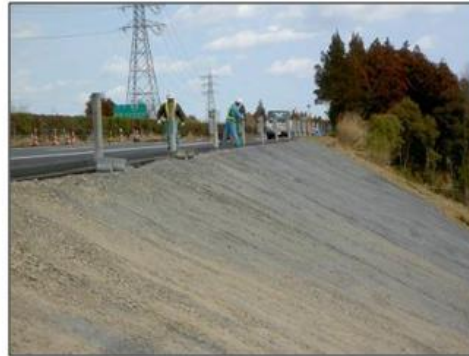
3/17 15:00 Setting guard-cable

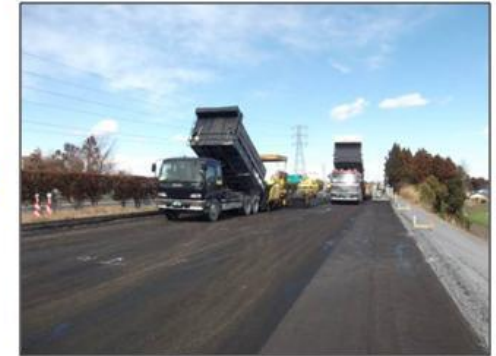
3/16 17:00 Paving

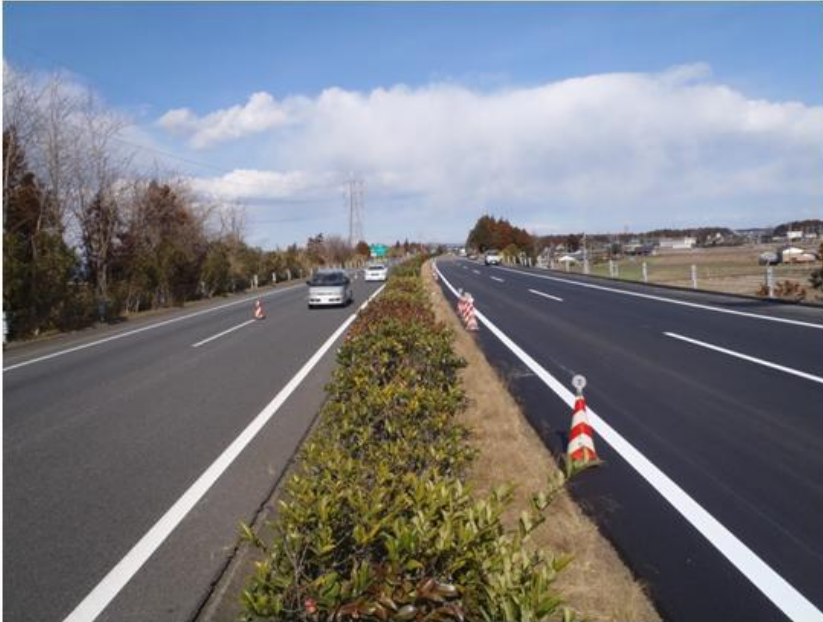
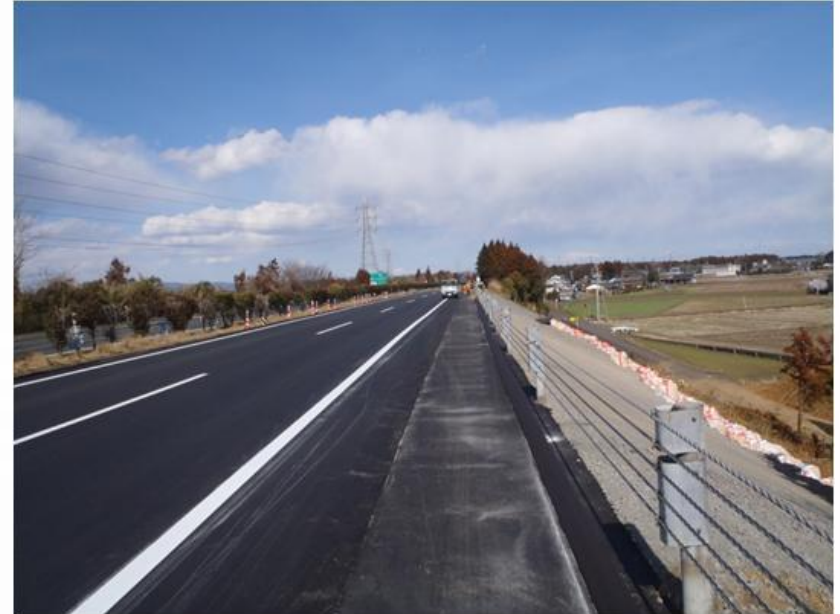
Completion of Repair Works(6 Days)

(Provisional restoration of pavement)

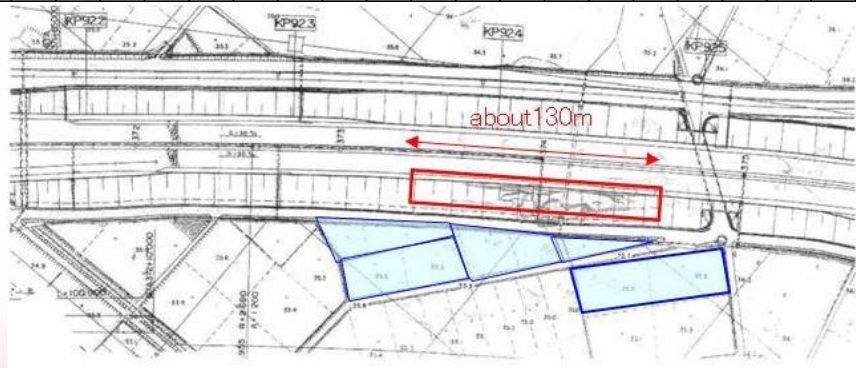
Time table for repair works

Amount	3/11		3/12		3/13		3/14		3/15		3/16		3/17		
		0	6	12	18	1	2	3	4	5	6					
Inspection				●	●											
Research & Design				●	●											
Removal of Pavement					●	●										
Tennancy of estate						●	●									
Removal of Soil	4,700m3					●	●	●	●	●						
Embankment	4,500m3					●	●	●	●	●	●	●				
Pavement	1190t										●	●				
Safety facilities													●	●

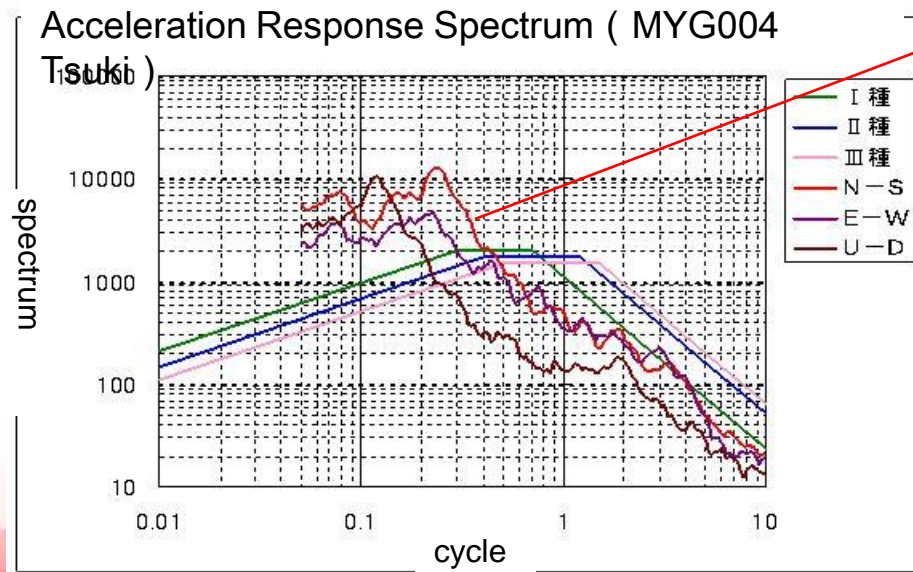
Structures with short natural period are got strong response

Natural period of Sendaitobu Viaduct (one after next picture) is about 1.3 sec
