XXIV<sup>th</sup> WORLD ROAD CONGRESS Mexico City 2011

# Large road bridges rehabilitation Example of the Aquitaine bridge

#### **Suspension bridge**

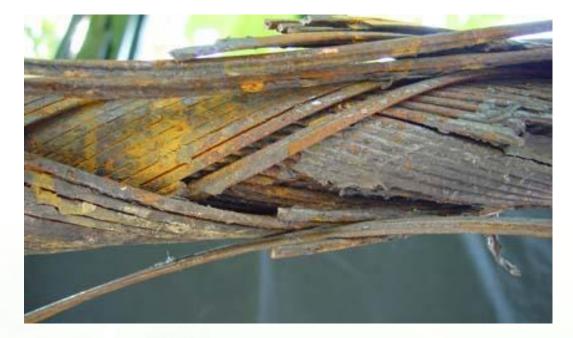
#### **Assessment : opening of 5 suspension clips**

A severly damaged strand under clip n°8 after removal

Brittle breaking due to friction between wires and stress corrosion

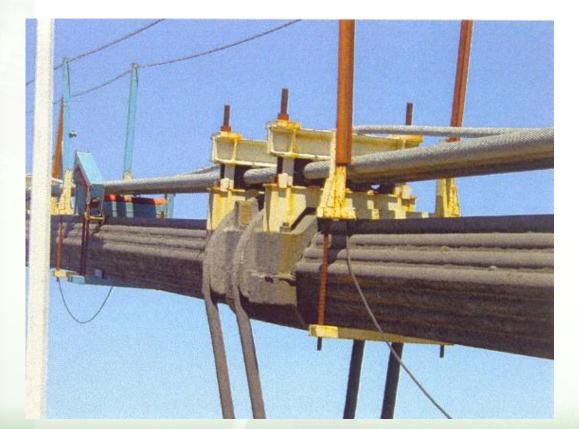
Installation of auxillary suspension (4 x 19T15 stands

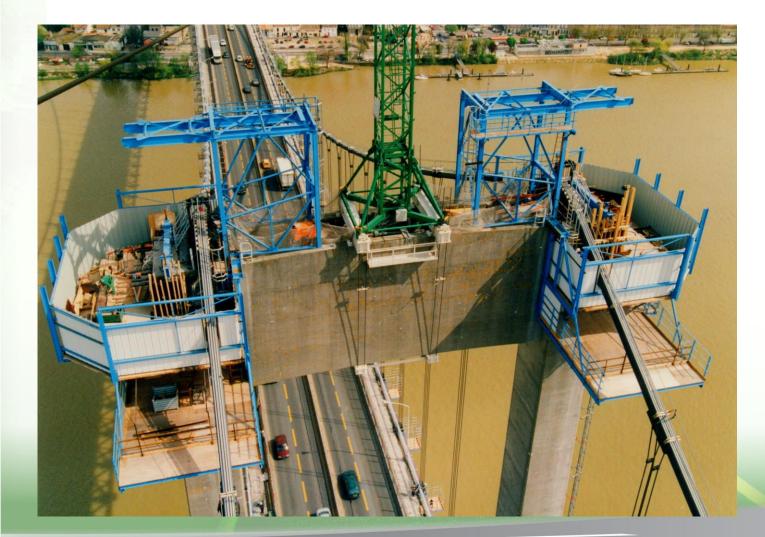
Widening of the tower heads

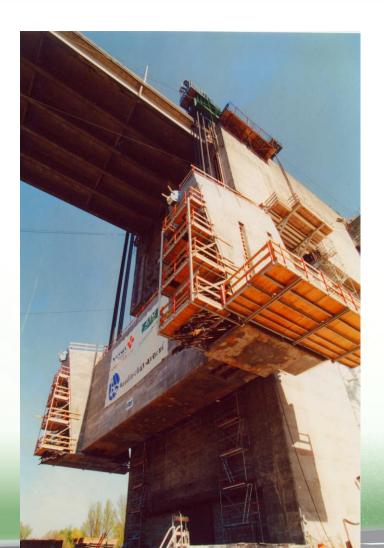
## Lifting of the anchorage beam (left bank)

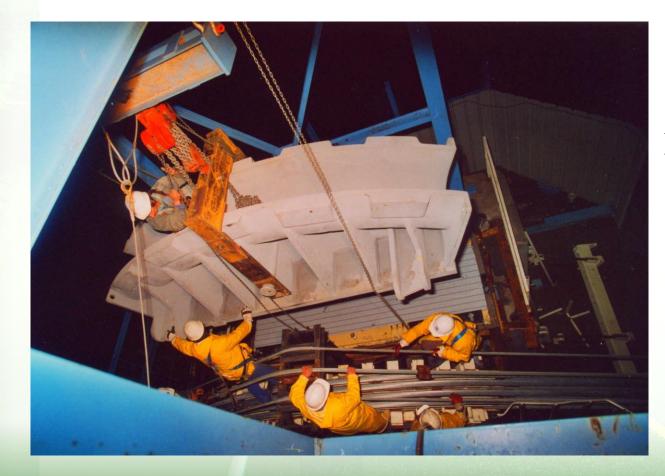
## Lifting of a saddle on a tower head

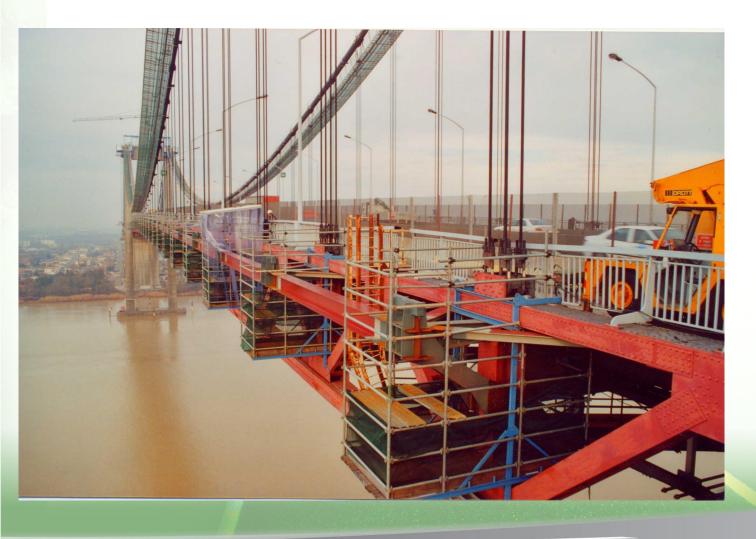
Widening of the deck

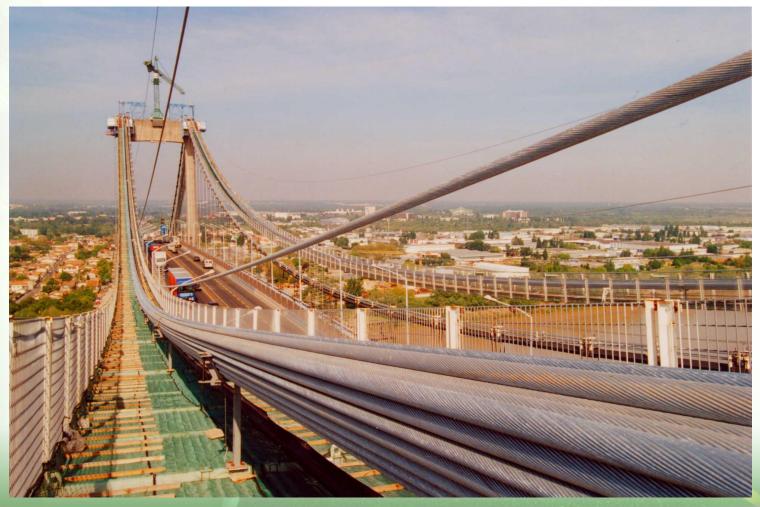
Launching of the new strands

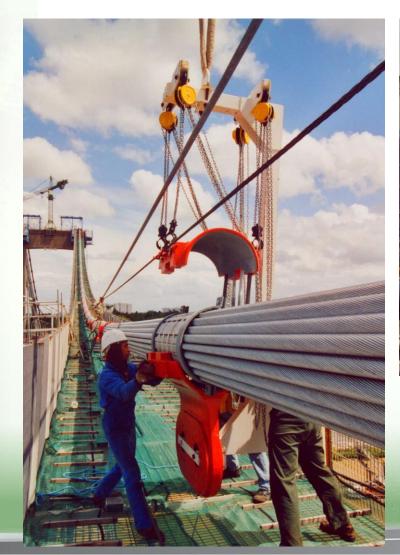
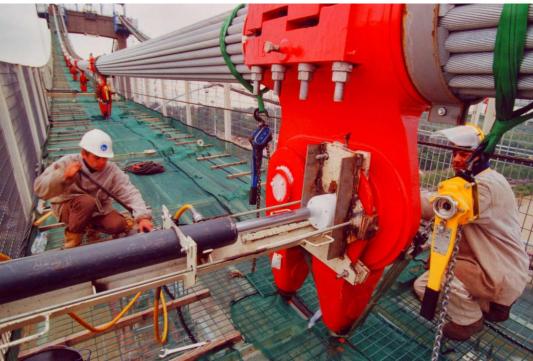
Lay of the clips and the suspenders

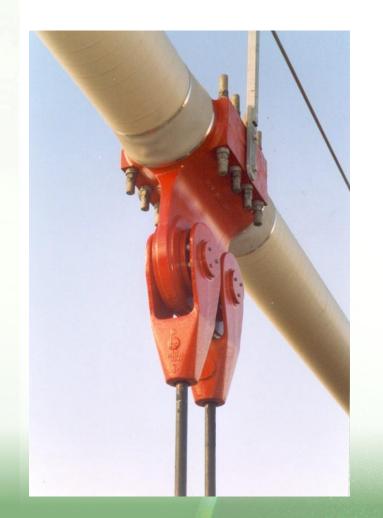
#### The new suspension cable

- 61 strands
- 4 protective barriers: Galvanized wires
   Galvanized wrapping wire
   Air tigth duct
   Dehumidification

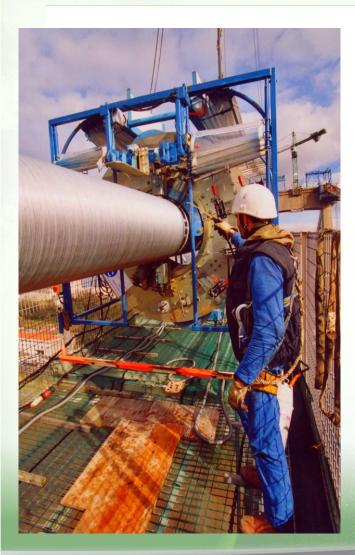
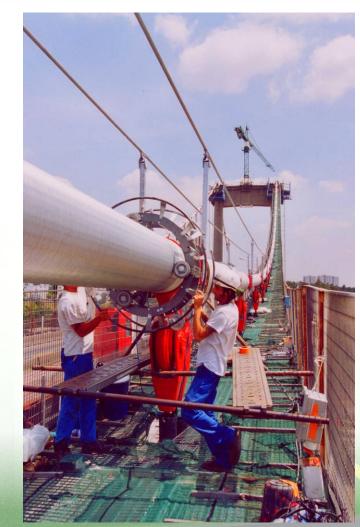
Final protection of the cables

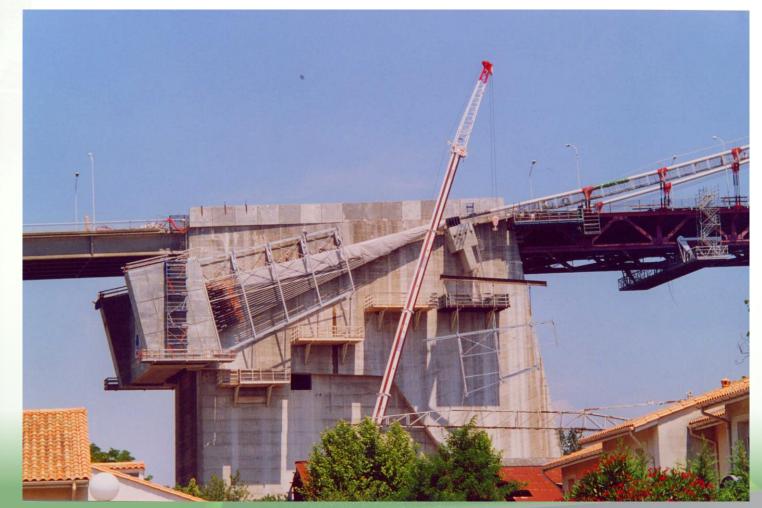
Air tight covering of the anchoring chambers
