XXIVth WORLD
ROAD CONGRESS
Mexico City 2011

SLIPPERY ASPHALT RUNWAYS AFTER REJUVENATION

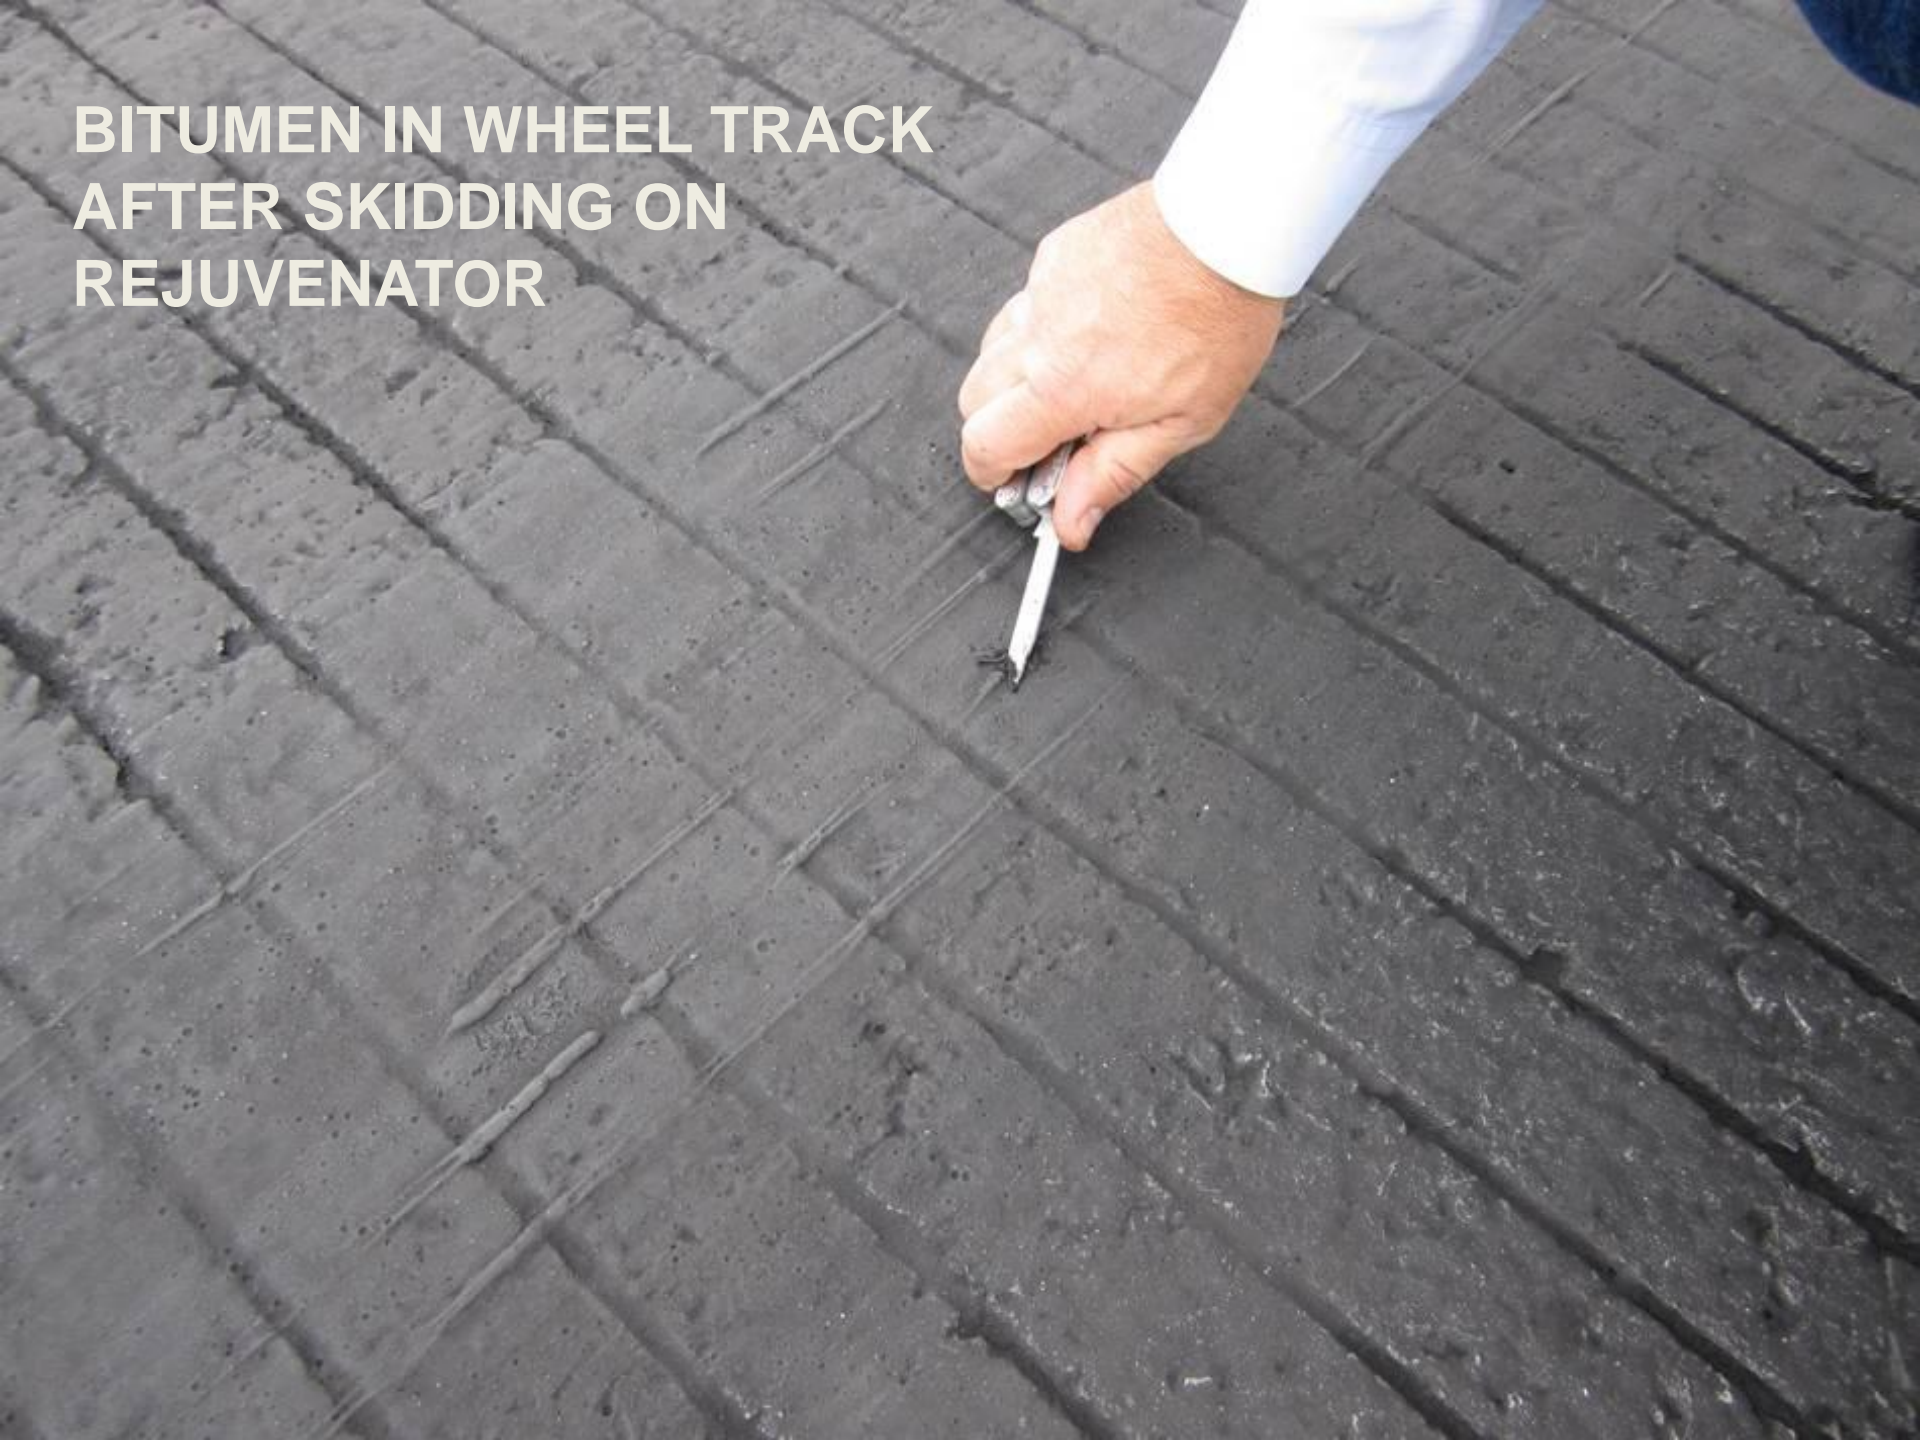
**BITUMEN IN WHEEL TRACK
AFTER SKIDDING ON
REJUVENATOR**

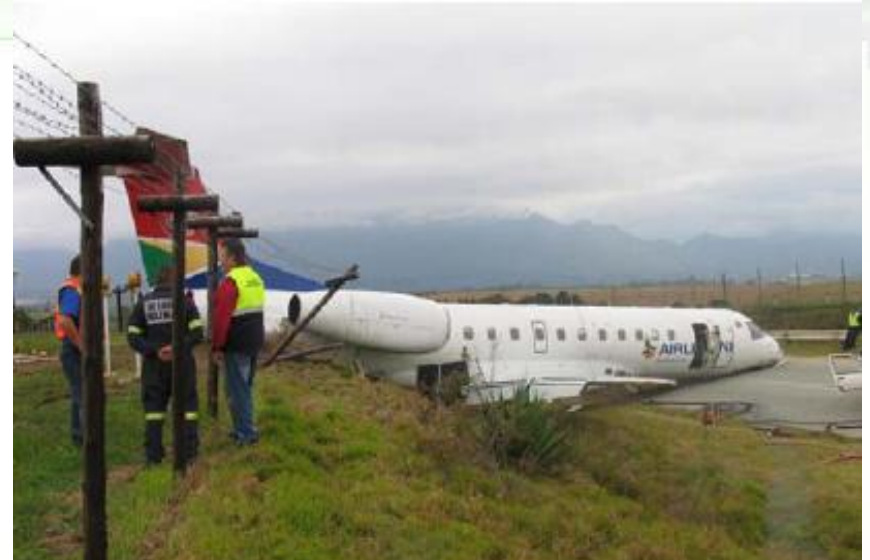
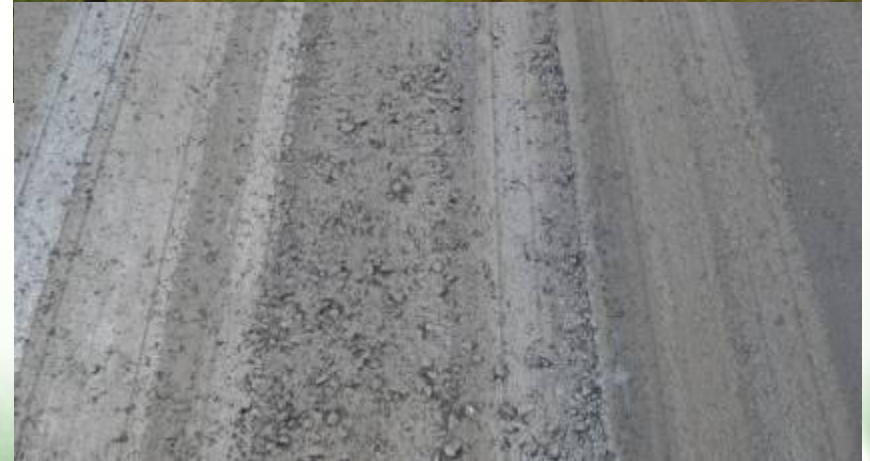
SOUTH AFRICAN ACCIDENT

- Dec 2009 at George.
- Old runway asphalt was rejuvenated,
 - runway had poor shape, runway not grooved.
- During the first rains, Embraer 135 overran runway.
- Rejuvenation had destroyed microtexture, filled the macrotexture.

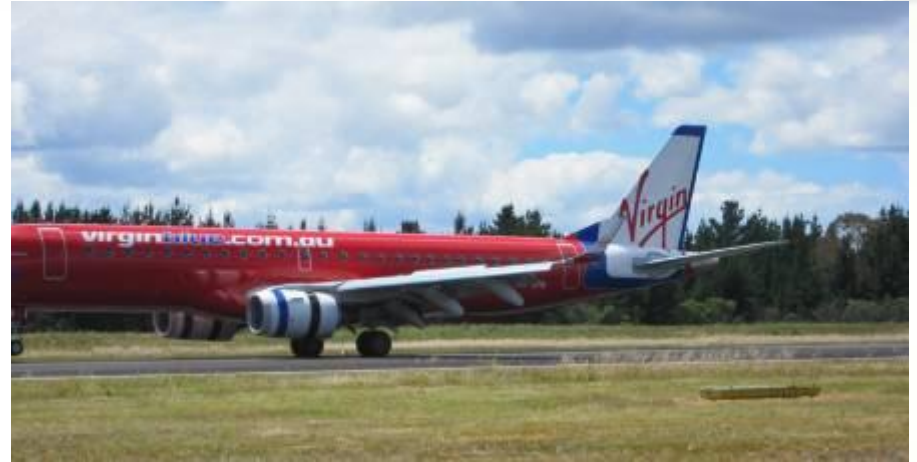
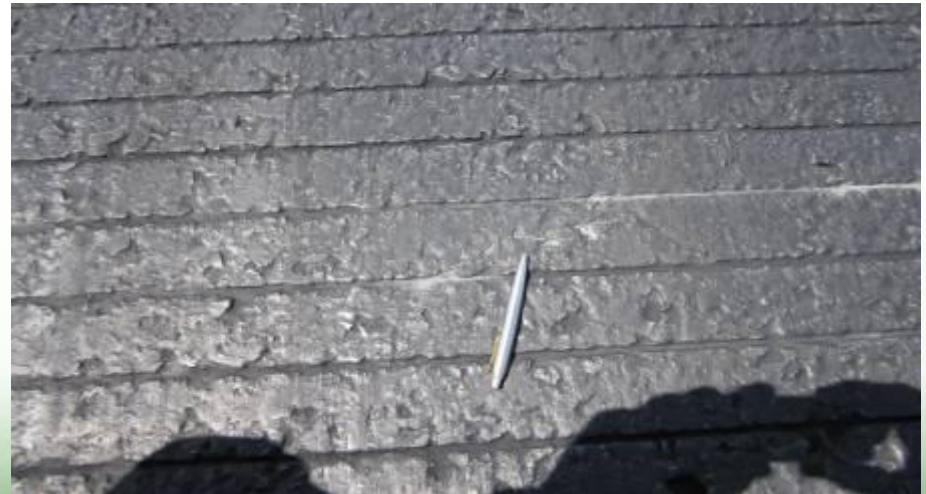
AUSTRALIAN INCIDENT

- Nov 2010 at Hobart.
- Old runway asphalt rejuvenated,
 - rubber build-up,
patches ungrooved.
- Reports of slippery conditions, then Boeing 737-800 overran,
- Rejuvenation destroyed microtexture, filled macrotexture, part-filled grooves.

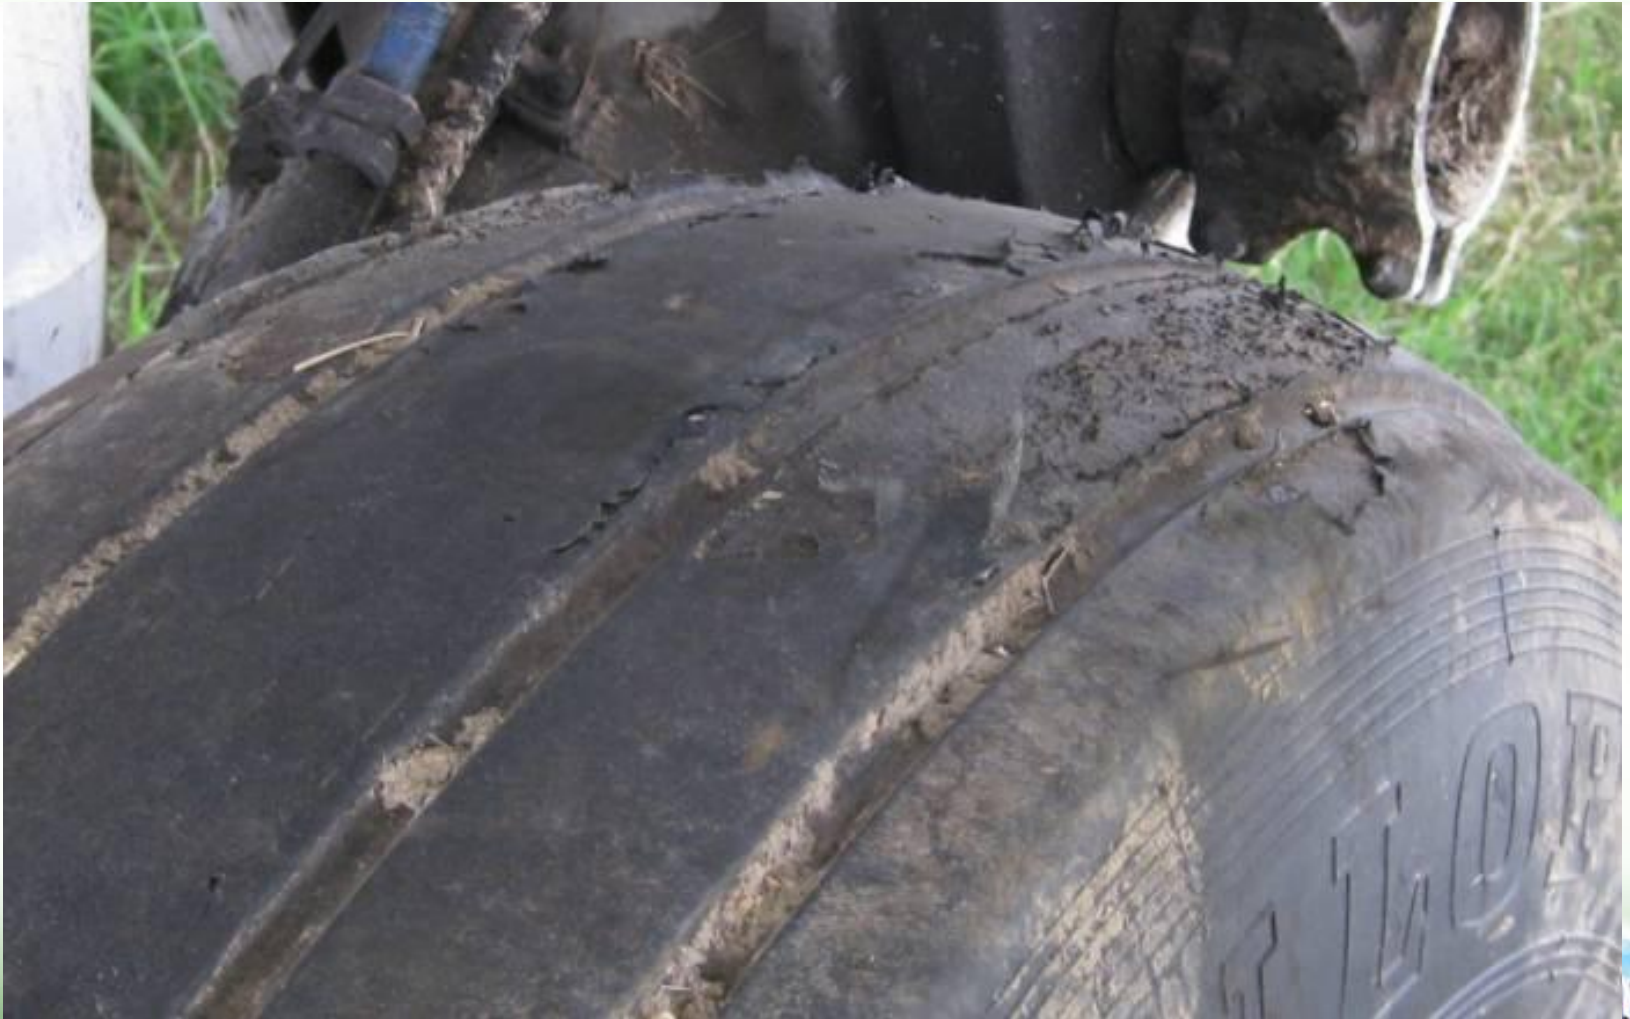
TYRE DAMAGE DUE TO REVERTED RUBBER SKIDDING AT GEORGE

- Occurred on smooth, wet or puddled runways:
 - loss of braking down to 5-8 knots,
 - tyres had patch of sticky, soft rubber on tread (*reverted rubber*).
- Melted tyre rubber forms seal around edge of contact patch:
 - seals in high pressure super-heated steam under contact patch,
 - steam pressure lifts tyre away from the surface.
- Clean white streaks seen on asphalt surface:
 - contaminant cleaned off by high pressure super-heated steam.

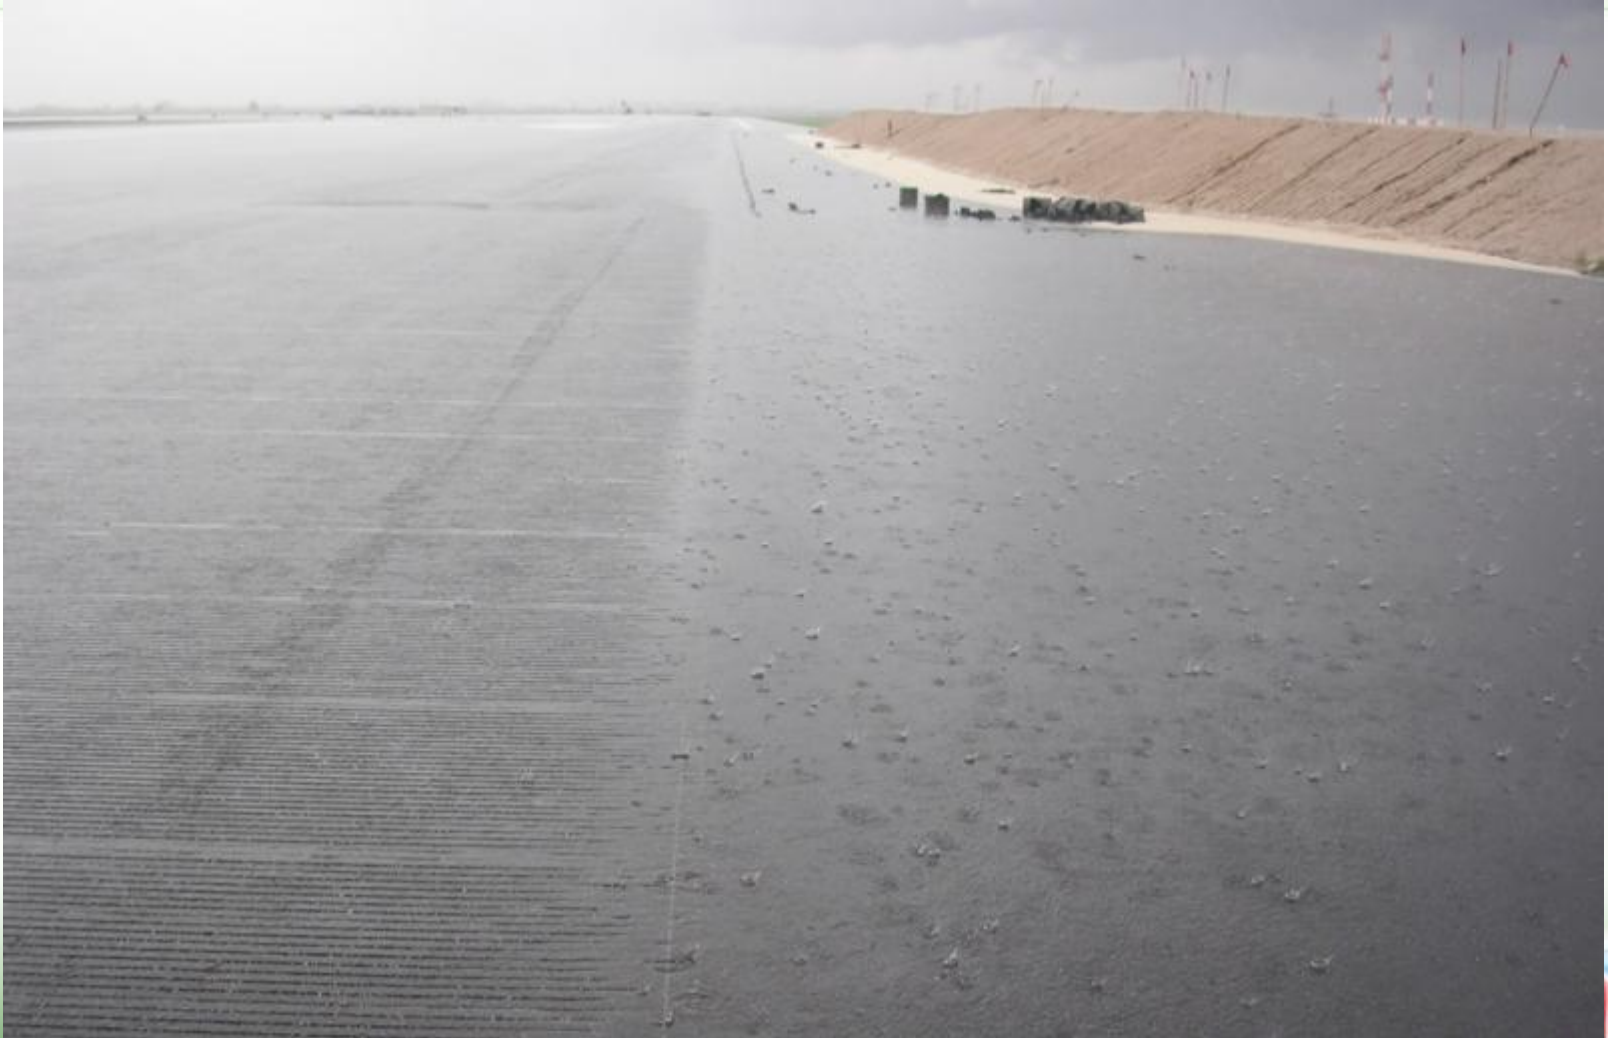
GROOVING FOR ADDED MACROTEXTURE - in a tropical storm at Bangkok

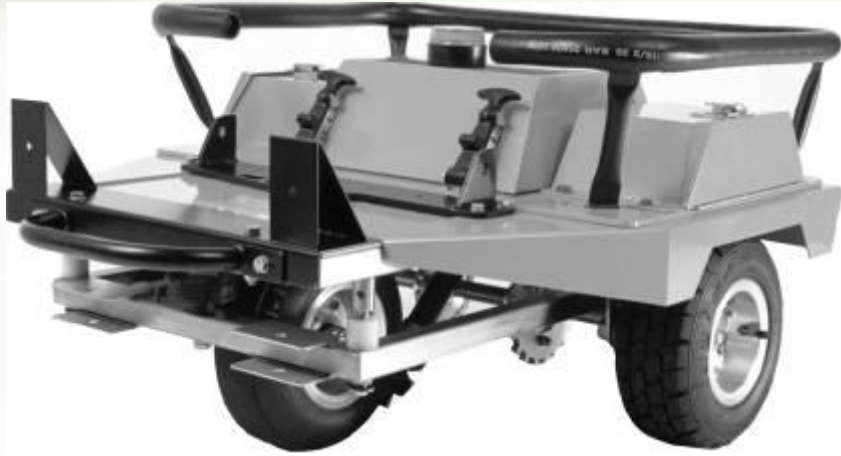
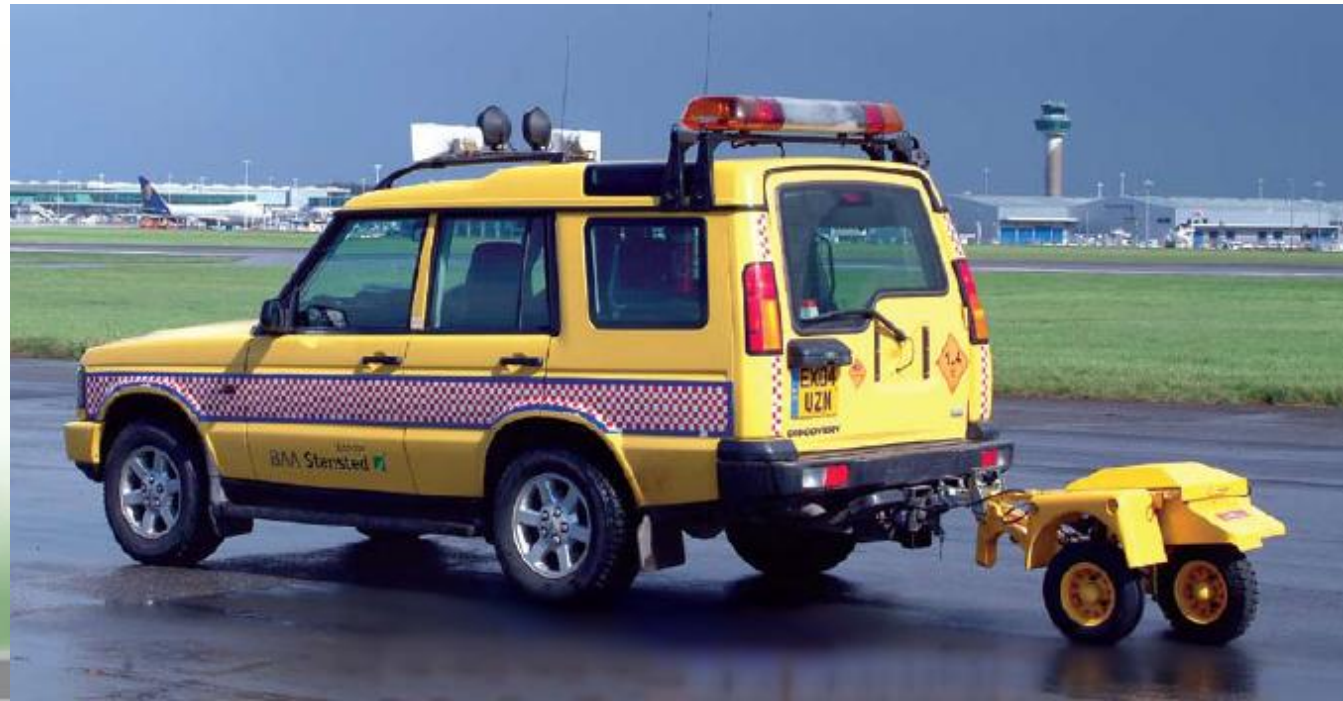
CMFE FRICTION TESTING EQUIPMENT

- Difficulty in detecting rejuvenation / slippery runway.
- Experience is that continuously measuring friction equipment (CMFE):
 - **cannot be relied upon** to detect slippery runways for the reverted rubber skidding mode,
 - potential problem is apparent upon visual inspection by **highly experienced** airport engineers,
 - but not to casual or general inspection.
 - CMFE may show friction using self-wet as acceptable.

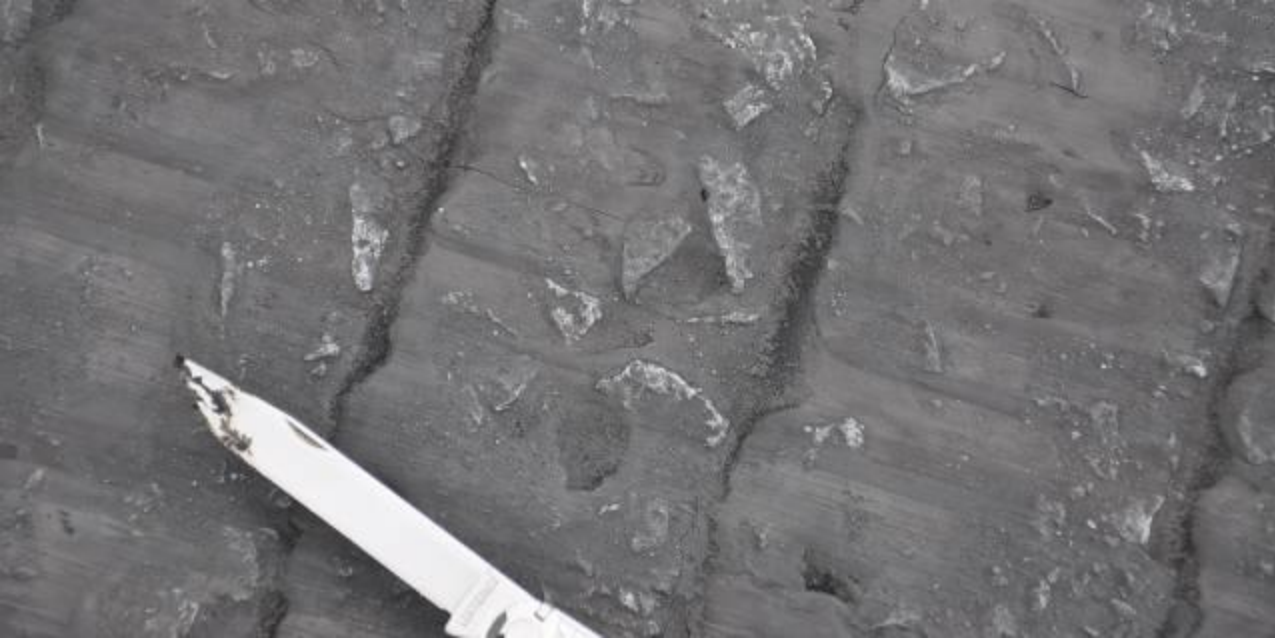
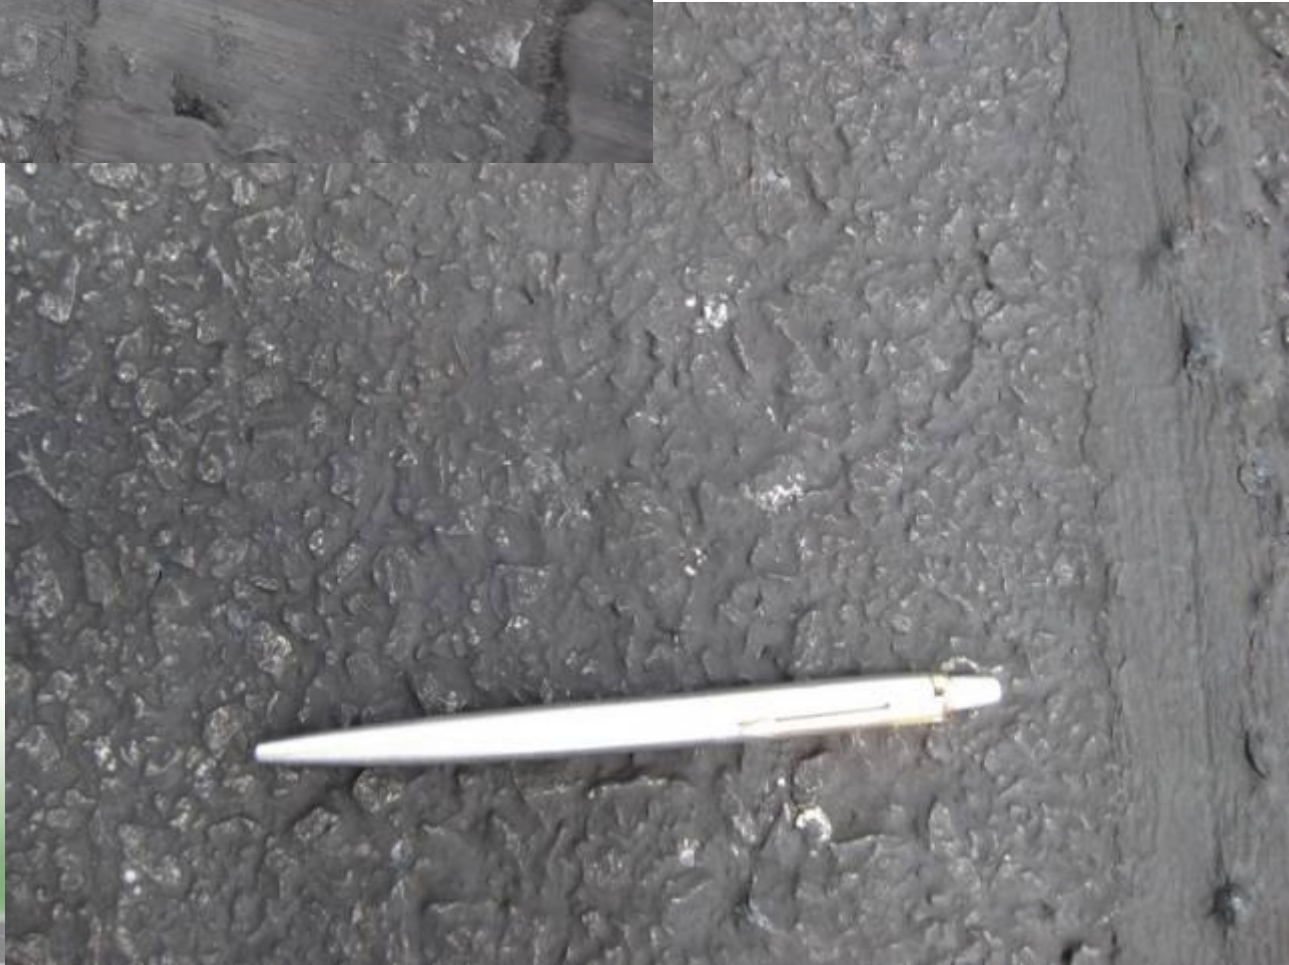
REJUVENATOR EFFECT ON TEXTURE
