**XXIV<sup>th</sup> WORLD  
ROAD CONGRESS**  
Mexico City 2011

# BALANCING ASPHALT RUT RESISTANCE WITH DURABILITY AND SAFETY REQUIREMENTS ON RUNWAY REHABILITATIONS

**Emile Horak, Steve Emery and Ivan Mihaljevic**

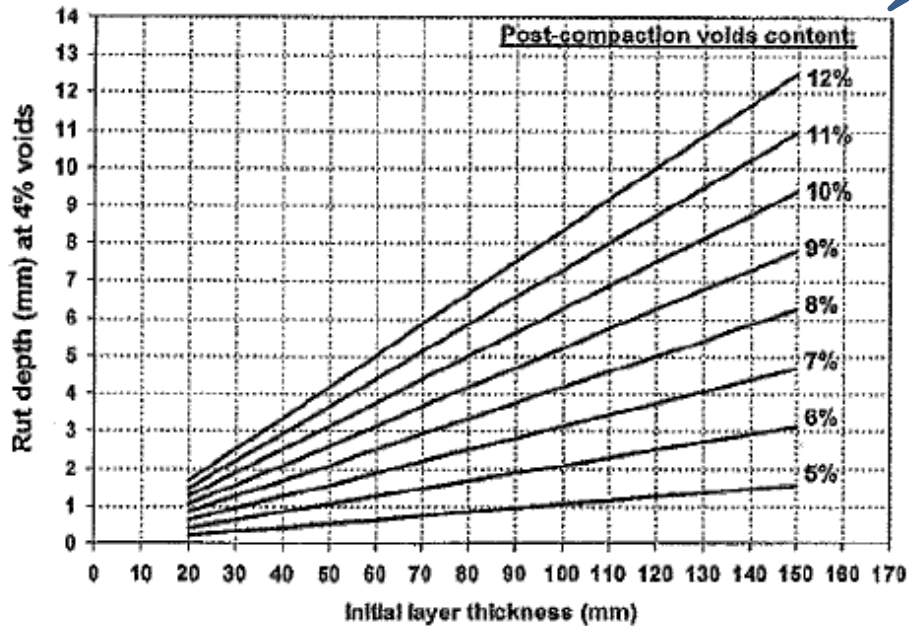
# Phase I compaction due to high void content in HMA

Estimation of rut depth due to initial asphalt consolidation (Verhaeghe et al CAPSA 2007)

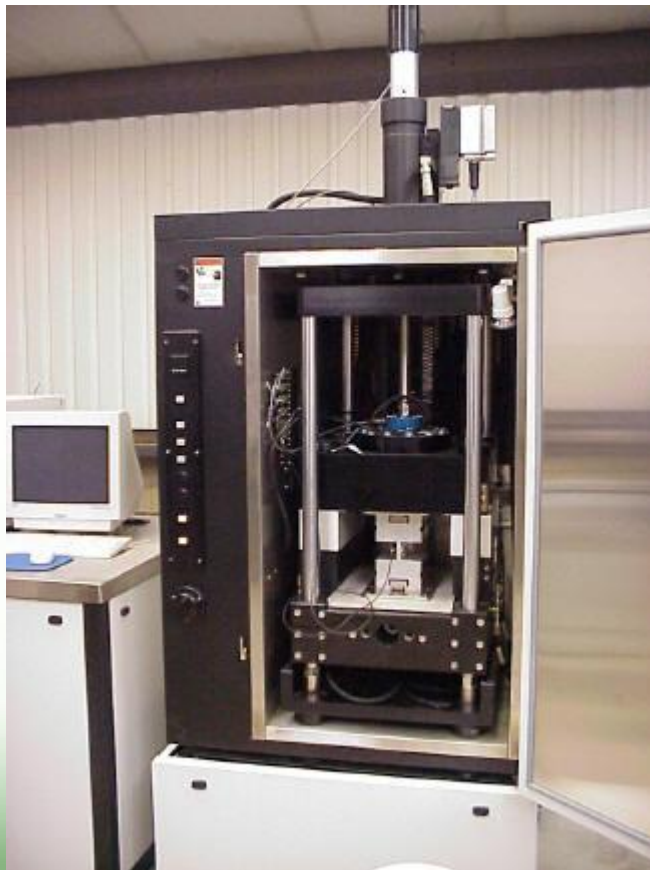
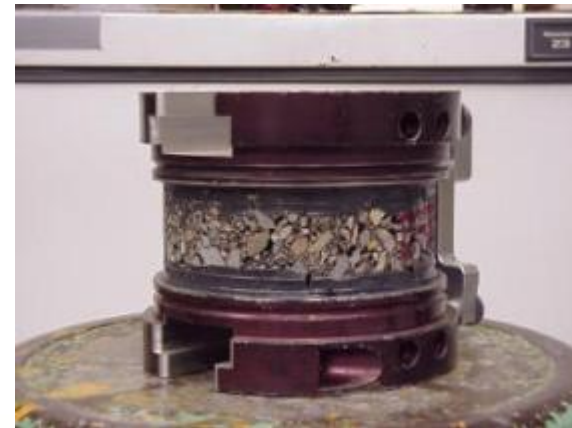
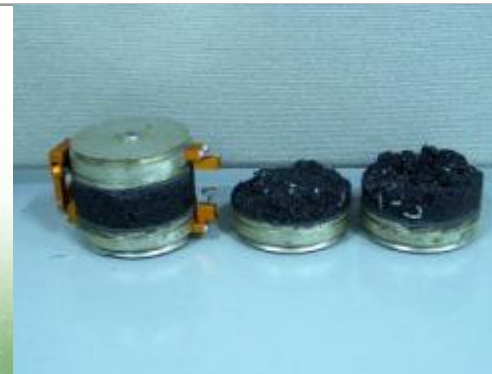
# Superpave Repeated Simple Shear Test at Constant Height (RSST-CH) apparatus and samples

Prepared Sample (above) and Sample After Test (below)

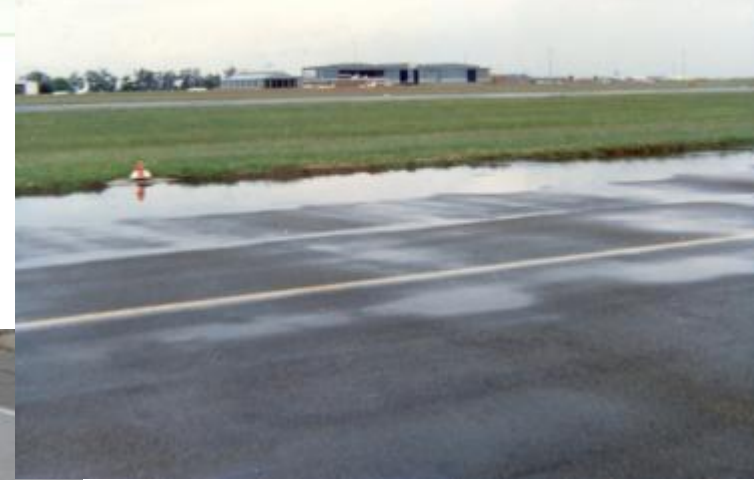
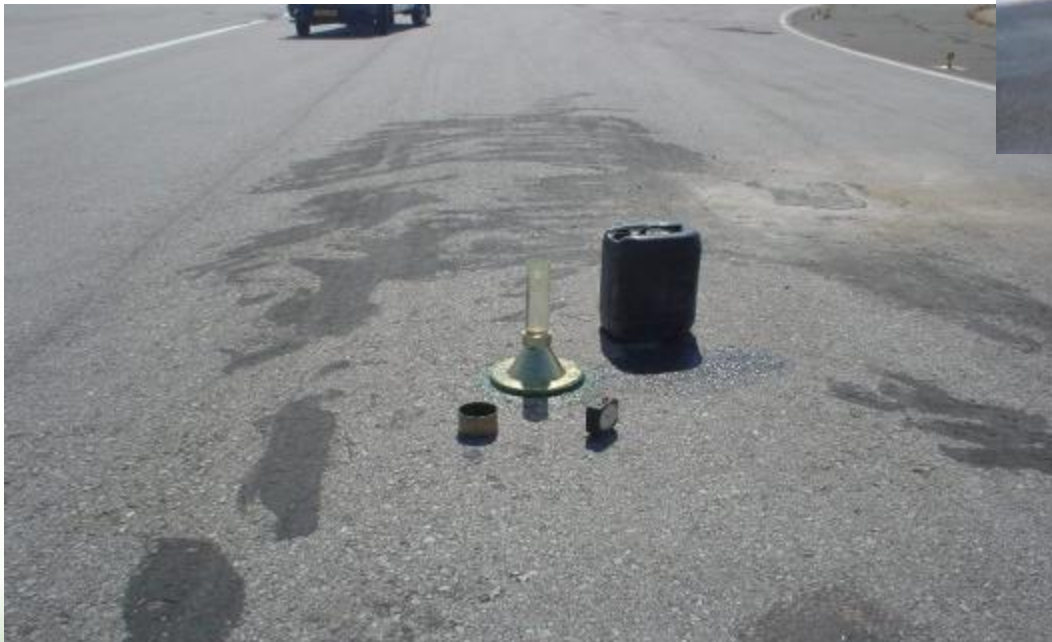
Permeability and stripping on airports

Geometric problems and problems with falling head permeability measurements

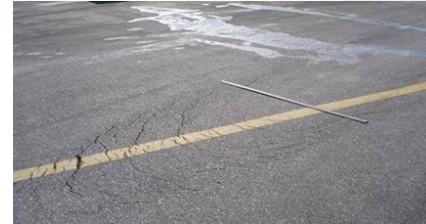
- Moisture transport: Moisture in (liquid or vapour state) infiltrates the asphalt mixture - asphalt binder/mastic - reaches the asphalt binder – aggregate interface.

- The main processes are:

- infiltration of surface water (water permeability)
- capillary rise of subsurface water and
- permeation or diffusion of water vapour.

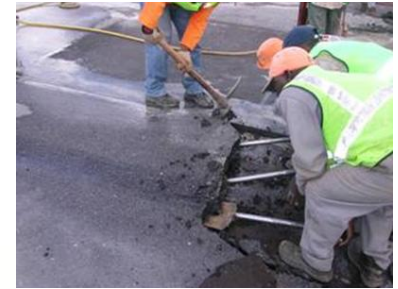
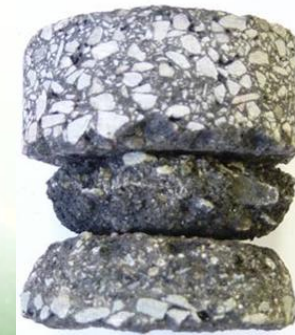
- **Response of the system: Changes in the internal structure - a loss of load carrying capacity of the material.**
- **The main responses are:**
  - detachment/debonding
  - displacement
  - dispersion
  - film rupture/micro-cracks
  - desorption
  - spontaneous emulsification

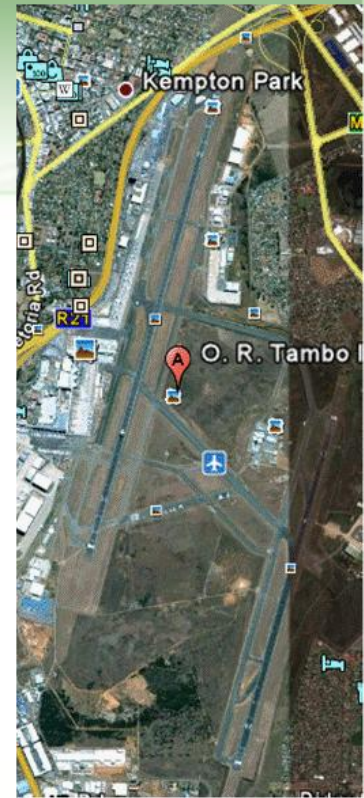
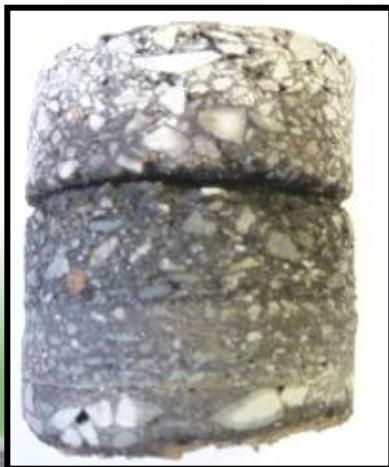
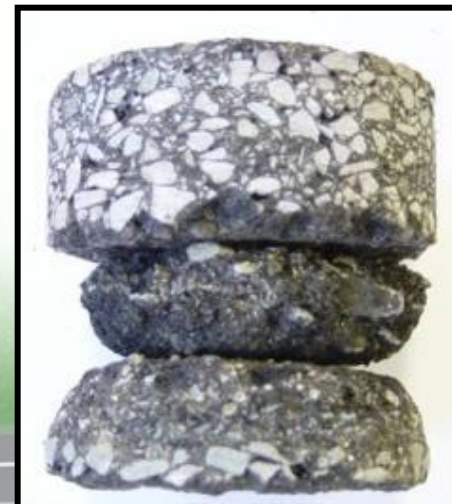
OR Tambo International Airport (ORTIA)  
(Main runway 03R 21L overlaid 2006)

Coring (100mm) - Open Graded Friction (OGF)

- two lower layers

- Stone Mastic Asphalt (SMA)

- Open Graded Asphalt (OGA).

**Limited modified Lottman tests. The average value for the wet/ dry ratio values was 76.6%.**

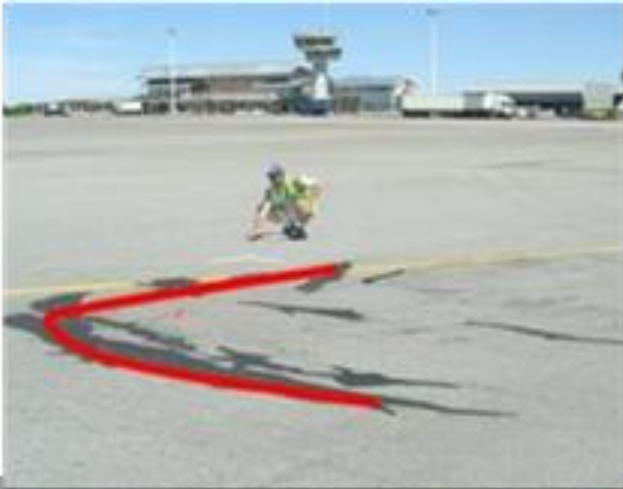
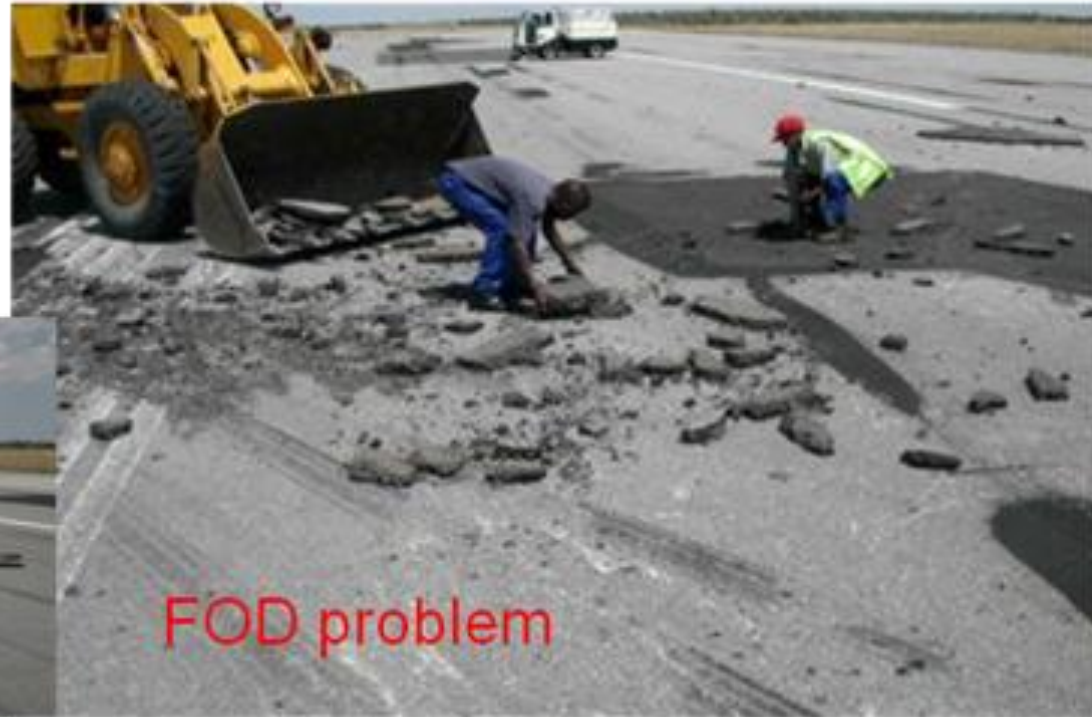
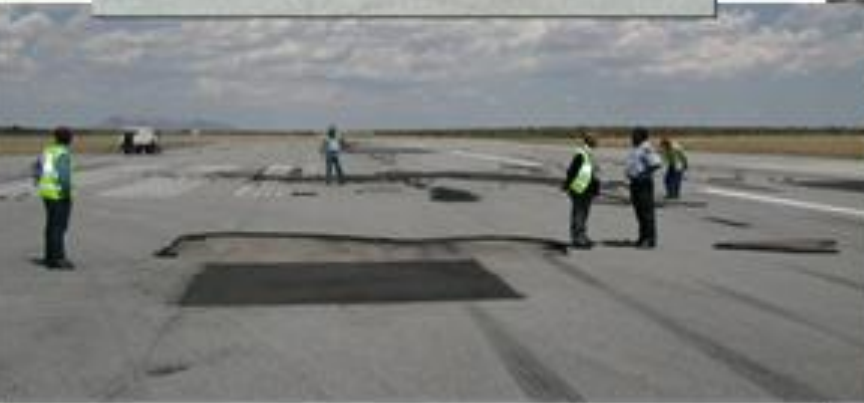
# Debonding and delamination on Hosea Kutako International Airport (HKIA)

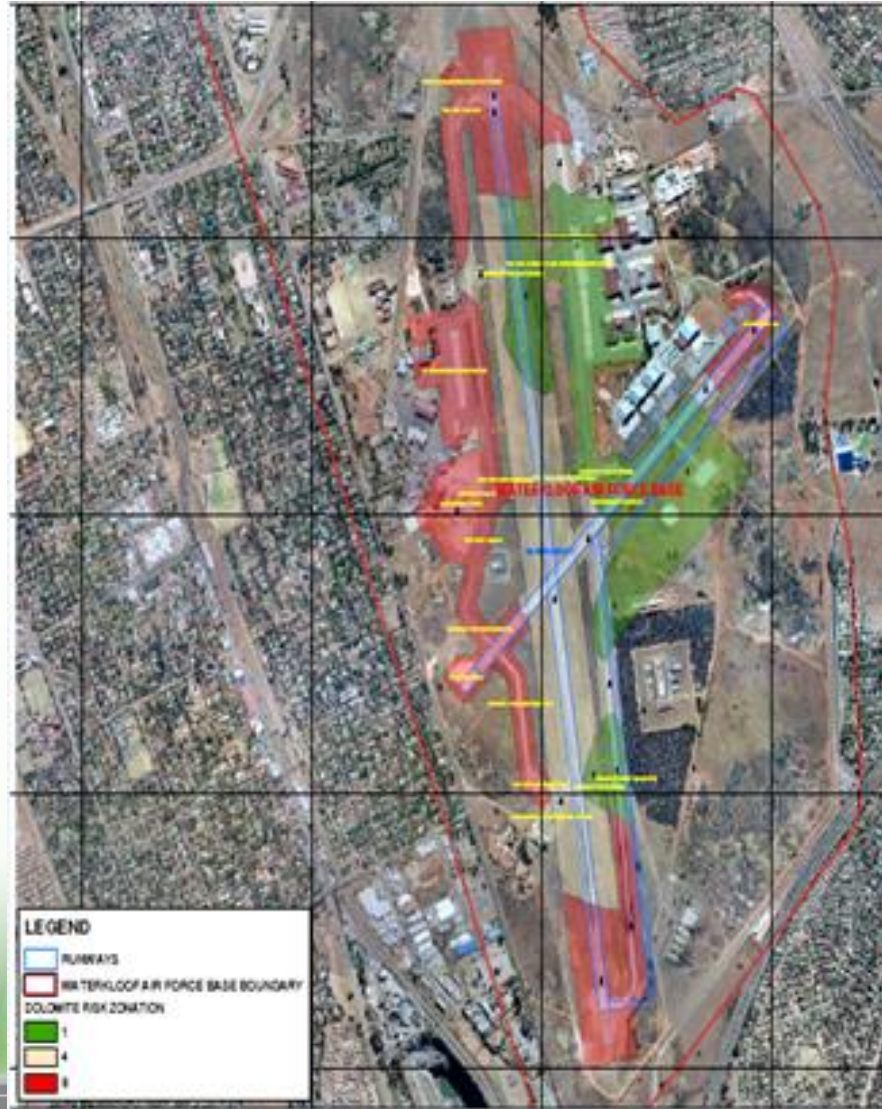
# Waterkloof Airforce Base reconstruction due to sinkhole problems

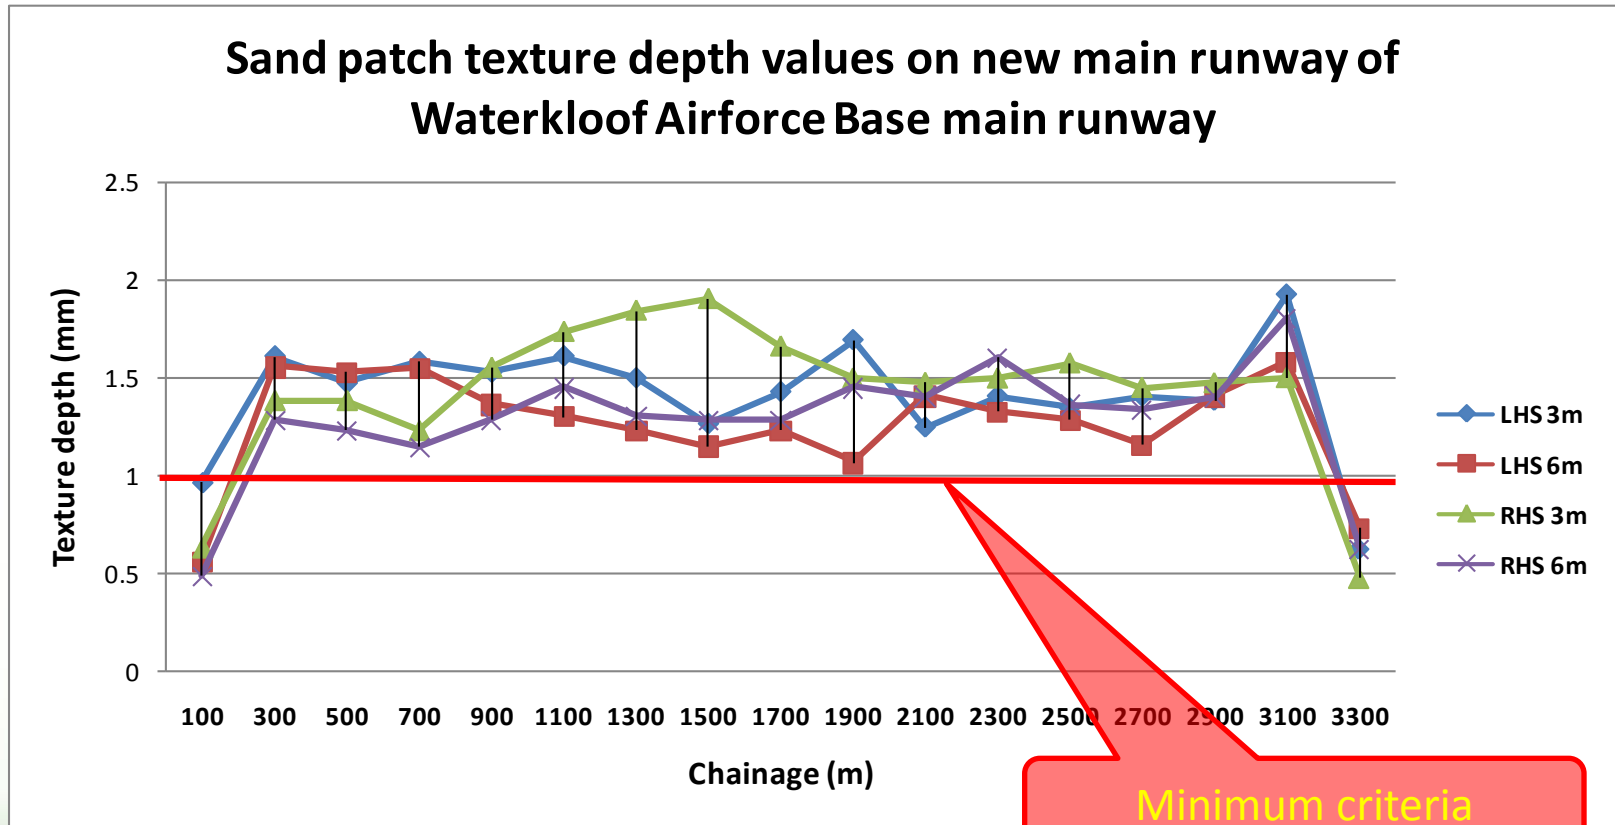
# Improved macro texture application on Waterkloof Airforce Base (WAFB) main runway

Minimum criteria

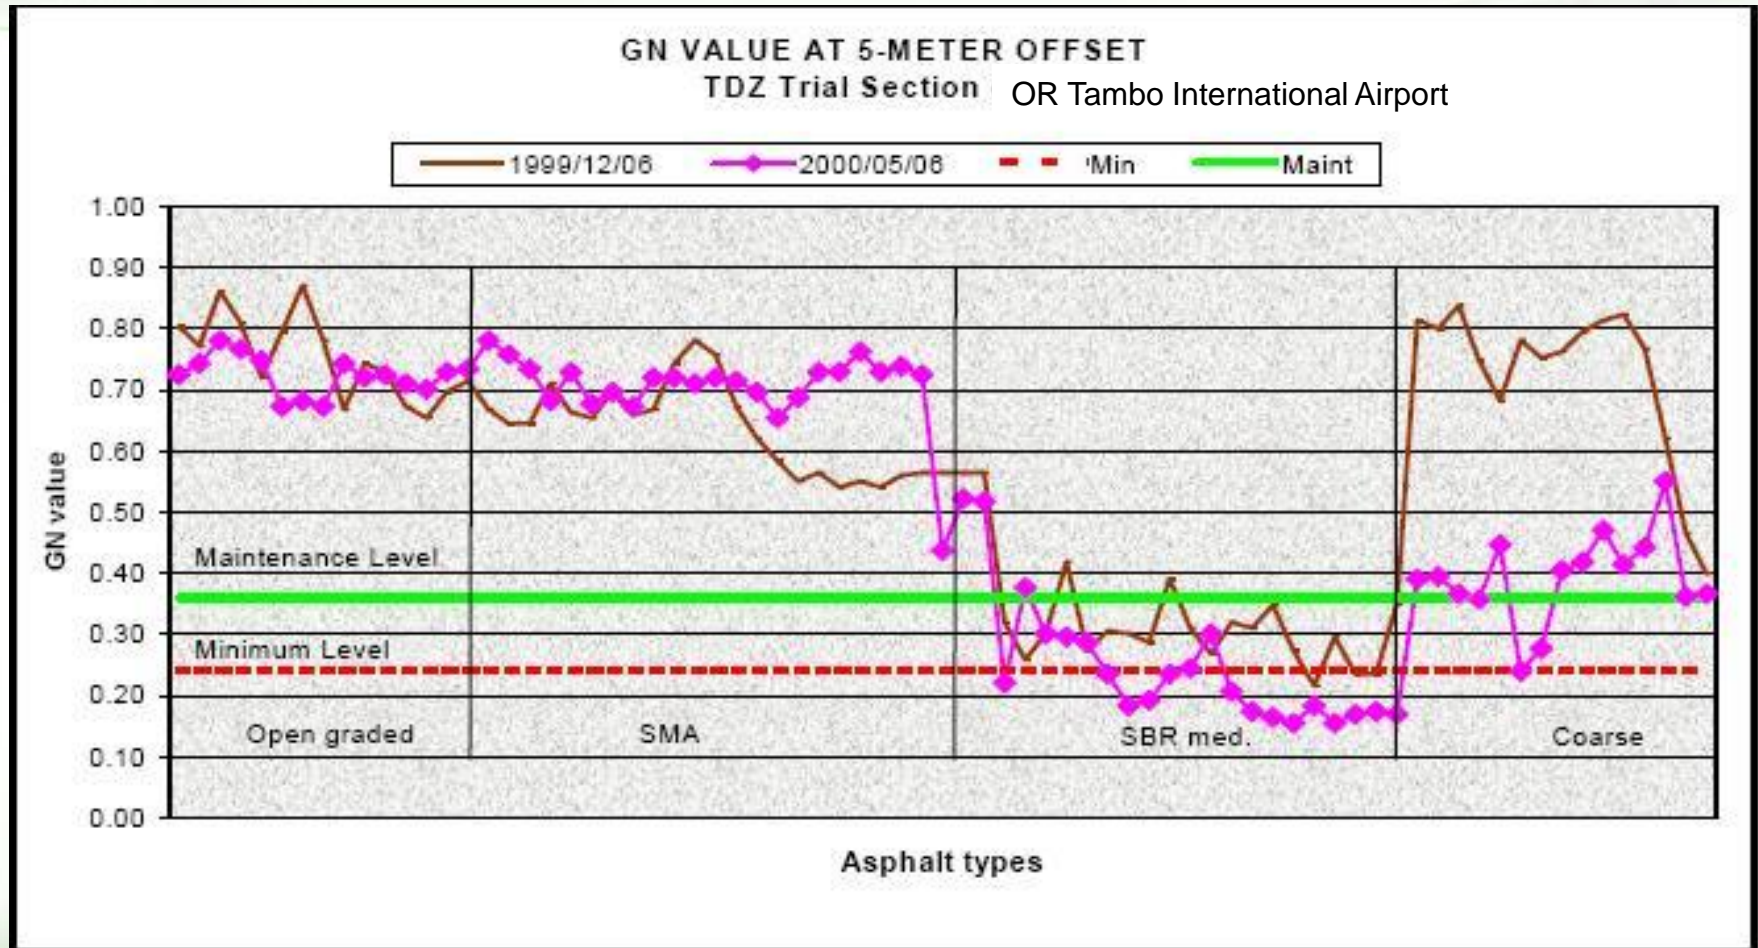
# Learning from other experiences in SA regarding SFC

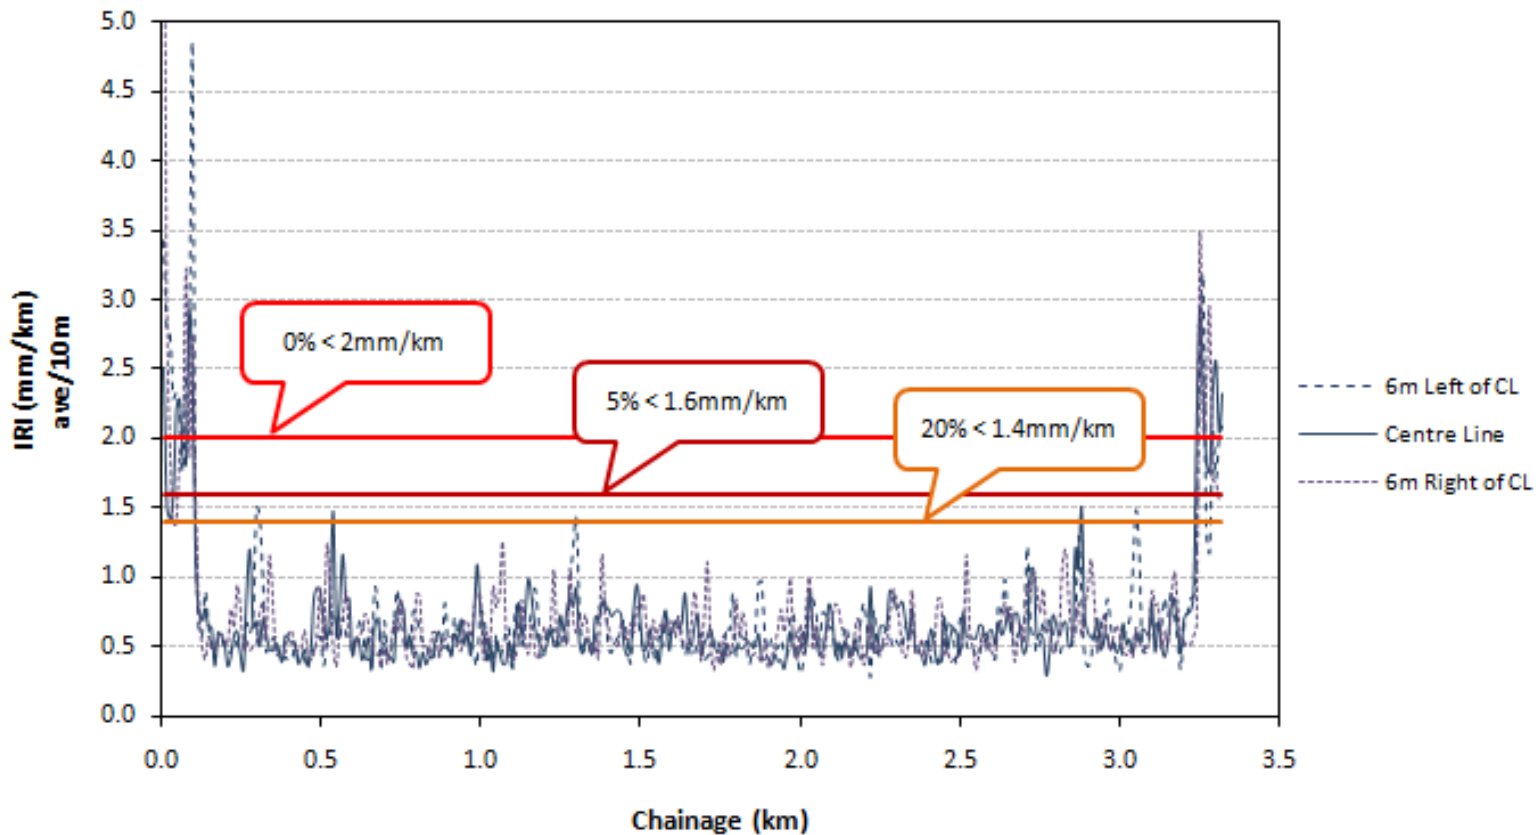
# Riding quality measurements on Waterkloof new main runway

IRI Waterkloof Main Runway 2010

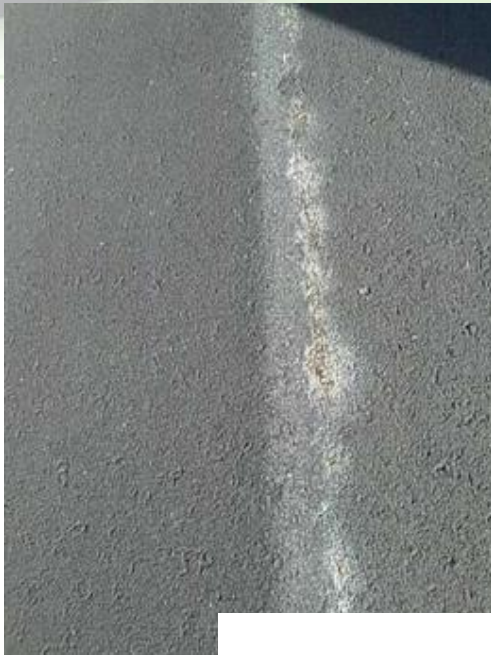
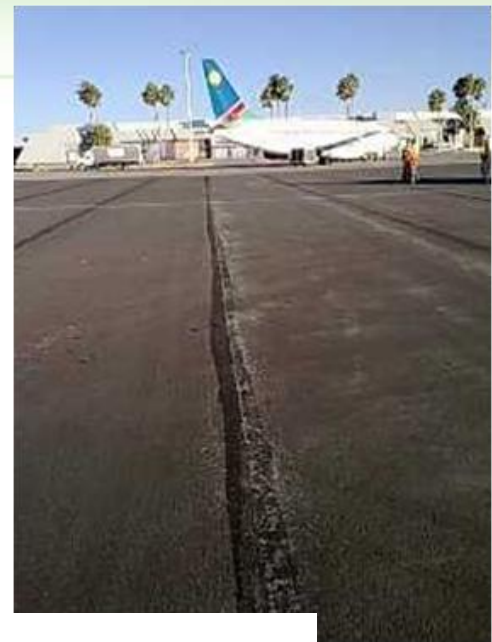
# White deposit at longitudinal joints on HKIA after excessive rain

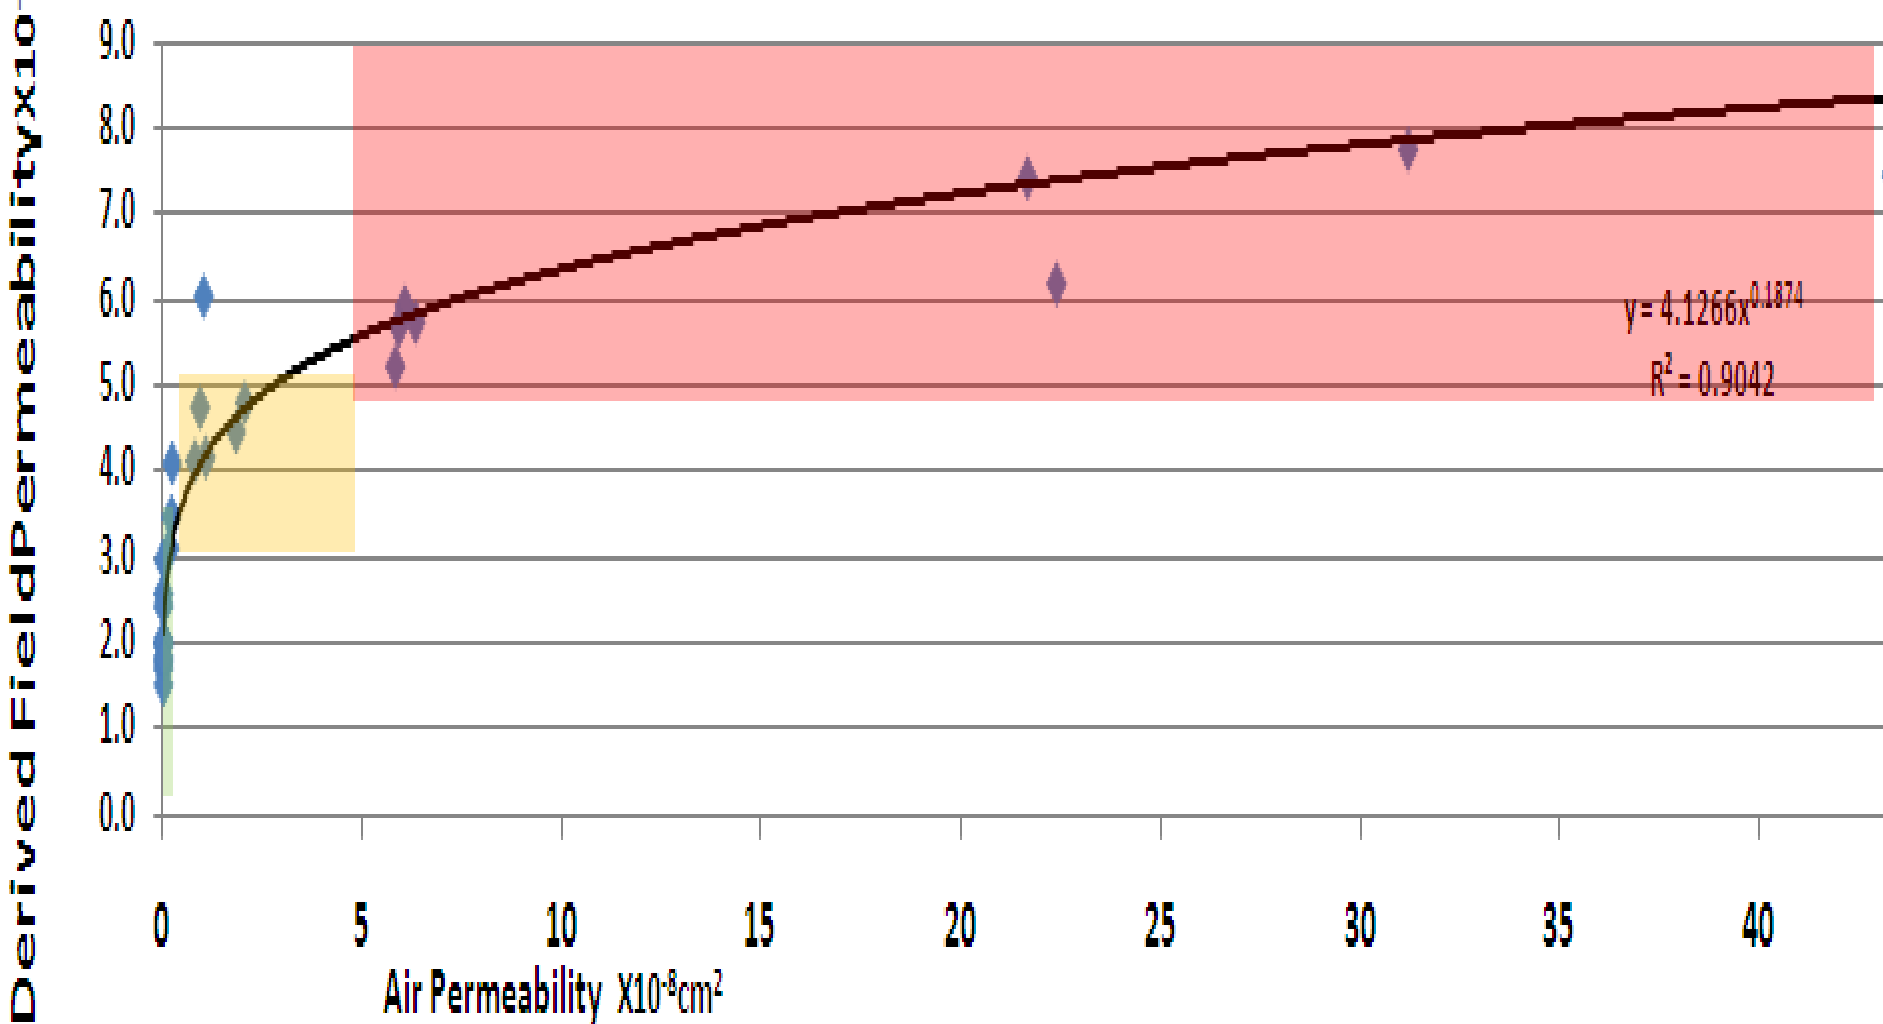
# Derived Field permeability versus air permeability HKIA
