RÍO PAPALOAPAN BRIDGE: DESIGN AND SUCCESSFUL APPLICATION OF SPECIAL NON DESTRUCTIVE INSPECTION TECHNIQUES

J. A. López-López, J. A. Quintana-Rodríguez, F. J. Carrión-Viramontes, José Luis Moreno-Jiménez

Instituto Mexicano del Transporte, Carretera Querétaro-Galindo Km. 12, 76703, Sanfandila, Pedro Escobedo, Querétaro, México.

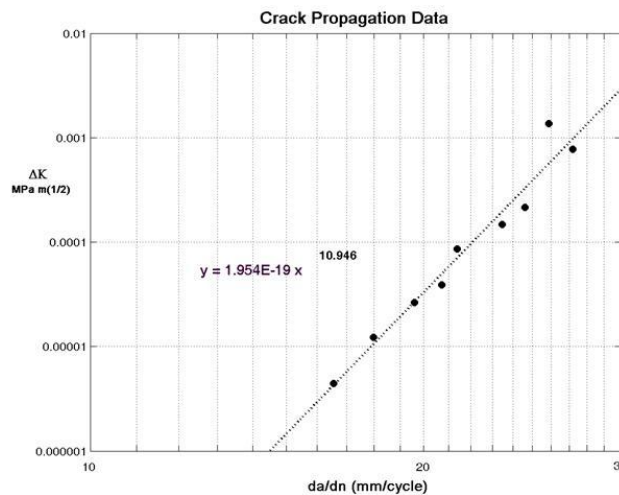
Figure 7 - Results from the crack propagation test (ΔK vs. da/dn), according to Paris model [6]

Fig. 7 shows a typical fatigue plot for ΔK to da/dn , from the crack propagation test and with the data fitted to Paris model [6]; calculations from the experimental tests, the fracture toughness and the coefficients for the Paris equation model for the anchorage steel are presented in Table 1. It should be mentioned that typical values of steels for the exponent in Paris equation (m) fall between 2 and 4; that is, a value of 10.9 corresponds to steel with a high fracture growth rate, compared to typical values.

Mechanical property		Experimental Value
Coefficients to Paris Model Equation	M	10.9
	C	1.9×10^{-19}
Fracture Toughness	K_{IC} [MPa \sqrt{m}]	26

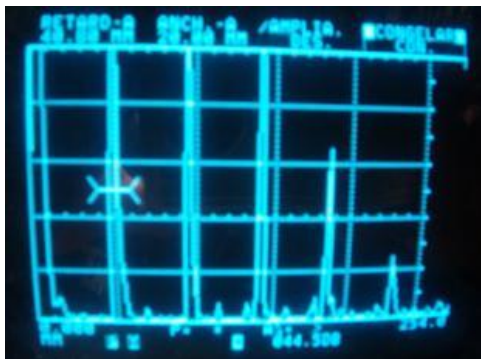
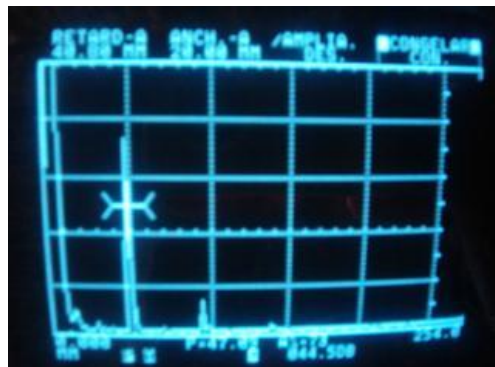
Figure 9 - Comparison of the back wall reflections of the two different grain sizes in the reference block

(a) Back wall reflections from the ASTM 7 and 8 grain size

(b) Back wall reflections from the ASTM 1 and 2 grain size

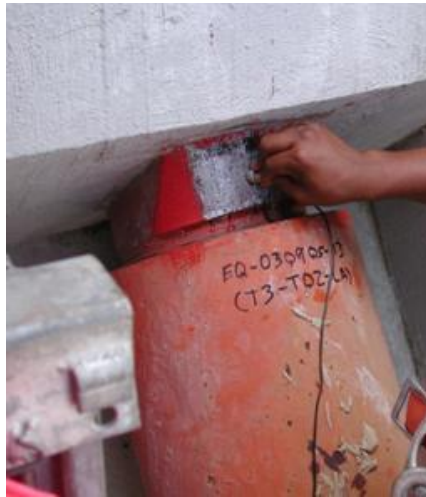
Figure 10 - Accessibility for the ultrasonic inspection of a cable upper anchorage element

Since the anchorage elements are almost completely embedded in concrete, field inspections were limited to the accessibility of the exposed surface (Fig. 10). Therefore, the inspections were complemented with 45 degree angle beam techniques to examine the internal zones of the element up to the welded zone to detect flaws in the material (Fig. 11).

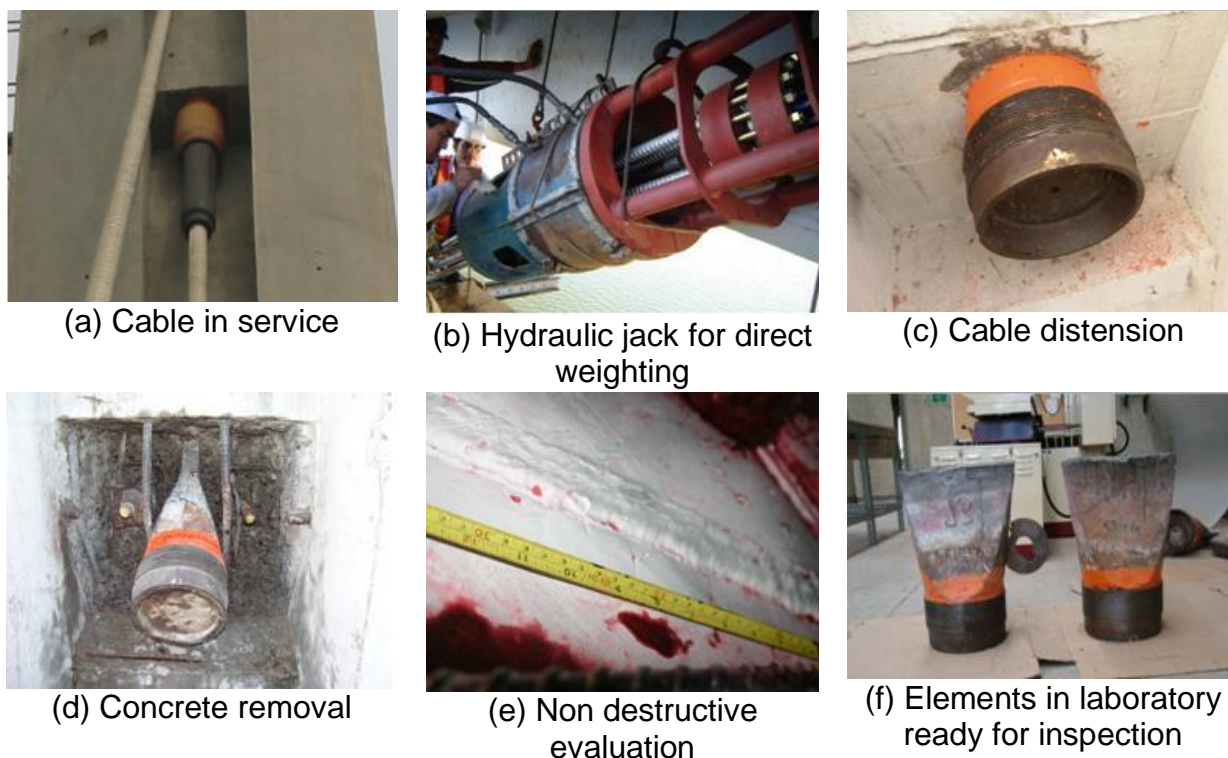
Figure 13 - Pictures showing the general process used for the rehabilitation of the upper anchorage elements.

- (a) Direct weighting of the cable with a hydraulic jack to measure its tension.
- (b) Distension of the cable; each cable was released from its bottom anchorage and then, unscrewed from the upper anchorage element.
- (c) Concrete removal to release the upper anchorage up to 5 cm away from the welded union in the tapered plate.
- (d) Nondestructive evaluation using penetrant inspection (PT), ultrasonic inspection (UT) and vibration measurements.
- (e) Anchorage removal.
- (f) Welding of the new anchorage element and rehabilitation of the concrete.
- (g) Laboratory inspection of removed elements, including sand blast, PT and UT detailed inspections, and specimens preparation for tension, fracture mechanics and fatigue testing, and microstructural and chemical analyses.

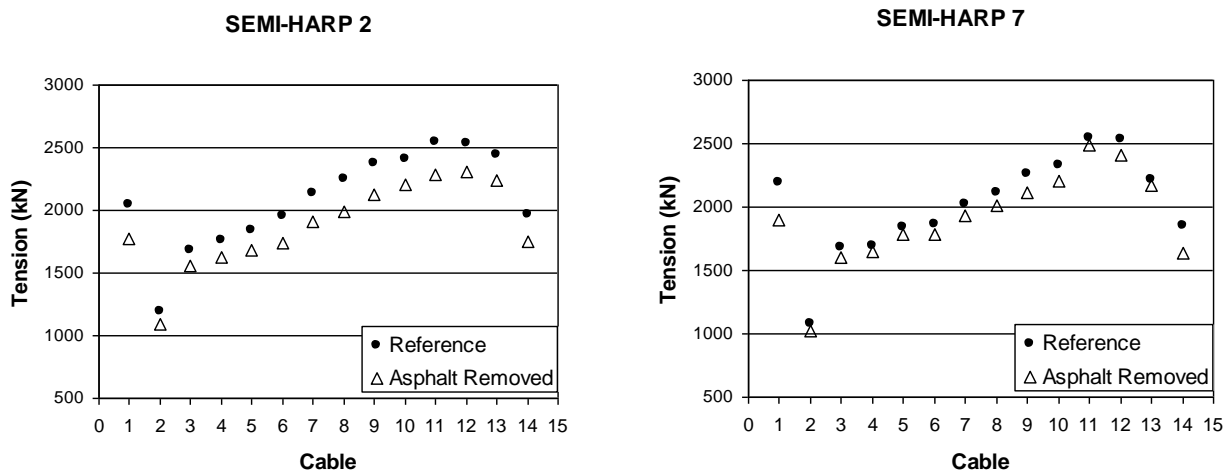
Figure 17 - Tension loads after asphalt removal on cables in semi-harps 2 and 7, with respect to the initial reference tensions.

Initial vibration measurements, prior to the rehabilitation, were used for reference. Fig. 17 shows the tensions on the cables in two semi-harps after removal of the asphalt on the down stream side and compared to the reference data. In this figure, it can be seen the difference between two opposite side semi-harps, where the average load decrease per cable in semi-harp 2 (on the down stream side) is 205 N, while for cables in semi-harp 7 (on the up stream side) is 107 N.

Full calculation of the total vertical load reduction in the 112 cables, resulted in 9181 kN. Estimation from the total material removed from the bridge deck was 9326 kN, which represents a 1.55% difference.

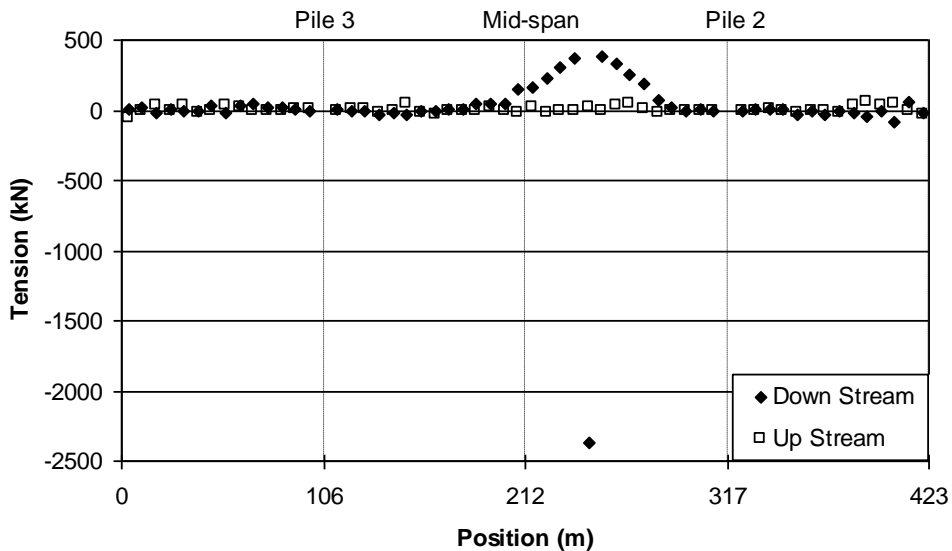
Figure 18 - Variation of the tension on the cables along the bridge after distension of cable 10 in semi-harp 3 (the x axis represents the position of the lower anchorage of each cable).

The first cable to be removed was cable 10 in semi-harp 3. In this case, cables tensions were compared to the asphalt removed data. Figure 18 shows the total load variation along the bridge at each side (down stream and up stream), where the influence of the cable distension affected mainly the 5 neighboring cables. Initial tension in cable 10 was 2363 kN and its corresponding vertical load was 1059 kN. Calculation of the vertical load changes in the 111 remaining cables resulted in 1129 kN, which corresponds to a 6.6% difference. If variations are calculated considering only the 7 closest neighboring cables, the total vertical increase is 1070 kN, which is within 1.1% difference; from this, it is concluded that the total cumulative error from the 112 cables is within 5.5%.

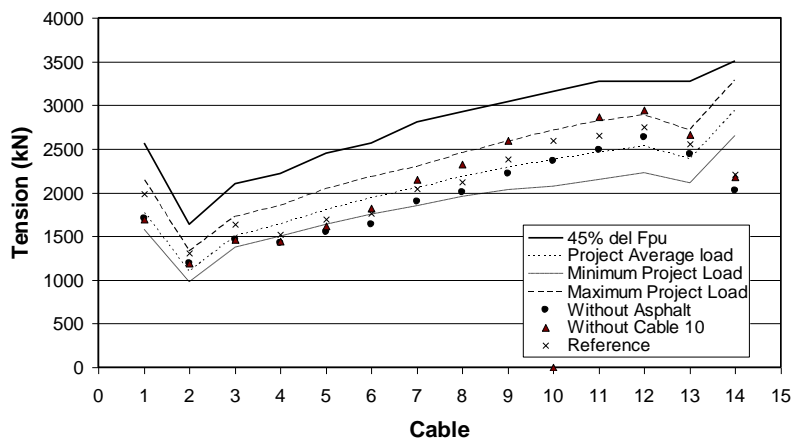
Figure 19 - Monitoring for different load conditions for semi-harp 3 during the first stage of rehabilitation of the bridge.

Figure 19 shows the comparison among the tensions in the cables of semi-harp 3 in the reference condition, after removal of the asphalt on body B, and after the removal of cable 10. From this analysis, the load tensions on the contiguous cables to cable 10, show values within the maximum design limit, which is acceptable to a limited time period required for the rehabilitation of the upper anchorage element.

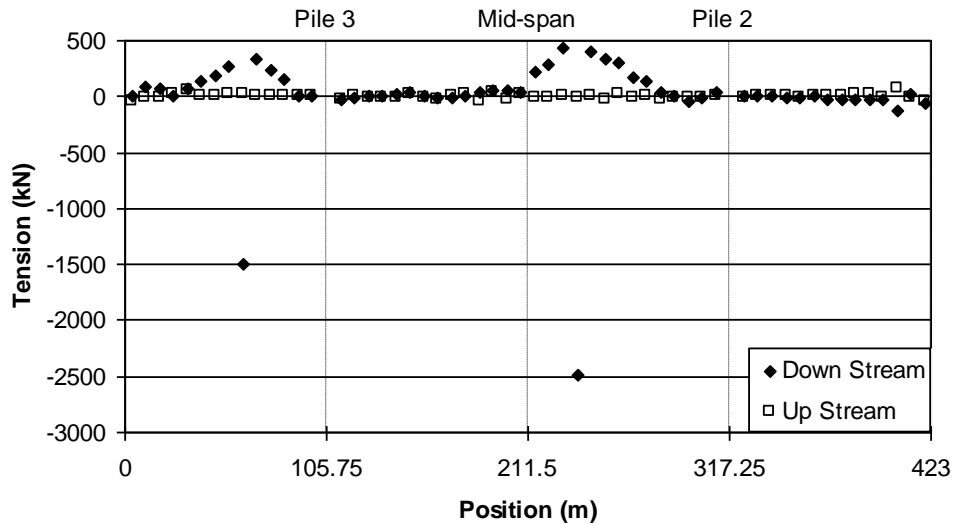
Figure 20 - Variation of the tension on the cables along the bridge after distension of cables 6 in semi-harp 1 and 11 in semi-harp (the x axis represents the position of the lower anchorage of each cable).

To evaluate the condition where two anchorage elements were replaced simultaneously, figure 20 shows the case where cables 6 from semi-harp 1 and 11 from semi-harp 3, were removed. In this case, again it is noted that the distension effect is limited up to the 5 closest neighbors from the removed cable. In this case, the total removed vertical load was 1900 kN, while the total vertical load increase for the 110 remaining cables was 1962 kN; which corresponds to a 3.2% difference. Again, if variation is calculated only to the 7 closest cables, the difference is reduced to 1.4% from the total removed vertical load.

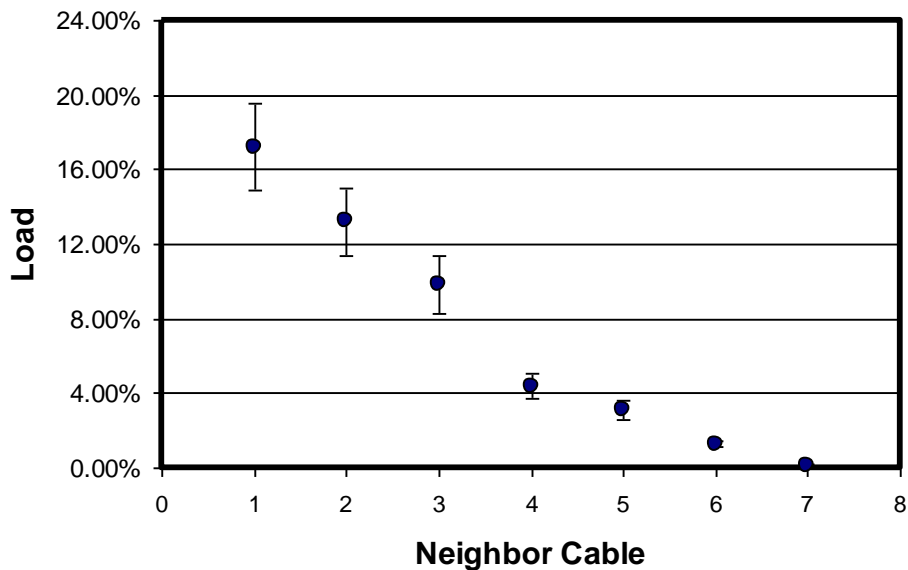
Figure 21 - Average load distribution to neighboring cables for a released cable.

Different load conditions were evaluated and statistical vertical load redistribution was calculated for each removed cable condition (Fig. 12). From this analysis, it is shown that the distension of one cable has limited influence to a few neighboring cables; thus bridge behavior can be estimated beforehand (Fig. 21).
