THE BRIDGE MANAGEMENT OF A TOLL MOTORWAY NETWORK RESULTS OF CURRENT DEVELOPMENTS AND IMPLEMENTATIONS

R. PÉREZ ARENAS & C. MILLÁN, Abertis Autopistas España

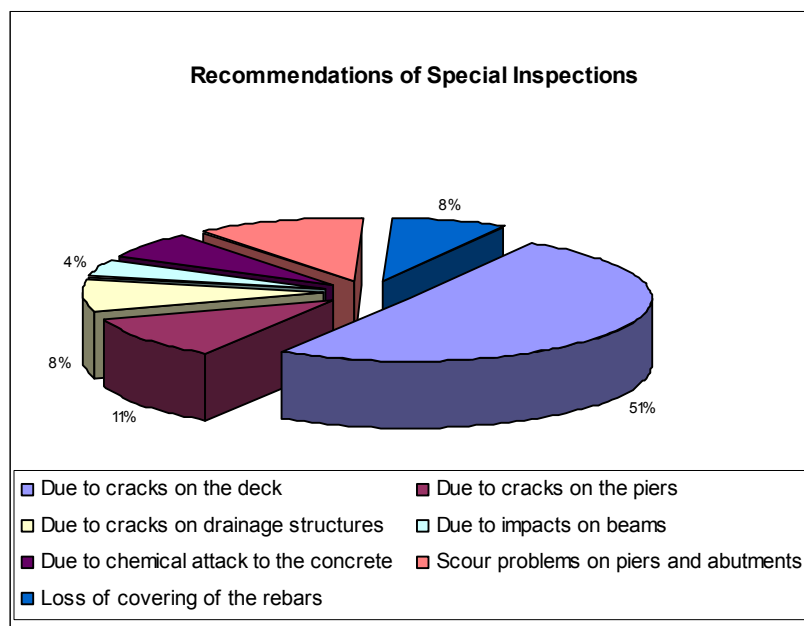
Figure 8 – Special Inspections. Origin of the required detailed investigations.

The main reasons for making these detailed investigations are summarised as follows:

- 45 bridges have a lot of cracks due to bending moments on the decks.
- 10 bridges have lot of vertical cracks on the piers.
- 7 underpasses have a lot of horizontal cracks on the top slab
- The deck of 4 bridges has been hit by a over gauged traffic
- 6 bridges seems to have some kind of chemical attack on the concrete
- 10 structures were affected by some scour problems
- 7 structures have some other kind of concrete damages (spalling, corroded reinforcing,...)

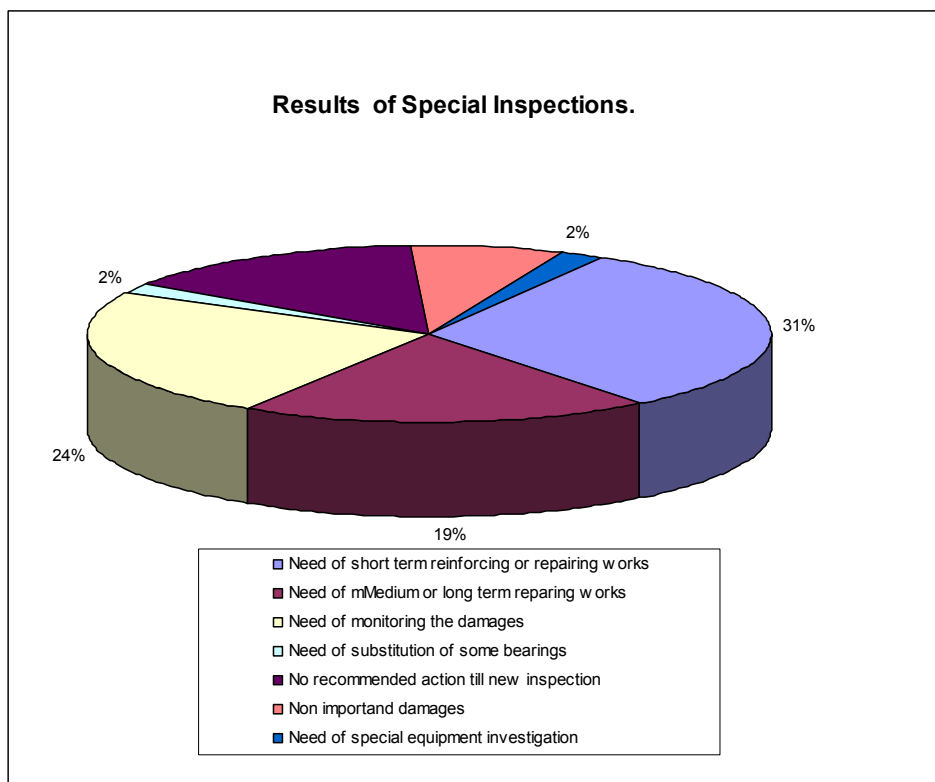
Figure 9 – Results of the Special Inspections

Following the main conclusions of the 89 Special Inspections are presented:

- 34 structures are recommended to be repaired in a short period of time
- 21 structures are recommended to be repaired in a not very long period of time
- 26 structures are recommended to be monitored in order to follow the evolution of the observed damages.
- The bearings of 2 structures are recommended to be substituted
- 16 structures were in good conditions and the observed damages were not dangerous.
- The observed damages of 8 structures were harmless.
- It was necessary to use special access equipment for investigating 2 structures, because the piers were very high.
