**XXIVth World
Road Congress
Mexico 2011**
Mexico City 2011.

The Great East Japan Earthquake Disaster

Keiichi Tamura

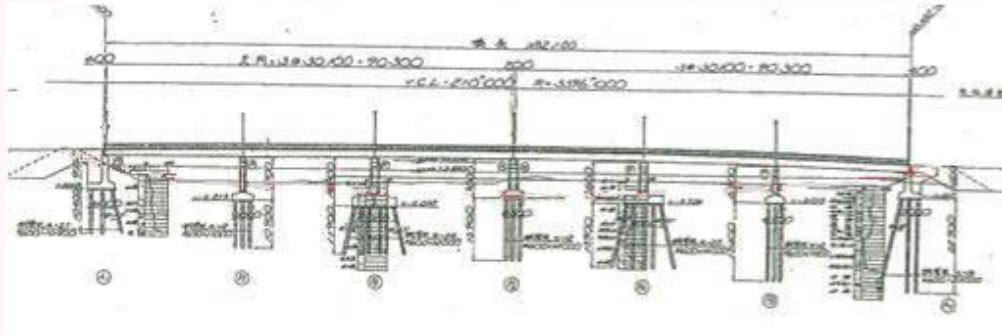
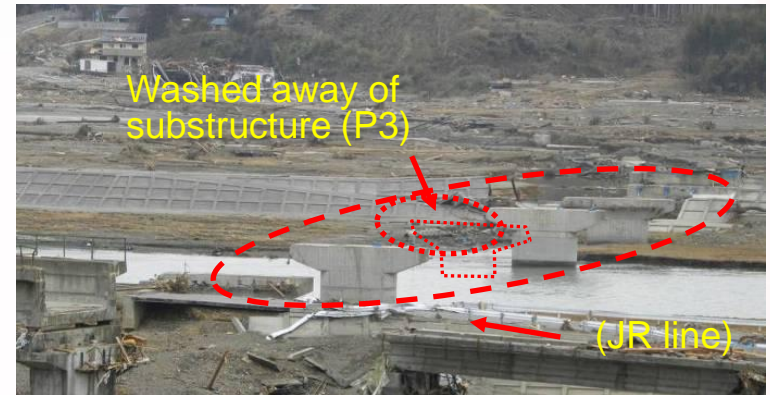
Koizumi Ohashi Bridge damaged by tsunami

- 6-span steel girder bridge (two 3-span-continuous girders).
- All girders and one RC pier were washed away.

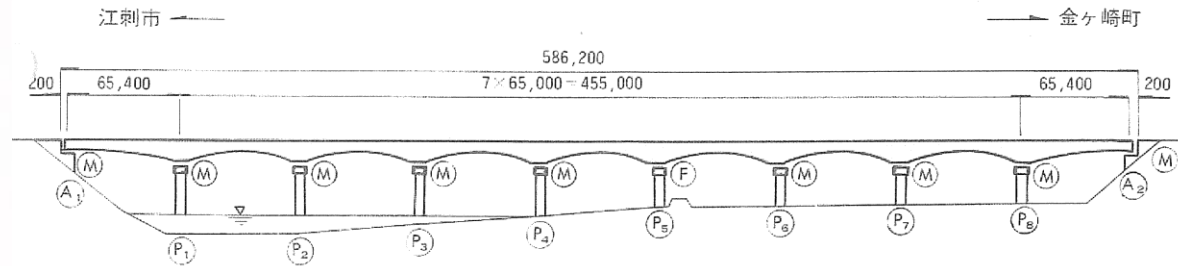
Ezaki Ohashi Bridge damaged by ground motion

- 9-span PC box girder bridge designed by pre-1980 specifications
- Shear cracks, spalling off of cover concrete and buckling of longitudinal rebars at section of cut-off of longitudinal rebars

Damage to RC columns at section of cut-off of longitudinal rebars

Temporary repair by wrapping up with carbon fiber sheet

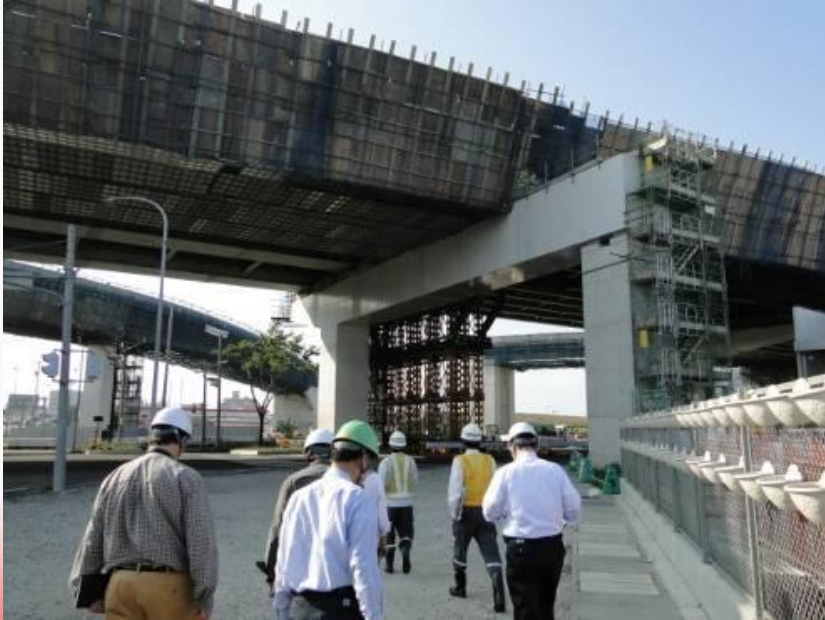
Sendai-Tohbu Viaduct damaged by ground motion

- 4-span steel box girder and 2-span steel girder bridge
- Designed by post-Kobe Earthquake specifications
- Elastomeric rubber bearings were ruptured.
