# **INCREASING THE CAPACITY OF THE AP-6 MOTORWAY AND GUADARRAMA TUNNELS: OPERATION BY REVERSIBLE ROADWAY AND EVOLUTION IN THE SAFETY SYSTEMS**

This communication examines both the design criteria used and the project carried out to increase the capacity and the modification of the existing circulation system, using the central carriageway of this section for reversible operation.

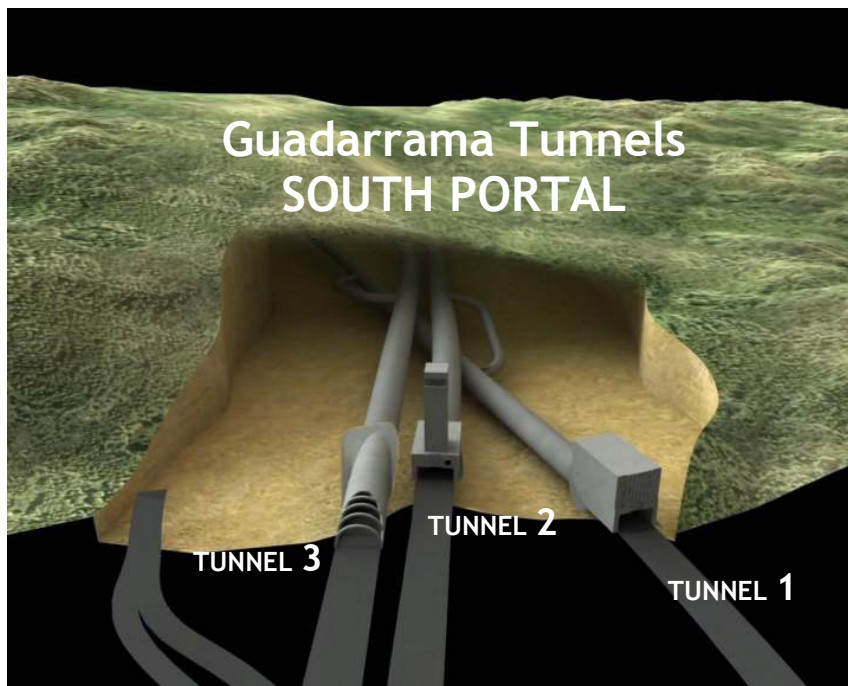
“Figure 2 – Guadarrama Tunnels. South Portal”

Tunnel 3 is for Madrid-bound traffic. Tunnel 3 accepts both light and heavy vehicles. Its alignment is approximately parallel to the alignment of tunnel 2, and both of these tunnels cross over tunnel 1 at about 250 metres from the South portal (fig. 2), after which the alignment of tunnel 3 is almost equidistant in height and length between the two other tunnels.

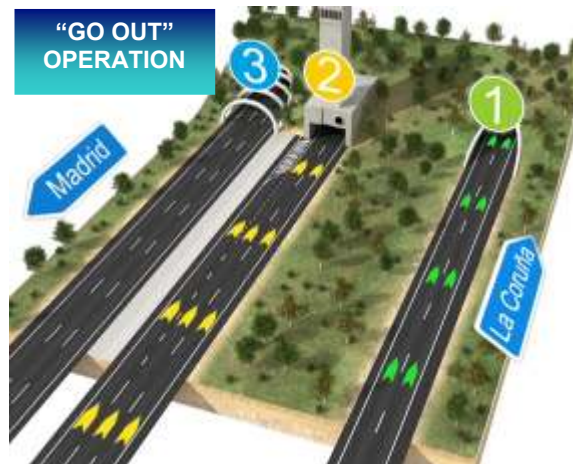
“Figure 3 – ‘Go Out’ Operation Configuration”

Tunnel 1, which until now has operated for the Madrid-bound roadway for all types of vehicles, become part from now on of a reverse-flow roadway which will operate for either Madrid-bound traffic or La Coruña-bound traffic according to demand and road conditions. In principle, this roadway is for light vehicles only, except for those occasional circumstances when it will become necessary to allow heavy vehicles to pass (for example, the closing of tunnel 2 or 3 in the event of a serious incident, or maintenance works).

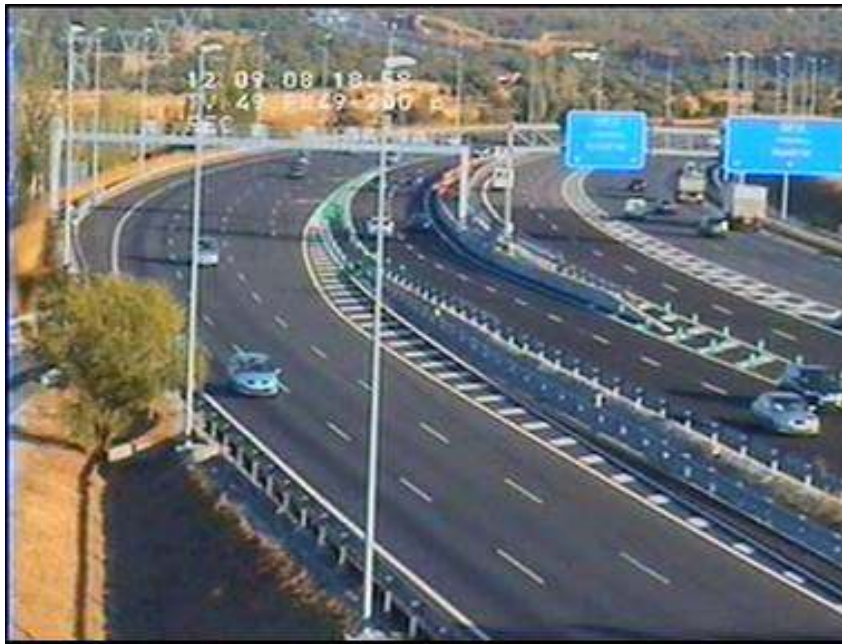
“Picture 1 – South Distributor”

From the point of view of layout design, important conditioning factors existed for the South Distributor (pict. 1) owing to the fact that it was necessary for it to be situated in a specific stretch that did not reach 2,000 m, between a slip road and viaduct. This stretch is situated on a wide curve to the left and with a slope of approximately 6%. In the ascending direction (entry) the treatment given was that of a fork, changing from one carriageway of 4 lanes to two carriageways of 2 + 3 lanes. It was therefore necessary to prepare the design with an ample length of transition from 4 to 5 lanes before the separation of the lanes, and then also proceed to make the transition from 4 to 3 lanes in the carriageway in the ascending direction (direction La Coruña). For the incorporation, the design was a confluence from two carriageways of 2+3 lanes to one of 4 lanes, with no greater complications, except the proximity of the deceleration lane for the immediately following slip road. [2]

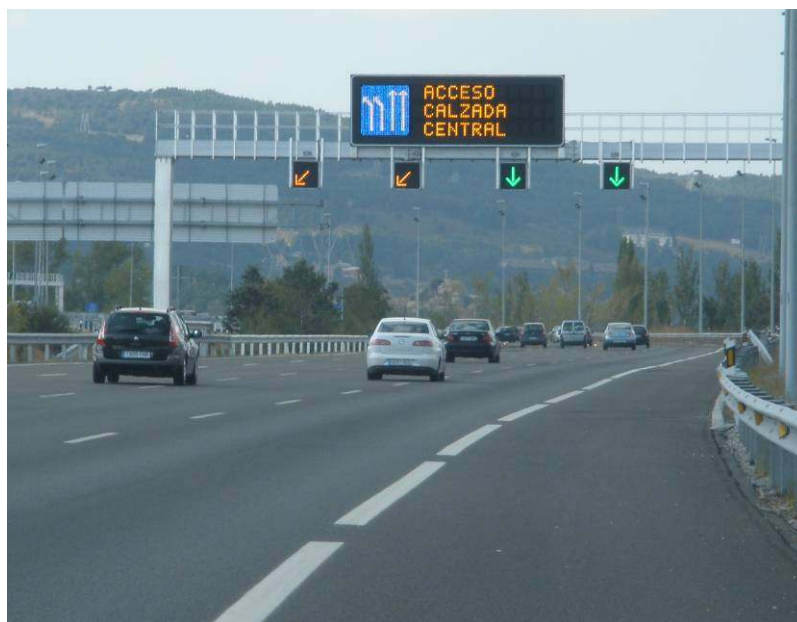
“Picture 2 – Variable Message Panel in South Distributor”

allows the monitoring and supervision of operations from the Control Centre. The system has been designed so that the opening and closing operations may be carried out totally automatically, although initially they were carried out with in-situ presence of operating personnel in order to validate the execution of the algorithms programmed into the system and in turn reinforce with their presence that which was indicated by the panels (pict. 2) and crosses/arrows at each moment. [4]

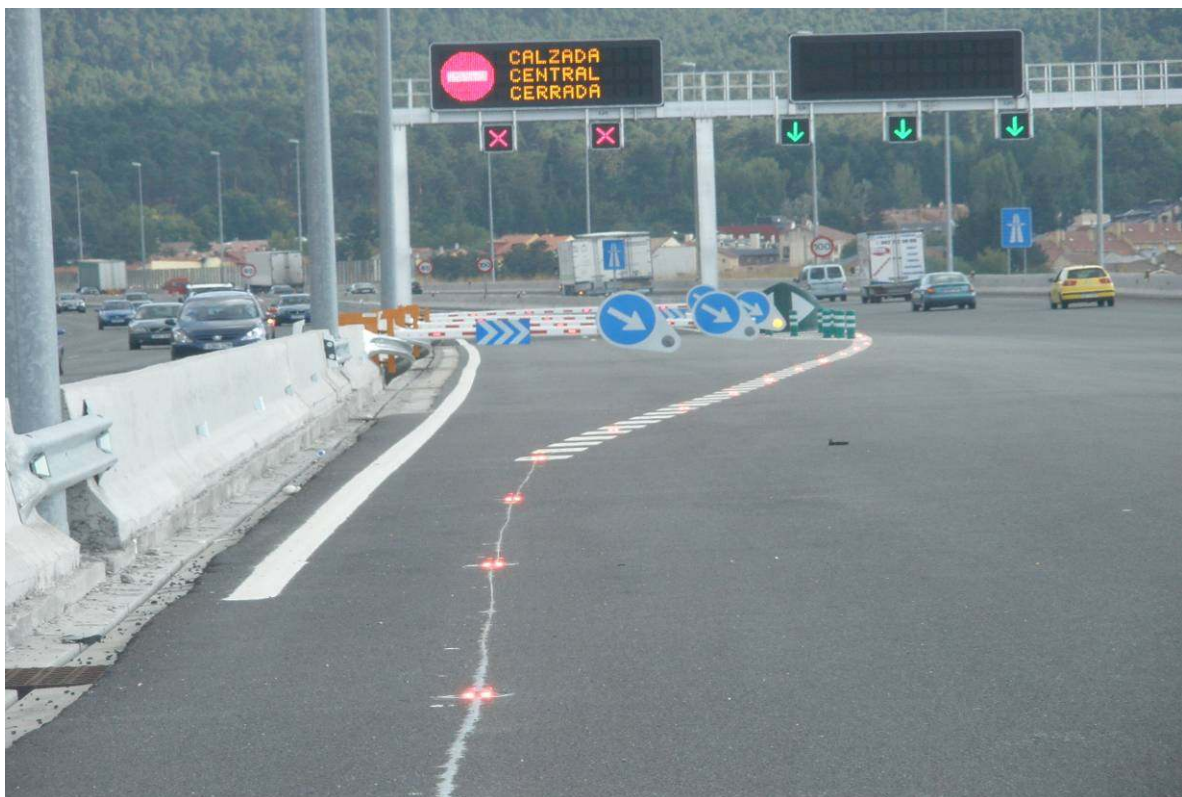
“Picture 3 – Variable Message Panel in North Distributor”

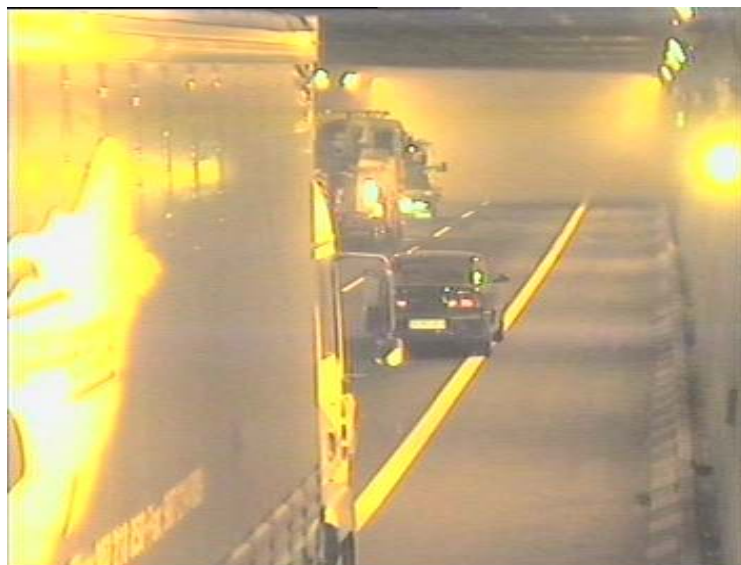
“Picture 5 – Smoke control through ventilation”

Immediately afterwards, the procedure for closing Tunnel 2 was implemented, in the first instance, and subsequently the closure of tunnel 3, in order to facilitate access by emergency vehicles from the operational base via the passages connecting both tunnels (fig. 7). The Tunnel Closure Plan was implemented automatically and without failures by means of the external signalling protocol via variable message panels, cross/arrow panels in the entrances and traffic lights and closure barriers. Also simultaneously, the Ventilation Protocol was activated, both in Tunnel 2 and in the evacuation passages to provide them immediately with excess pressure. With regard to the behaviour of the smoke, although the potential for generation could not have been high, it was ascertained that initially the

phenomenon of “backlayering” or backward flow of smoke due to buoyancy occurred, although only for a few metres, which allowed the zone upstream from the incident, occupied by the detained vehicles, to remain free from smoke at all times.

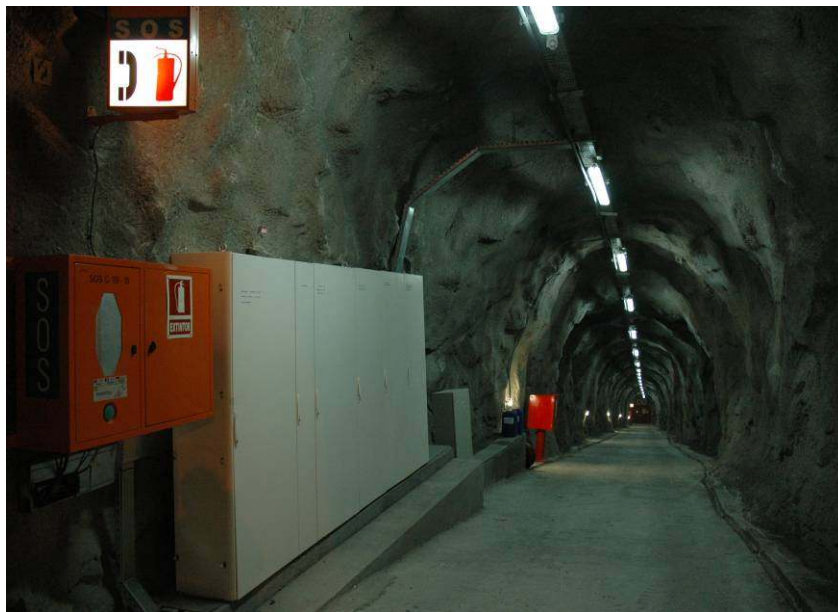
"Picture 6 – Inside the emergency passage"
